Report Number: Passadiço - 06

## **Construction Progress Report**

Monthly Period Reporting

Start: Thursday, 01 September 2022 End: Friday, 30 September 2022

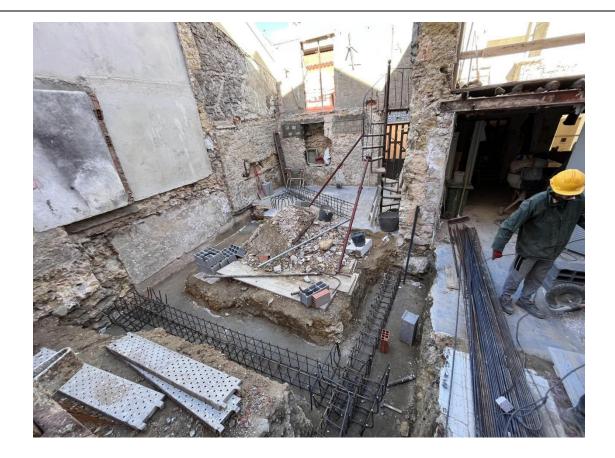
At the end of August, the builders finished a general excavation reaching the lowest level of this building. In September, they continued excavating the foundation foot, in order to reinforce the building foundation for the new structure. Following the steps, a thin layer of concrete was applied as a basement of the foundation, and then the reinforced steel bars were installed.
