Report Number: Laurel - 08

## **Construction Progress Report**

Monthly Period Reporting	Start: Saturday, 01 October 2022 End: Monday, 31 October 2022
Builder	LADRILLO S.A - Construção, Remodelações e Projecto

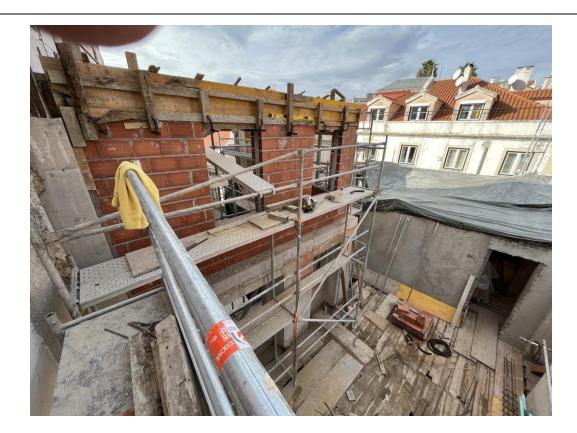
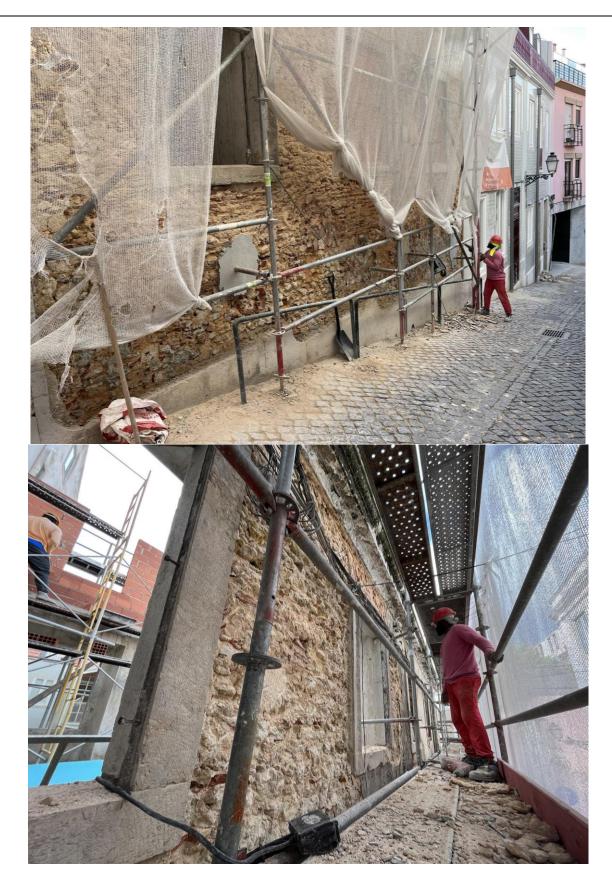
In October, the builders finished assembling a steel structure and wooden mode, poured concret to form a capping beam which tiles all the piling together to create the foundation for the next step. They continued installing the columns and bricks on the beam to build concrete structure from the 2nd floor to the 3rd floor.

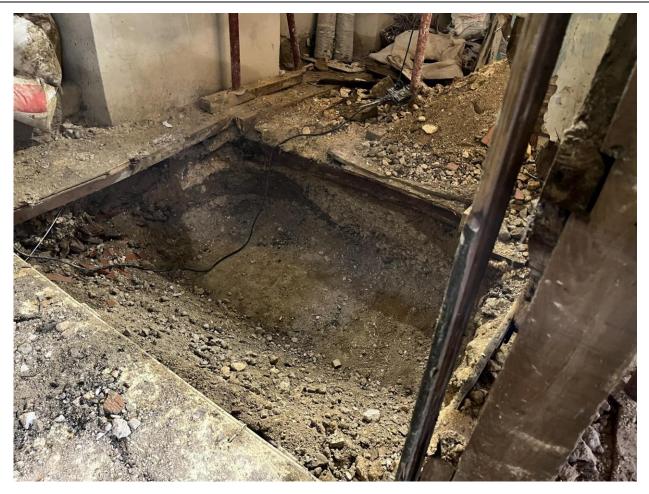
Following the work plan, the builder was doing an excavation for the footing of the building foundation, to build a steel structure to reinforce it in the future.

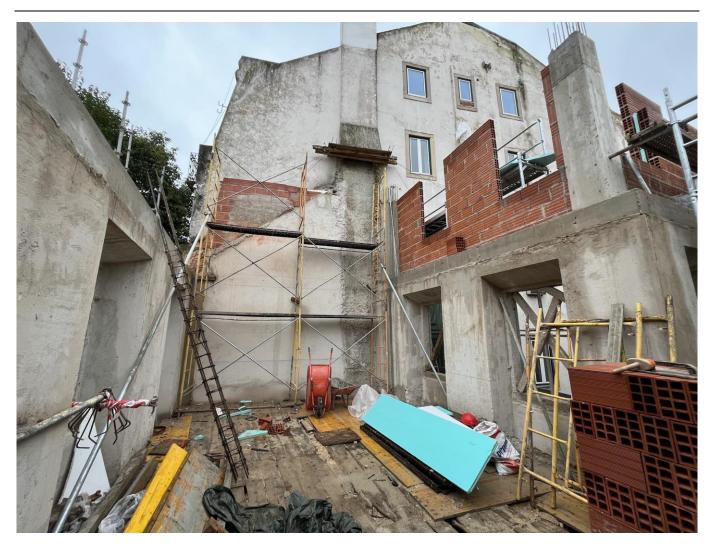
The exterior wall on the 2nd floor was finished in October. At the same time, the builders extended the existing walls attaching with the next building with bricks.
