Report Number: Passadiço - 07

## **Construction Progress Report**

Start: Saturday, 01 October 2022 End: Monday, 31 October 2022

**Builder** NS Reformas, Construccion Y Trading S.L.U

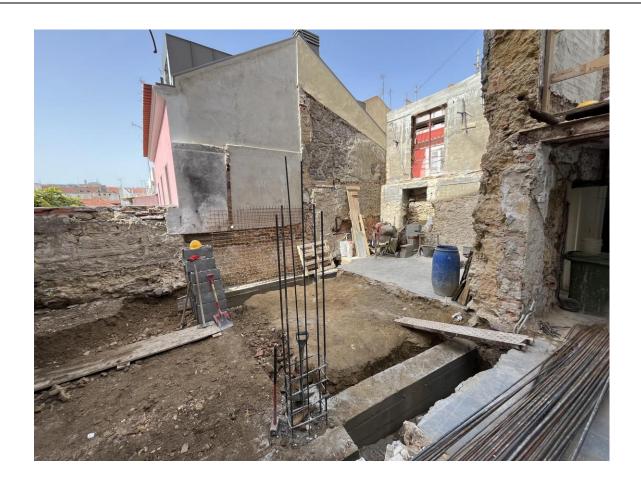
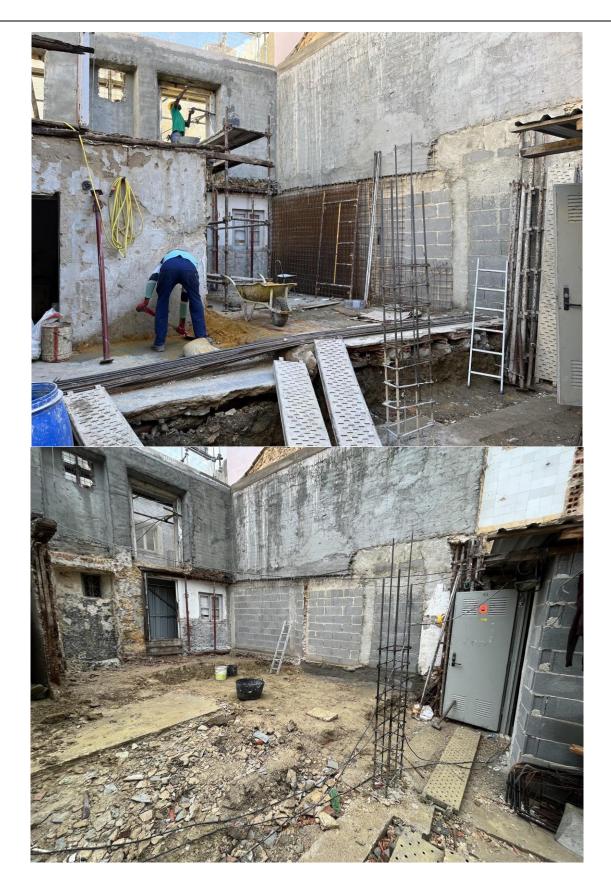
As mentioned in the previous reports, the builders excavated the foundation foot, in order to reinforce the new structure foundation. A thin layer of concrete was applied as a basement of the foundation in September. Following the steps, the reinforced steel bars and wooden mold were installed, then the builder poured concretes into the mold to form the foundation foot in October.

Also, the builders kept working on the capping beam. They poured concrete into mold to build the capping beam of external walls as well, in order to strengthen the outside wall structure and avoid future collapse. In the late October, they started assembling columns above the capping beam to execute the structure reinforcement to the 1st floor.

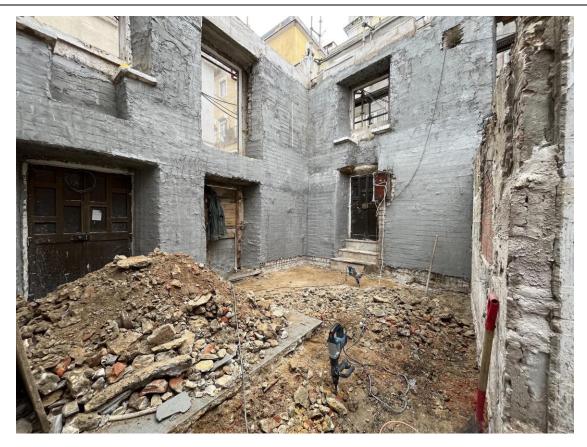
The builders removed the original plasters of the existing facade walls, and then filled the gas of the cracks, applied the mesh on the walls, and applied reinforced plasters as a protection of the walls. In October, they finished the structure reinforcement of the interior wall.

Besides, they started to demolish the ground floor and excavated deeper according to the architectural plan.
