**Project:** Largo Rodrigues de Freitas no 4 e 5 e Beco da Lage no 4, 1100-455 Lisboa

**Report Number:** Freiras - 20

## Construction Progress Report

Start: Friday, 01 March 2024 End: Sunday, 31 March 2024

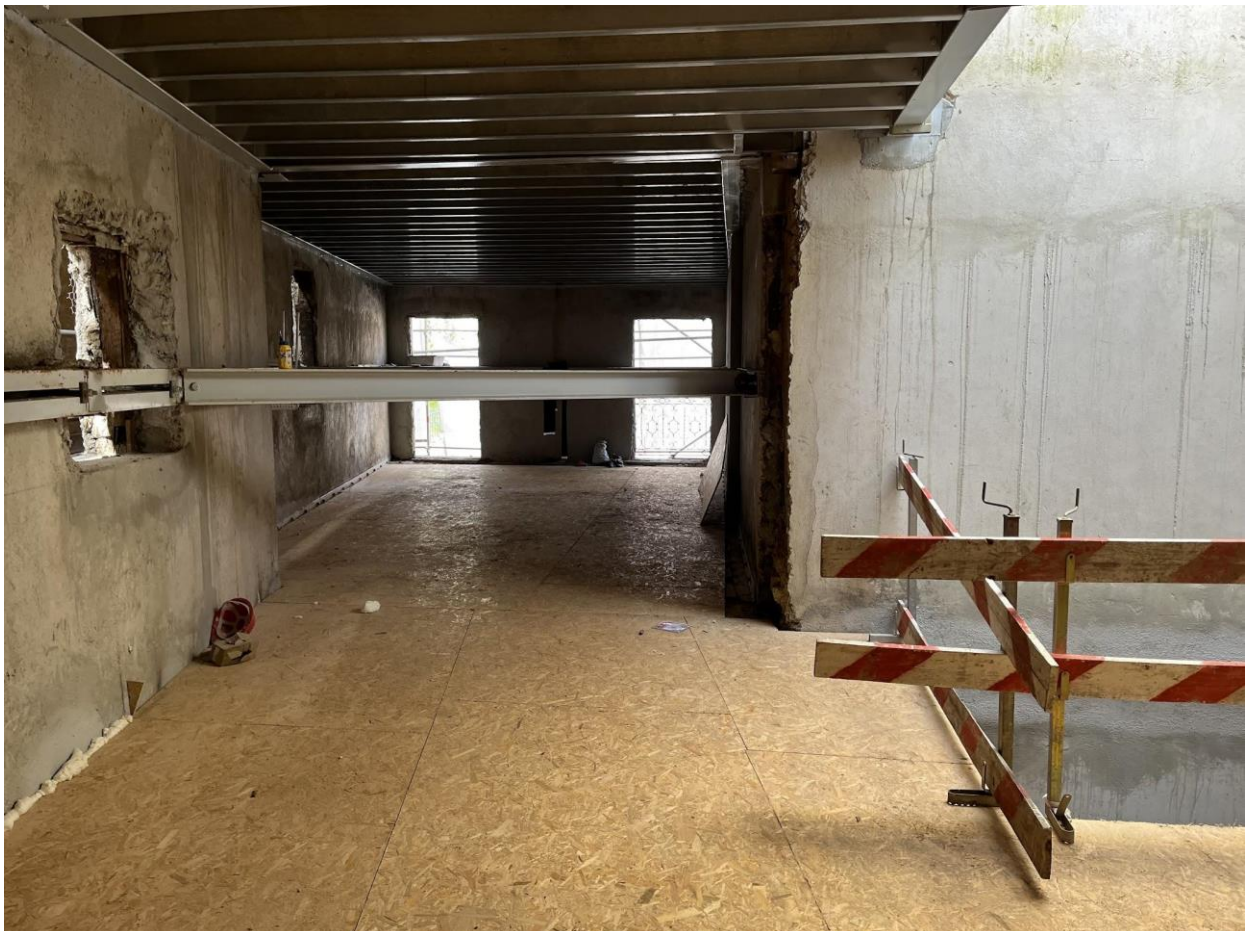
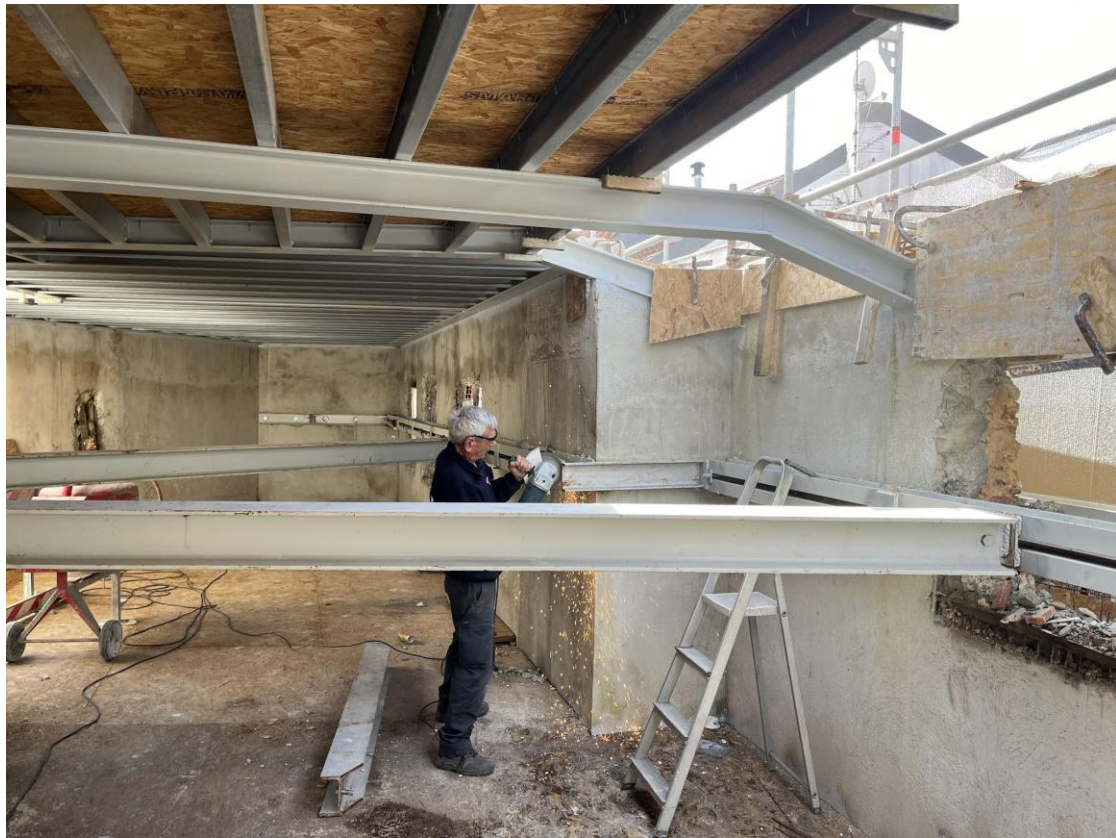
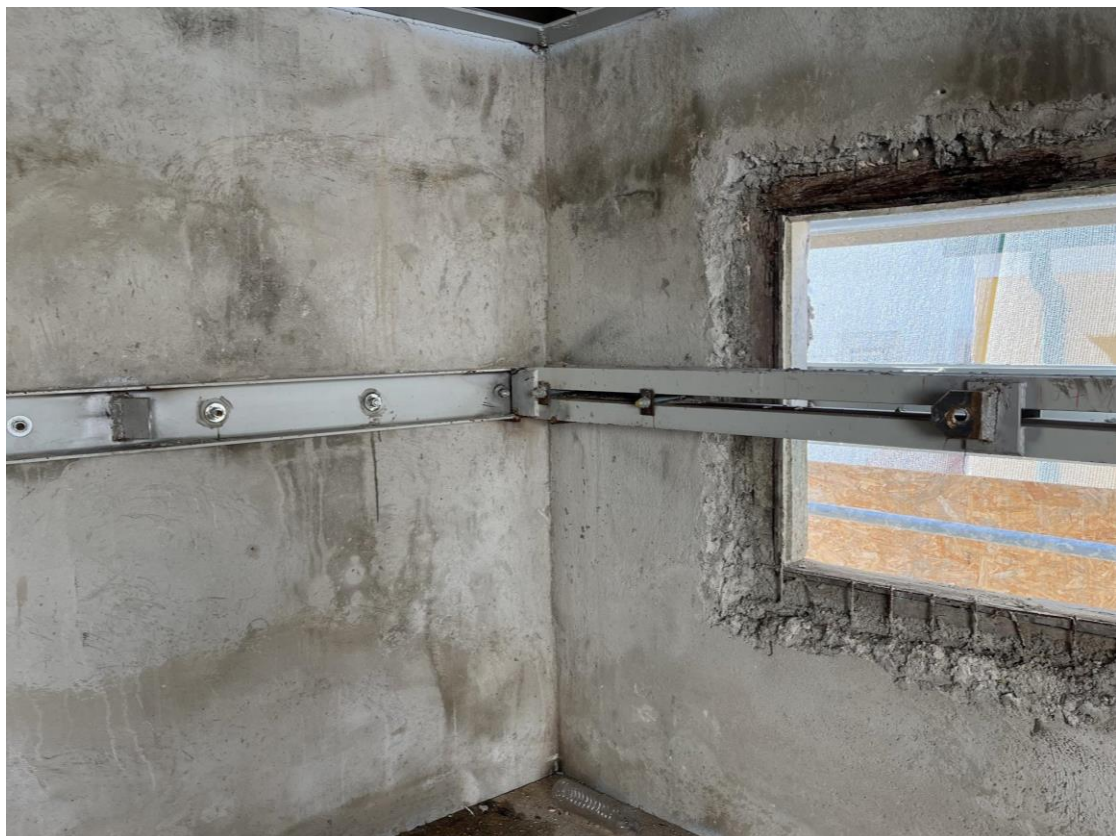
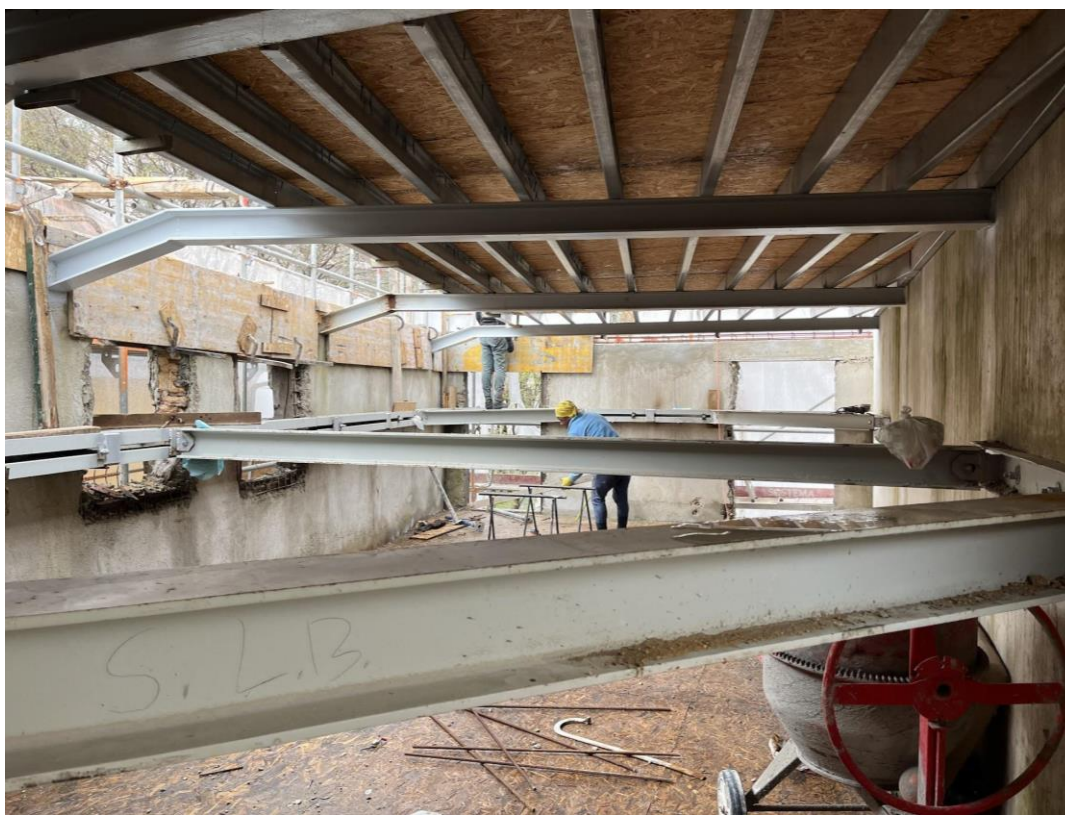
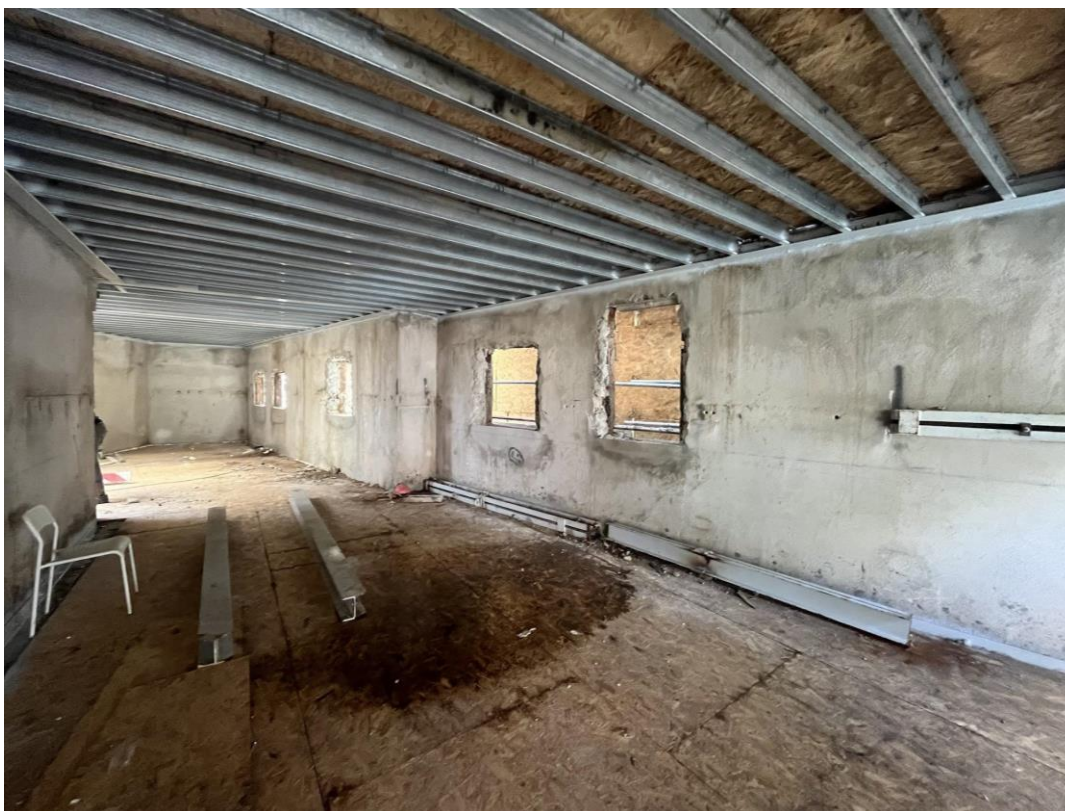
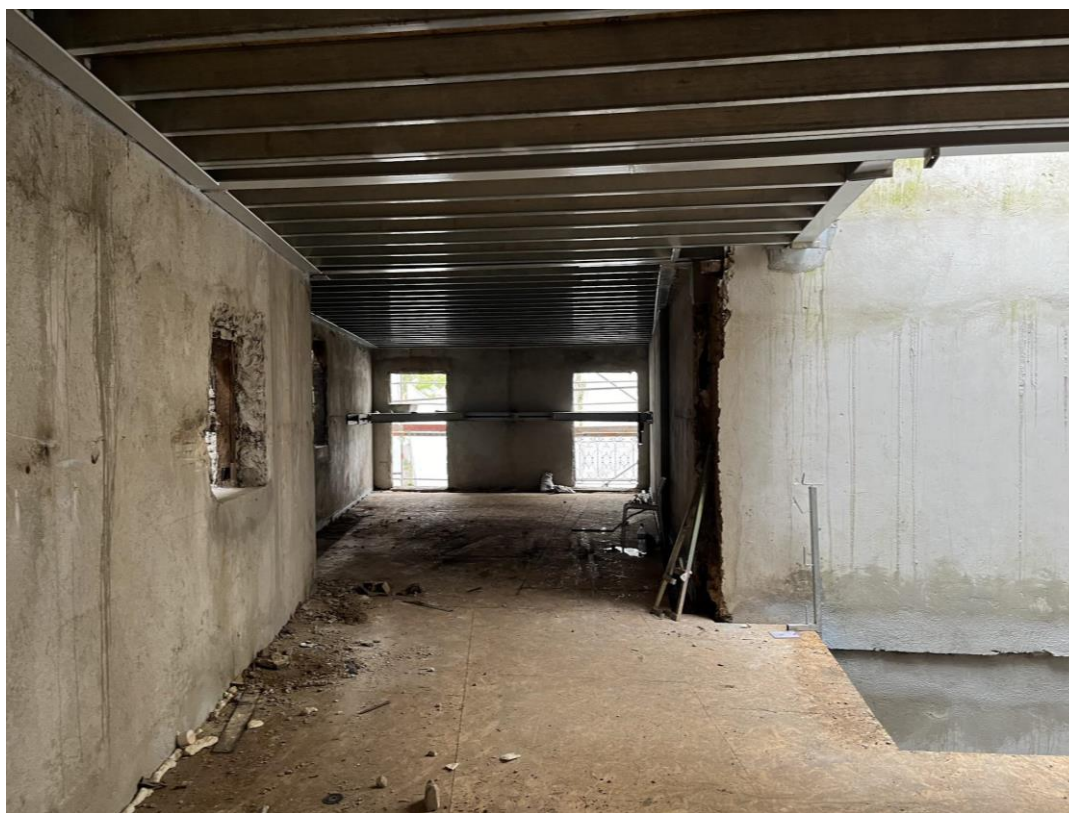
**In March, following the completion of installing the steel structure and placing panels on the 1st and 2nd floors, the construction team commenced the process of removing the provisional steel structure, with the exception of the parts on the main facade, which were retained to continue supporting the facade walls.**

**Subsequently, they initiated the placement of the bottom steels for the interior wall structure as a test of the partition wall layout. This step was taken to ensure compliance with the improved structural plan and design, which were based on real site measurements.**

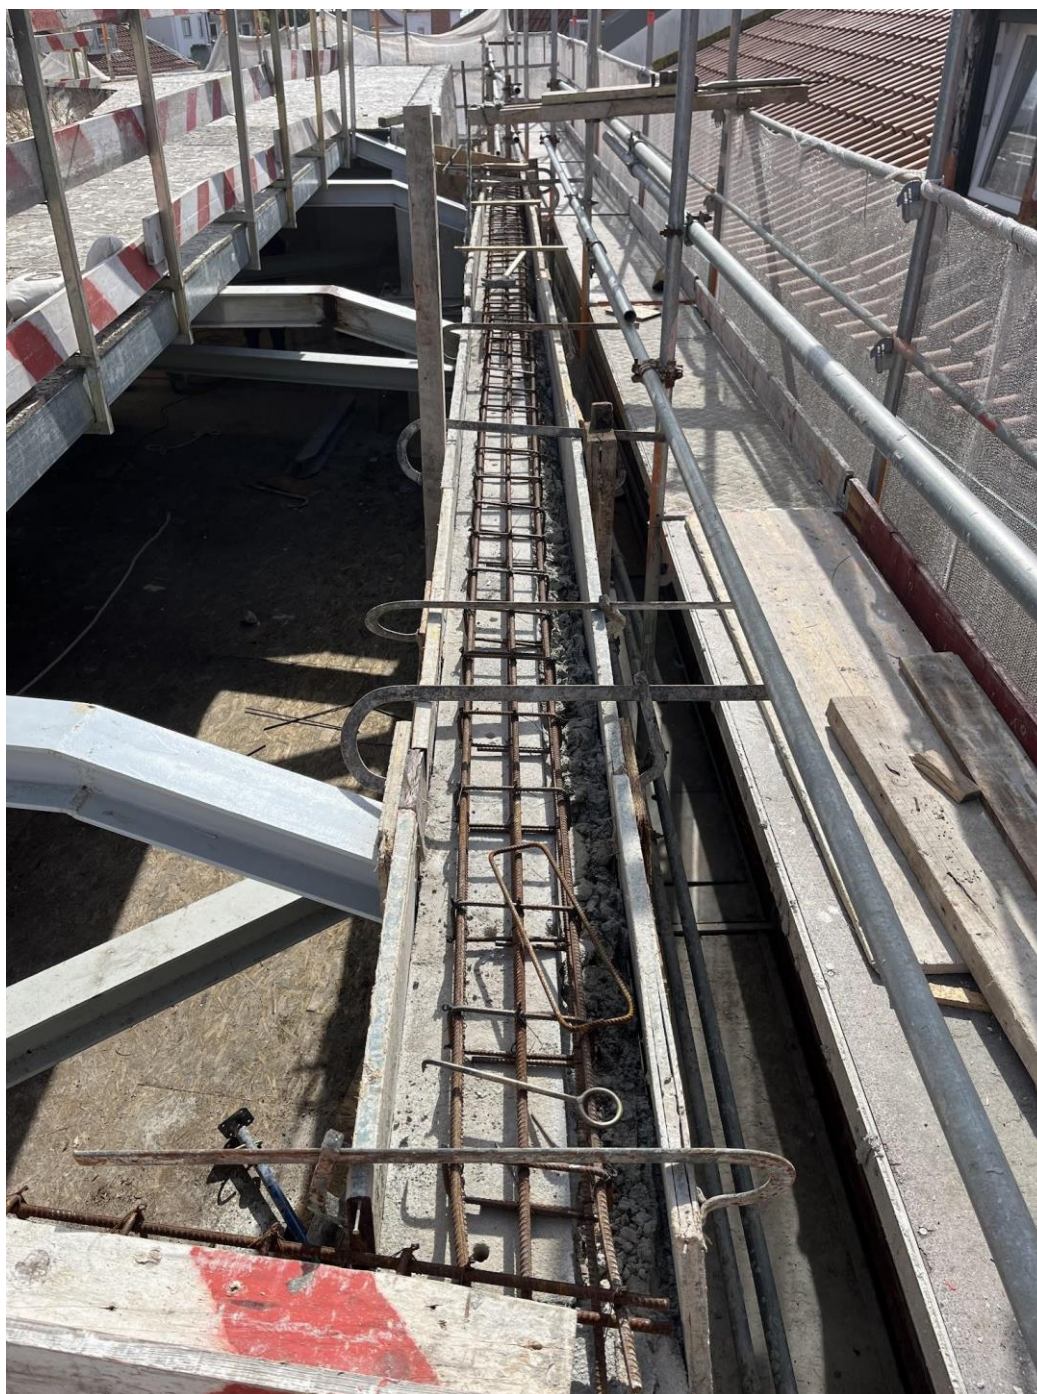
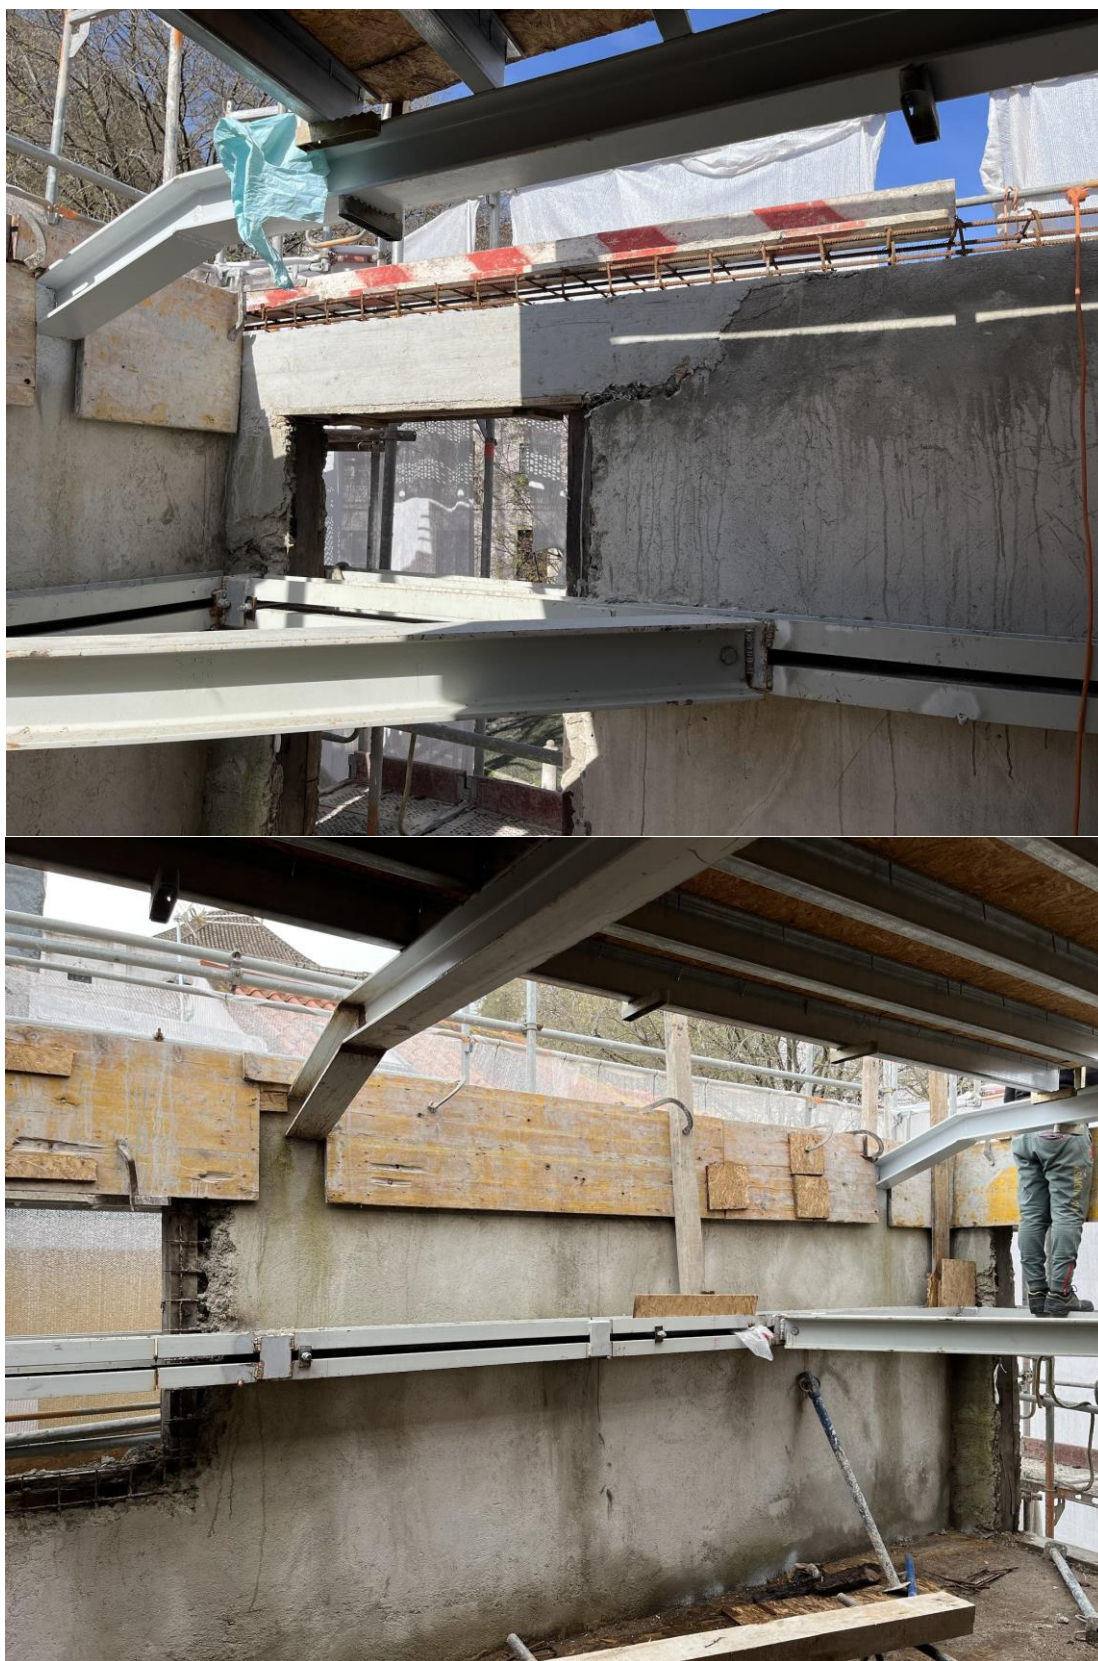
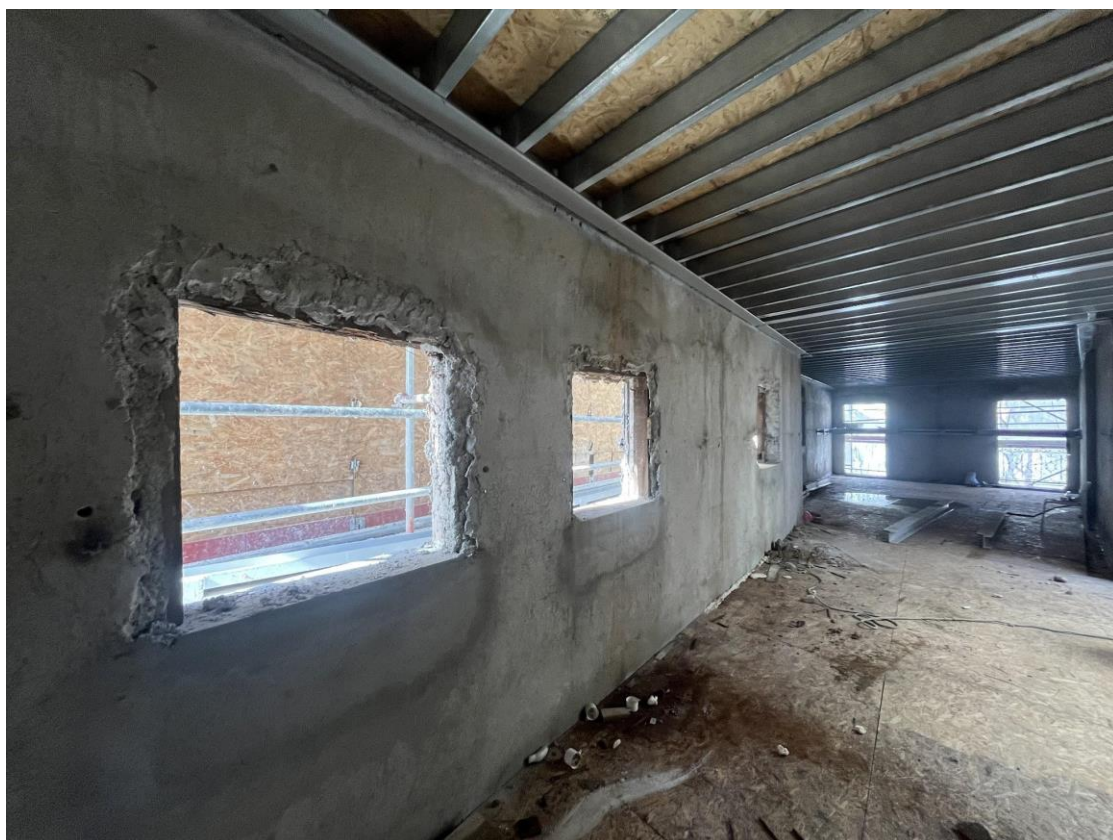
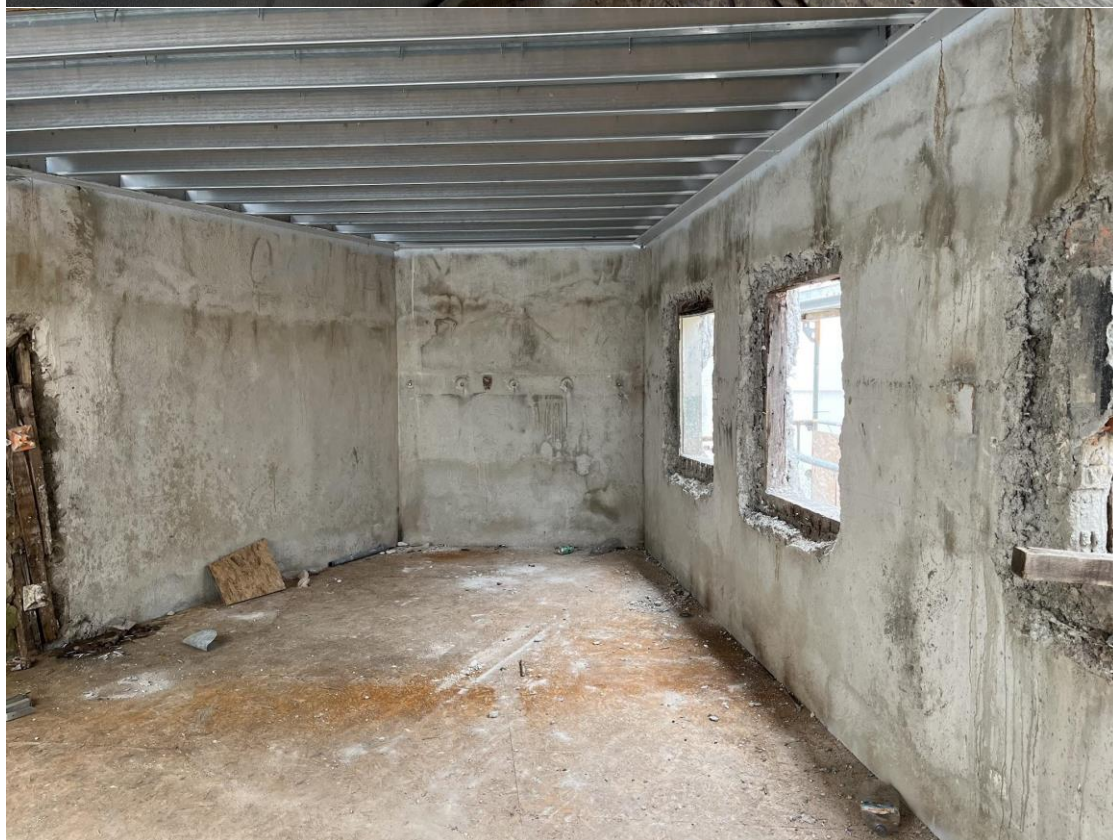
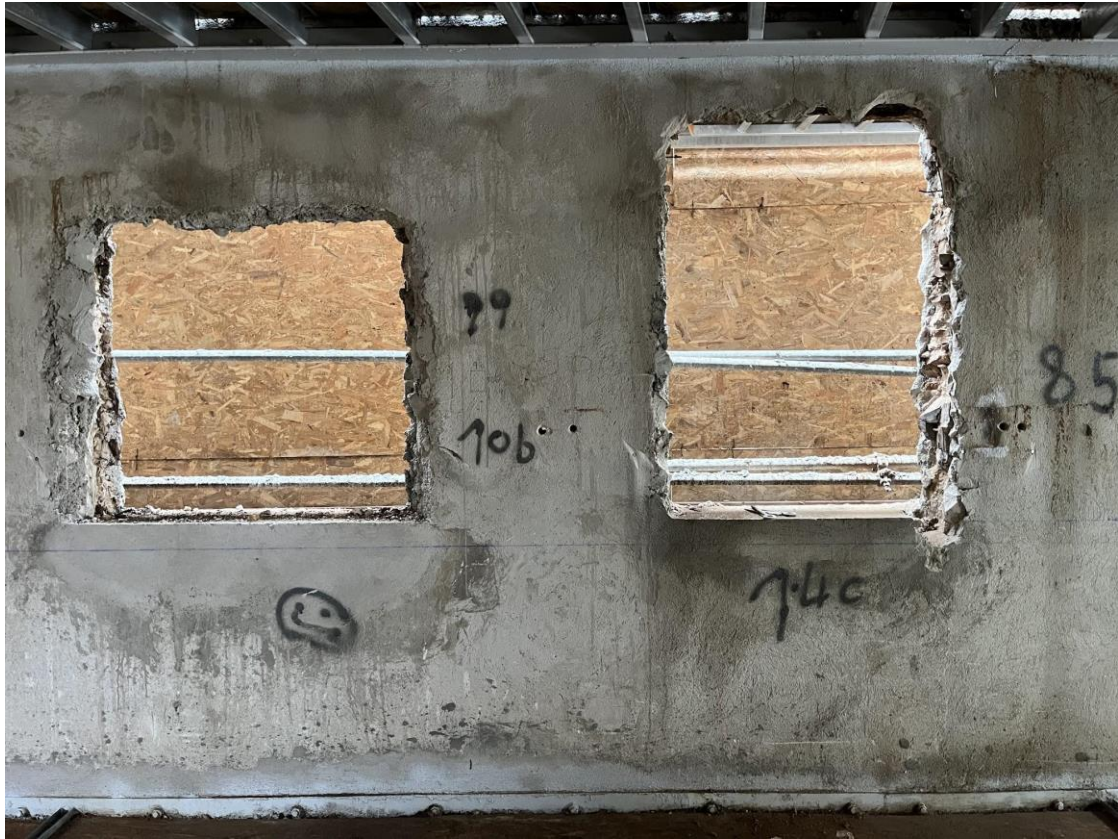
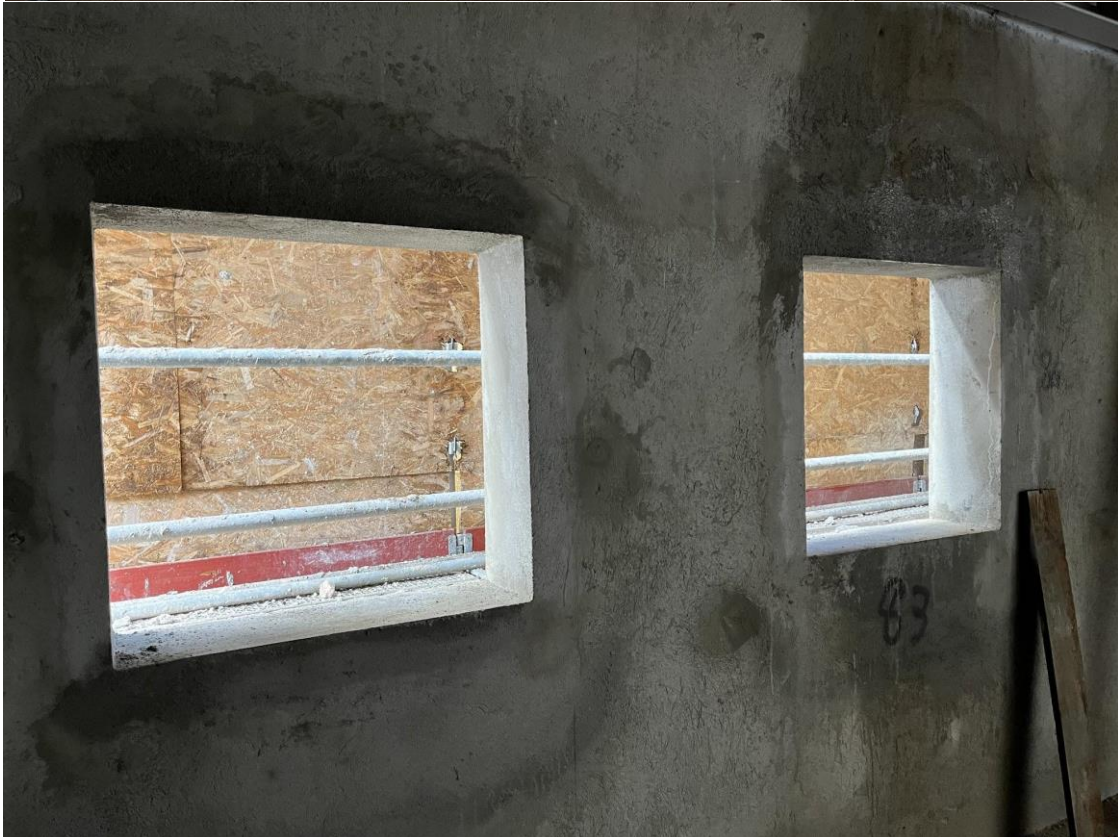
**As highlighted in previous reports, our FGI project manager and engineer are diligently prioritizing the attention of the structural integrity and stability of this aged building. To preempt any potential collapse of the walls and safeguard the facade, they've mandated the construction of a cap beam on the top floor to reinforce the exterior walls.**

**Additionally, the builders have bolstered the window frames by replacing any deteriorated wooden frames with reinforced bars, filling them with concrete fo added strength, and meticulously realigning the window shapes.**
