Report Number: Freiras - 21

## **Construction Progress Report**

**Builder** LADRILLO S.A - Construção, Remodelações e Projecto

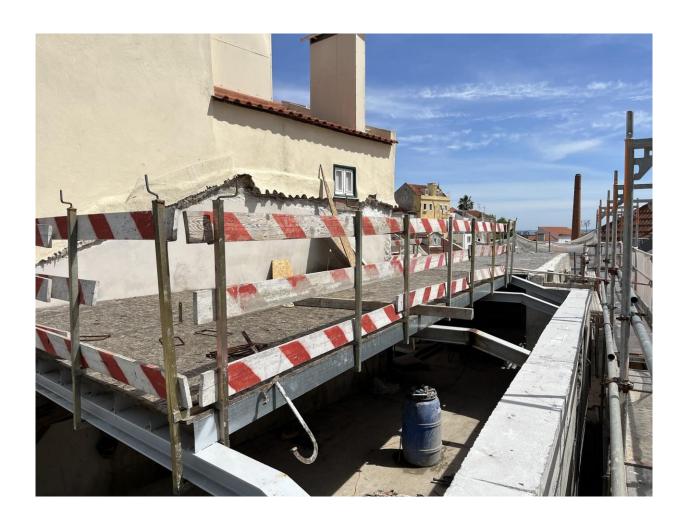
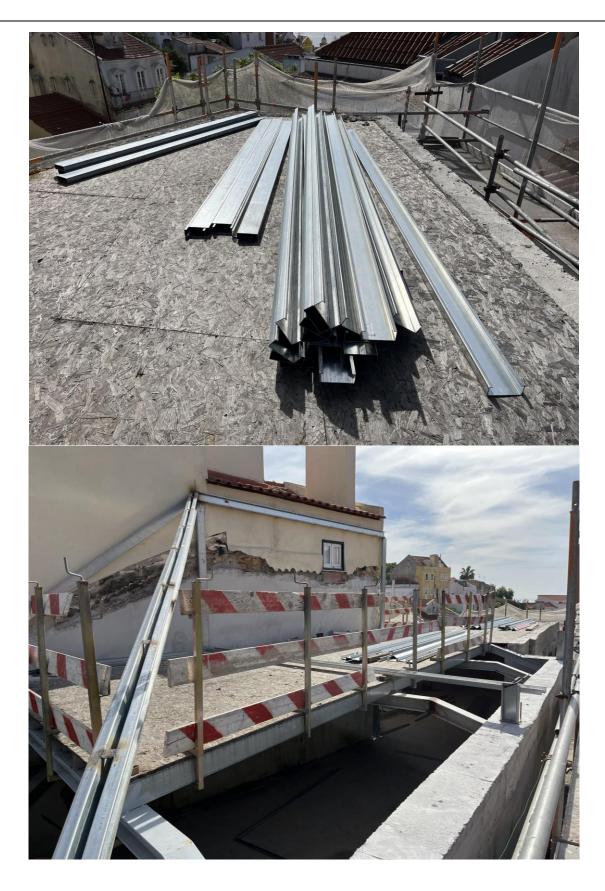
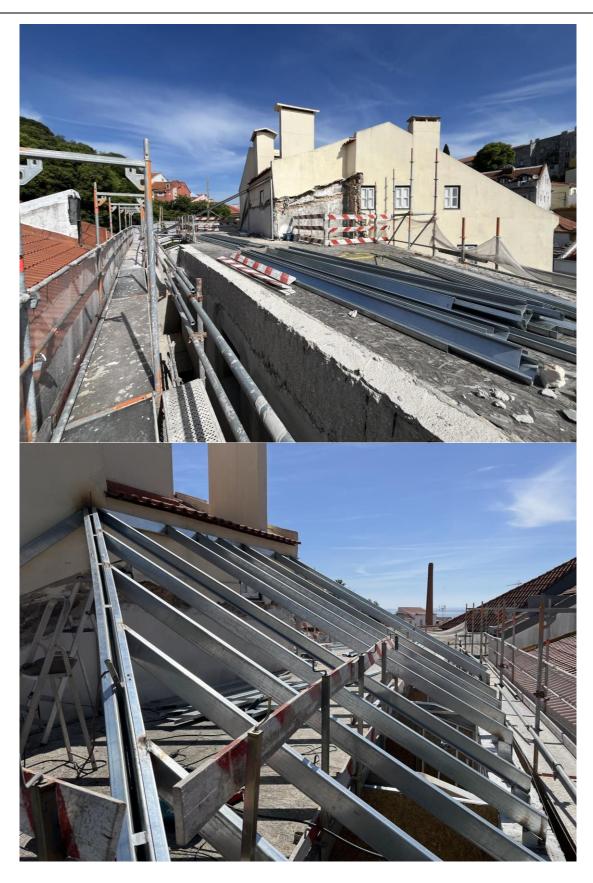
As noted in the previous report, the construction team initiated the layout of partition walls. Throughout April, they progressed further by assembling the steel structure for interior partition walls on the 2nd and 3rd floors. Subsequently, they installed drywall onto these steel structures, making a significant advancement in the construction process.

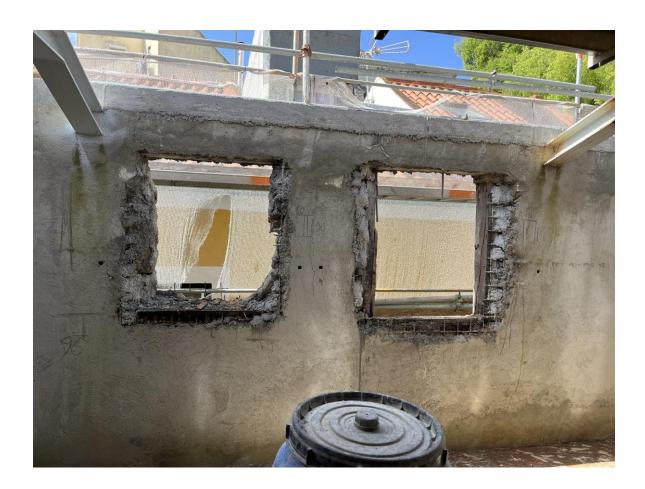
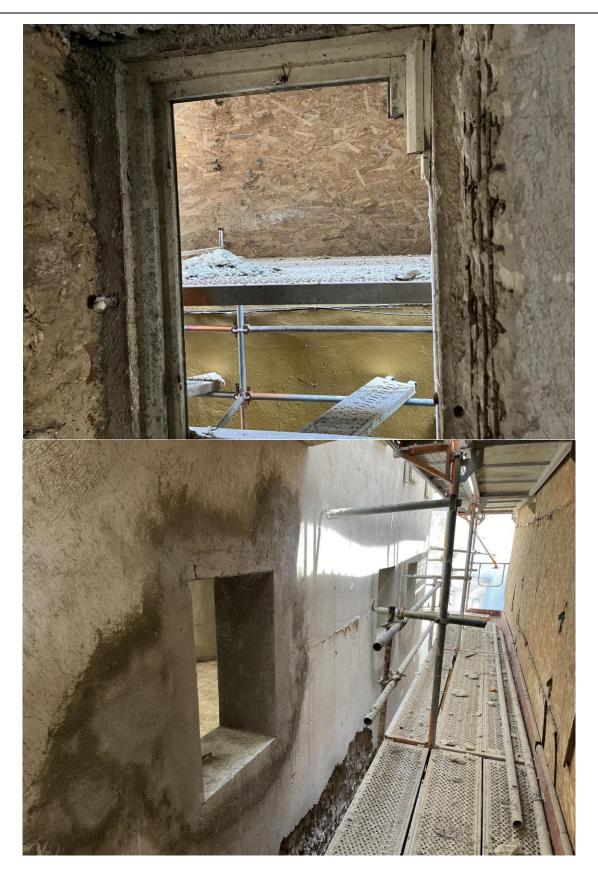
As emphasized in previous reports, our FGI project manager and engineer are meticulously focused on ensuring the structural integrity and stability of this aging building. Following the reconstruction of a cap beam on the top floor to reinforce the exterior walls, attention shifted to the top floor itself. In April, the builders commenced assembling the steel structure for the roof.

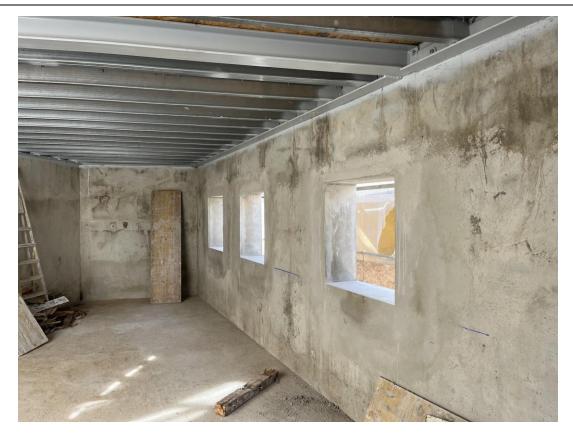
Furthermore, the builders persisted in reinforcing and repairing the window frames, by replacing any deteriorated wooden frames with reinforced bars, filling them with concrete for added strength, and carefully realigning the window shapes to ensure uniformity and stability. In addition to this meticulous work, they completed plastering the building facade, followed by leveling the facade walls in preparation for future decorative enhancements.
