**Project:** Rua do Passadiço 55, Lisboa

**Report Number:** Passadiço - 26

## Construction Progress Report

Start: Wednesday, 01 May 2024    End: Friday, 31 May 2024

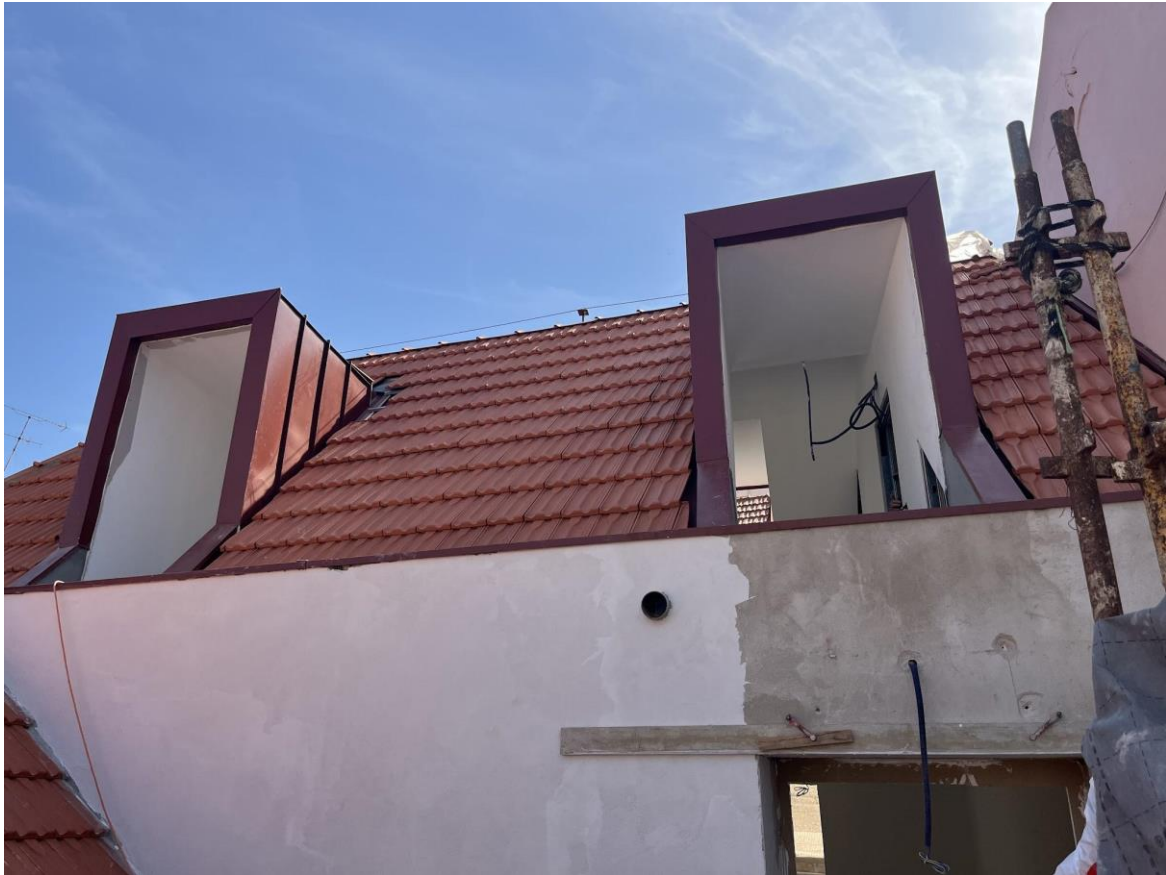
**In May, the builders finished the roof tiling and also completed placing zinc cladding to cover the edge part of the roof.**
