Project: Largo Rodrigues de Freitas no 4 e 5 e Beco da Lage no 4, 1100-455 Lisboa

Report Number: Freiras - 25

Construction Progress Report

Monthly Period Reporting

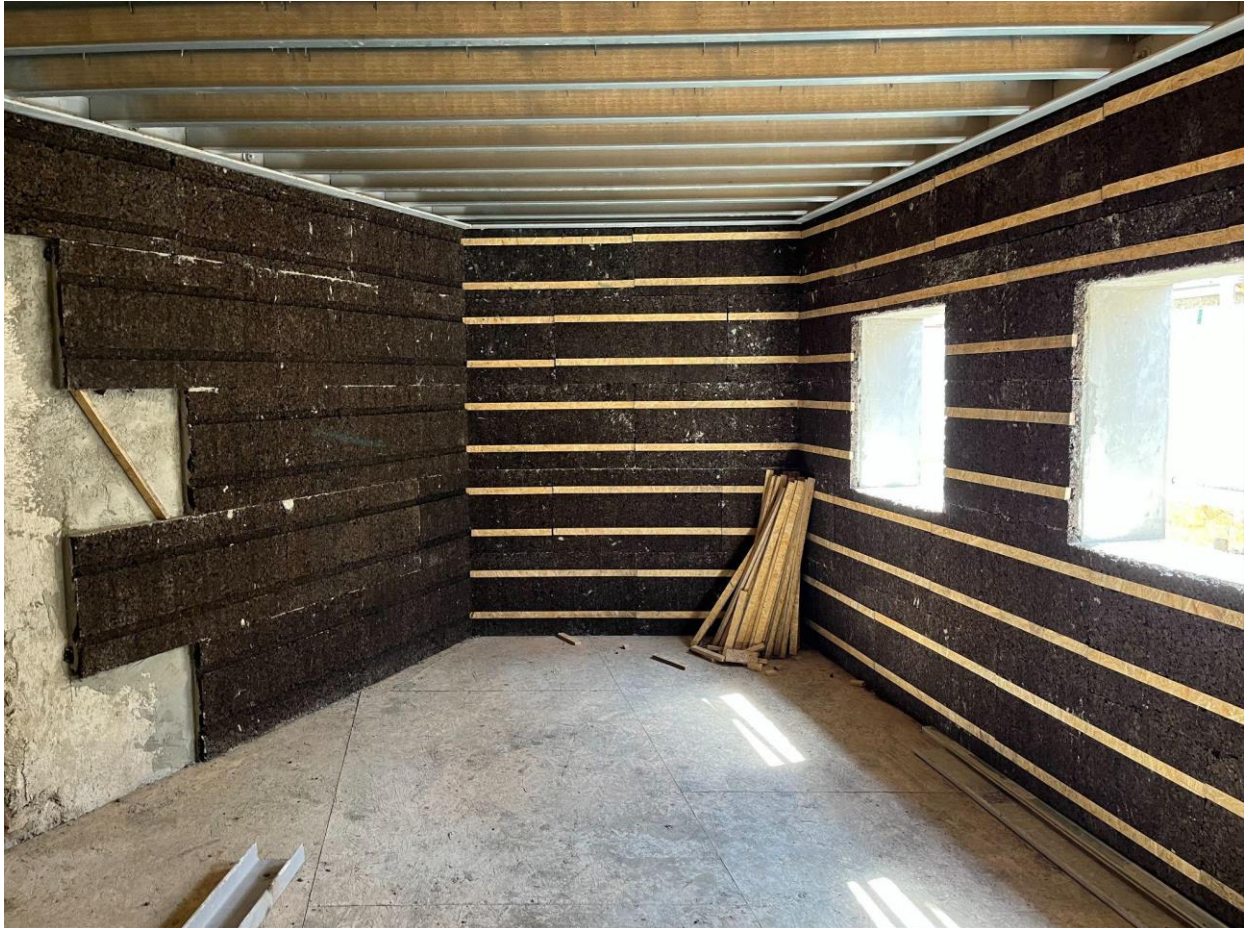
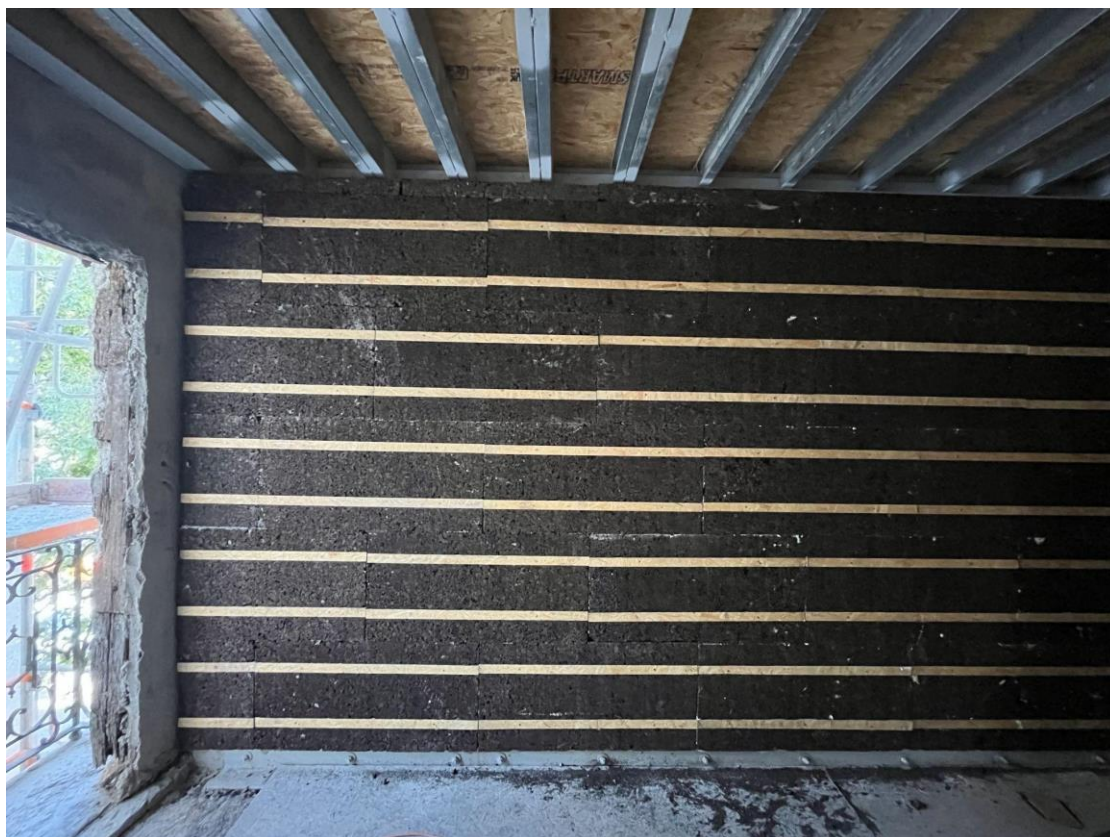
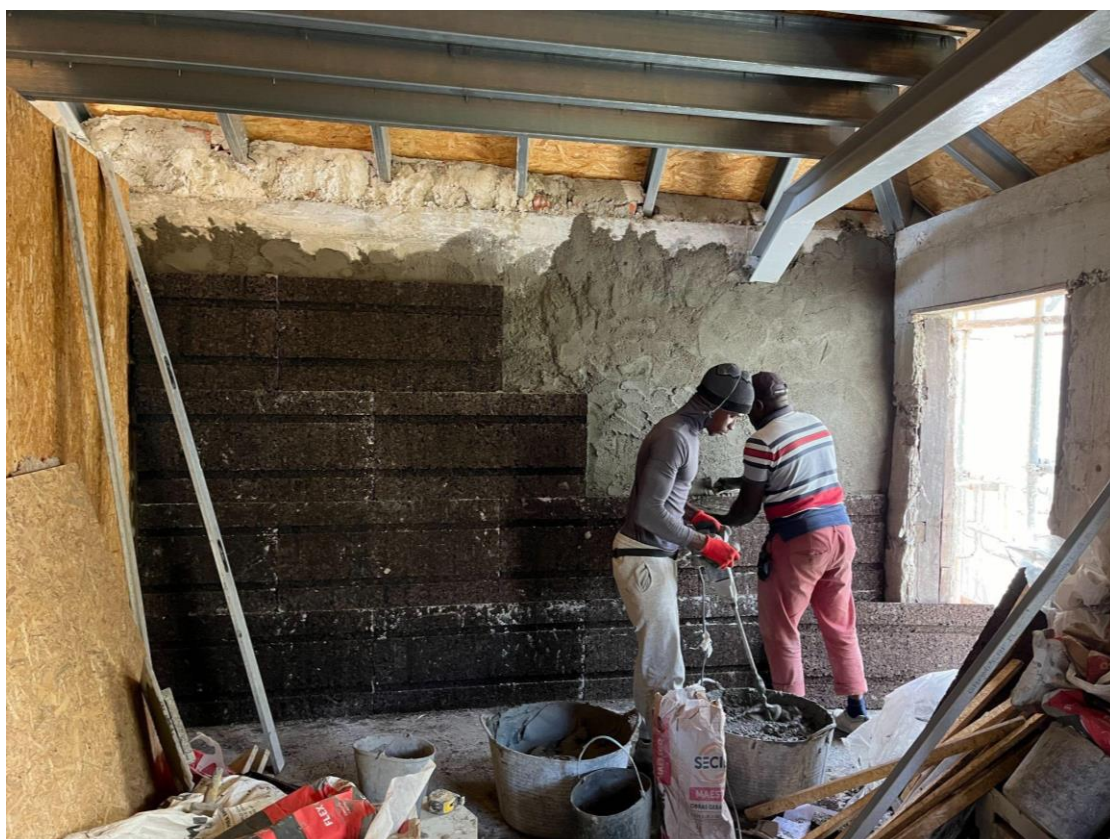
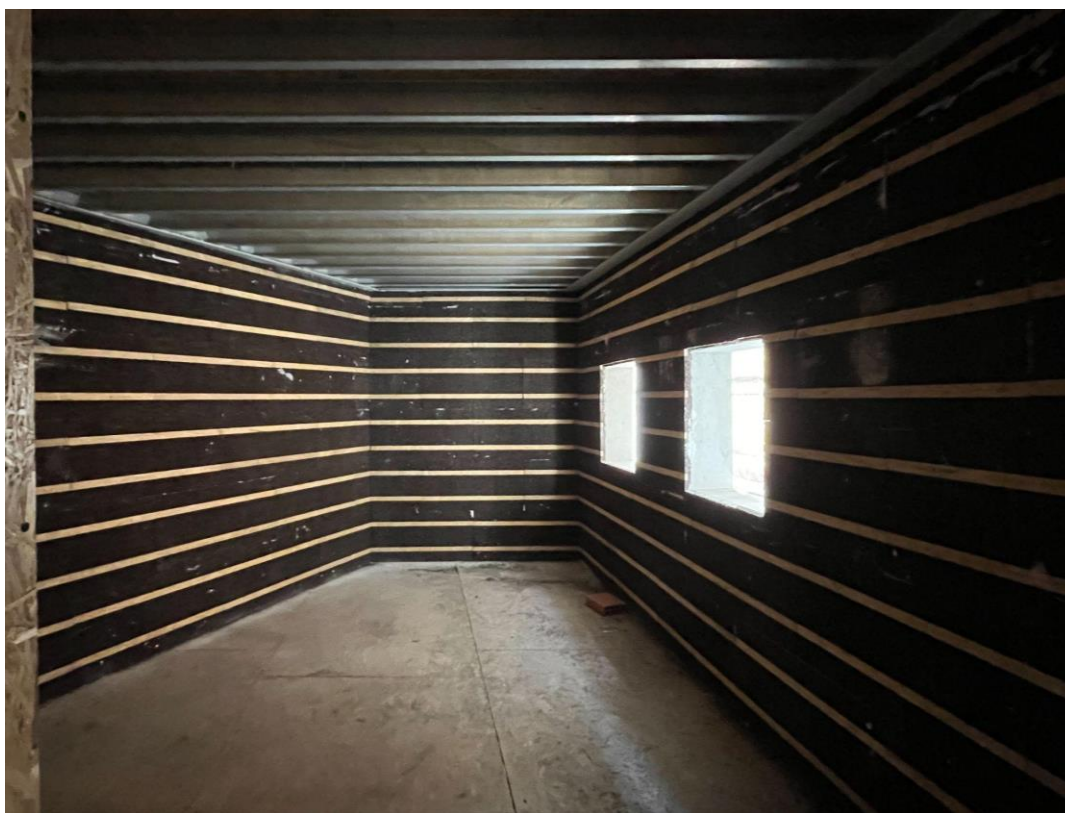
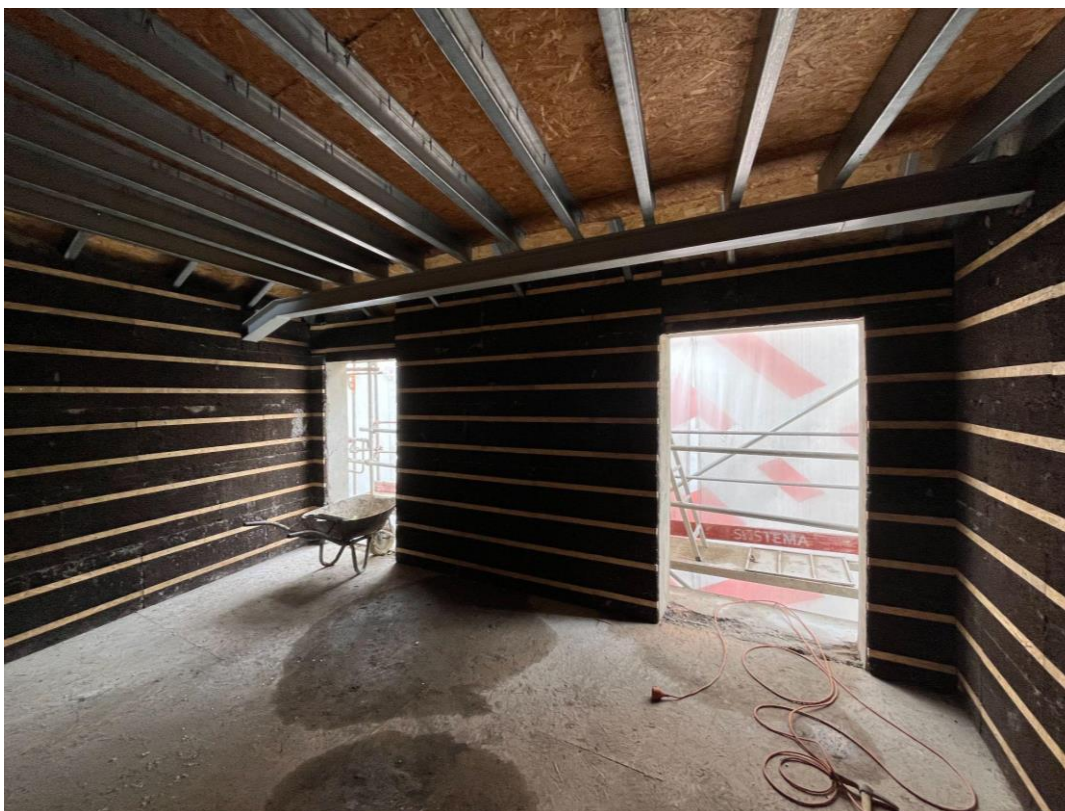
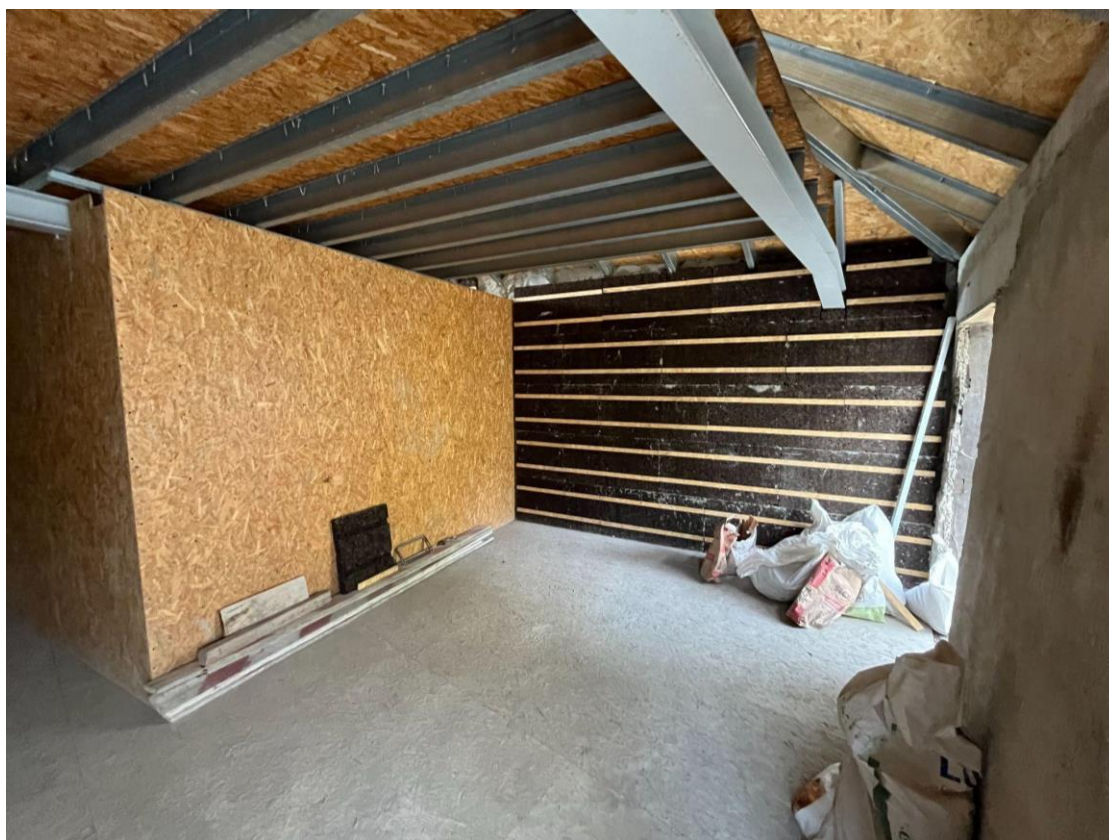
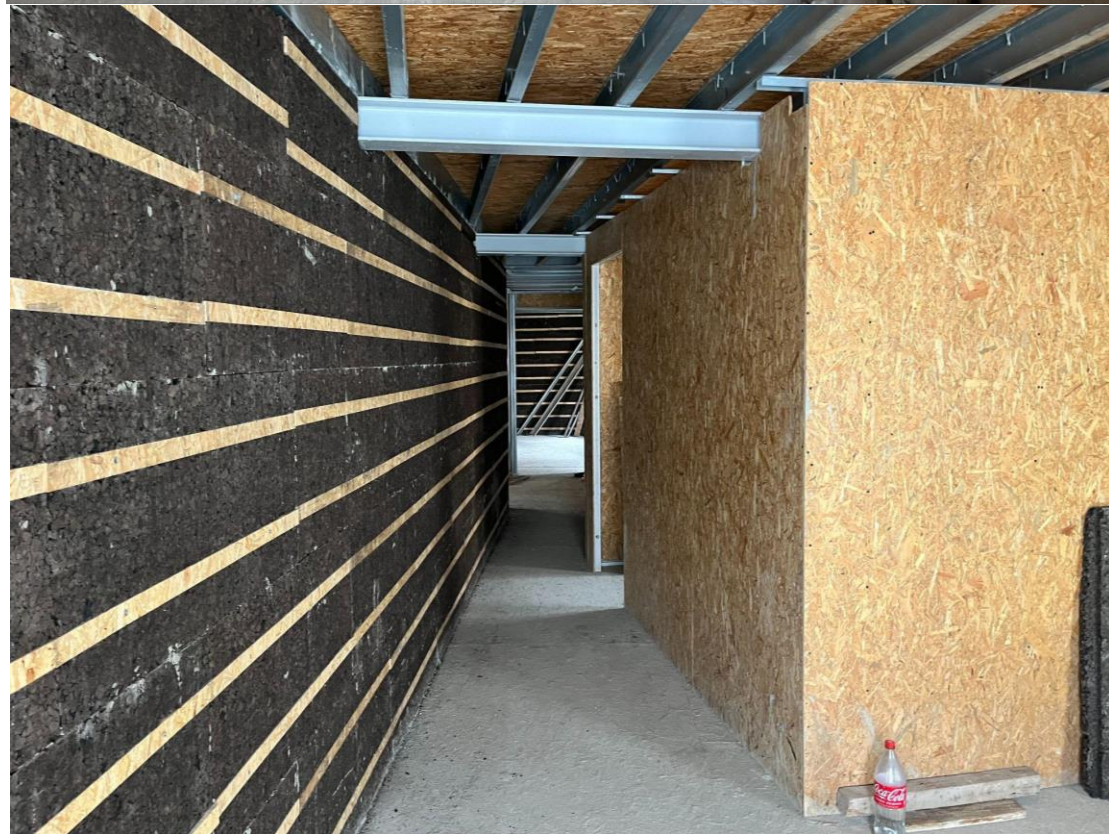
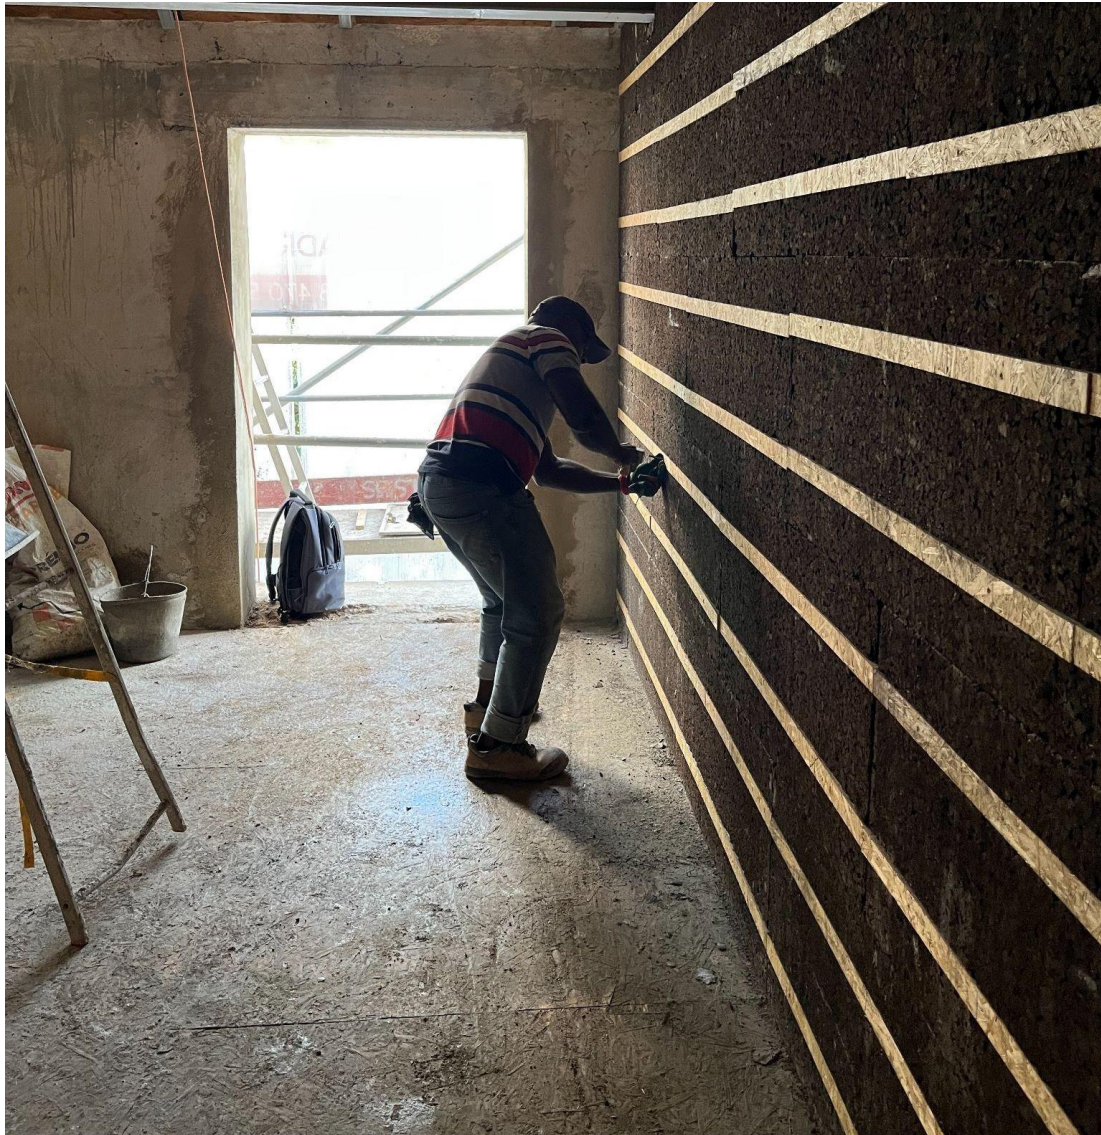
As detailed in the previous report, the construction team started the installation of insulation on the apartment exterior walls in August. This work progressed into September, following a sequential approach starting with the 1st, 2nd, and 3rd floors, as well as the attic, while excluding the ground floor. The insulation was installed to improve the building's thermal performance and soundproofing, ensuring enhanced energy efficiency and occupant comfort.

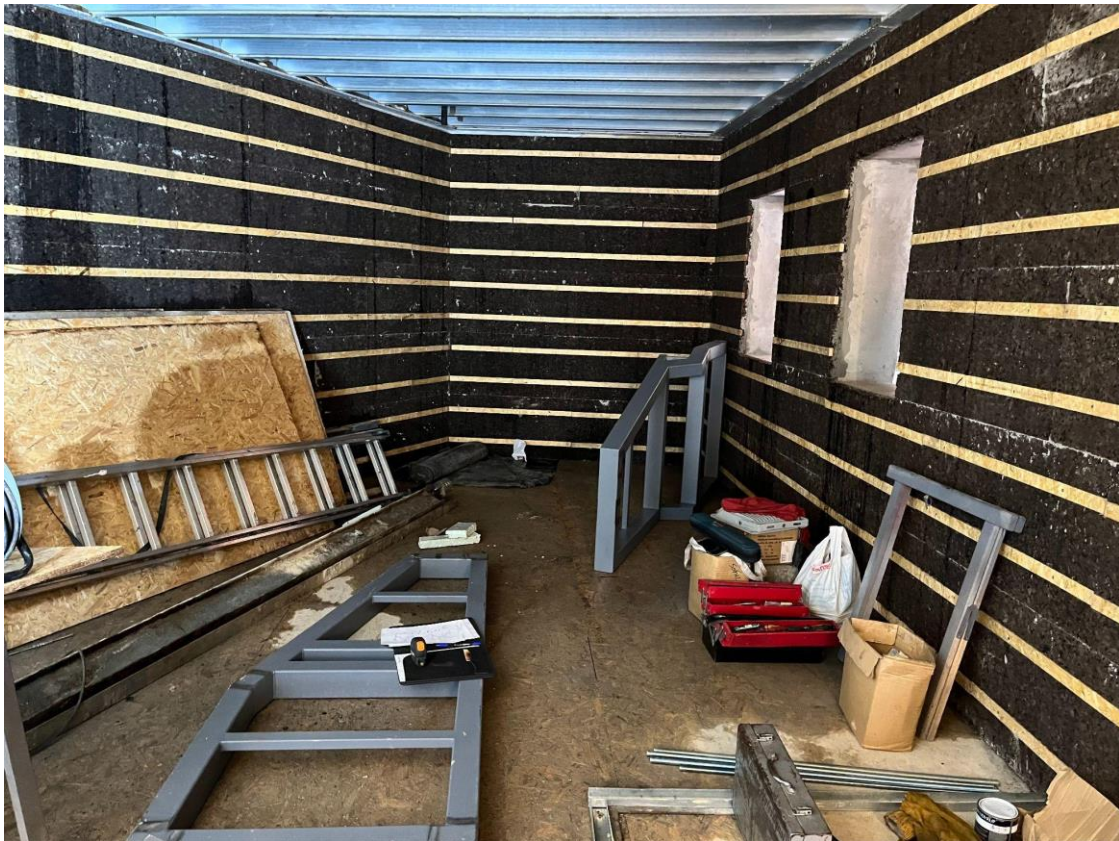
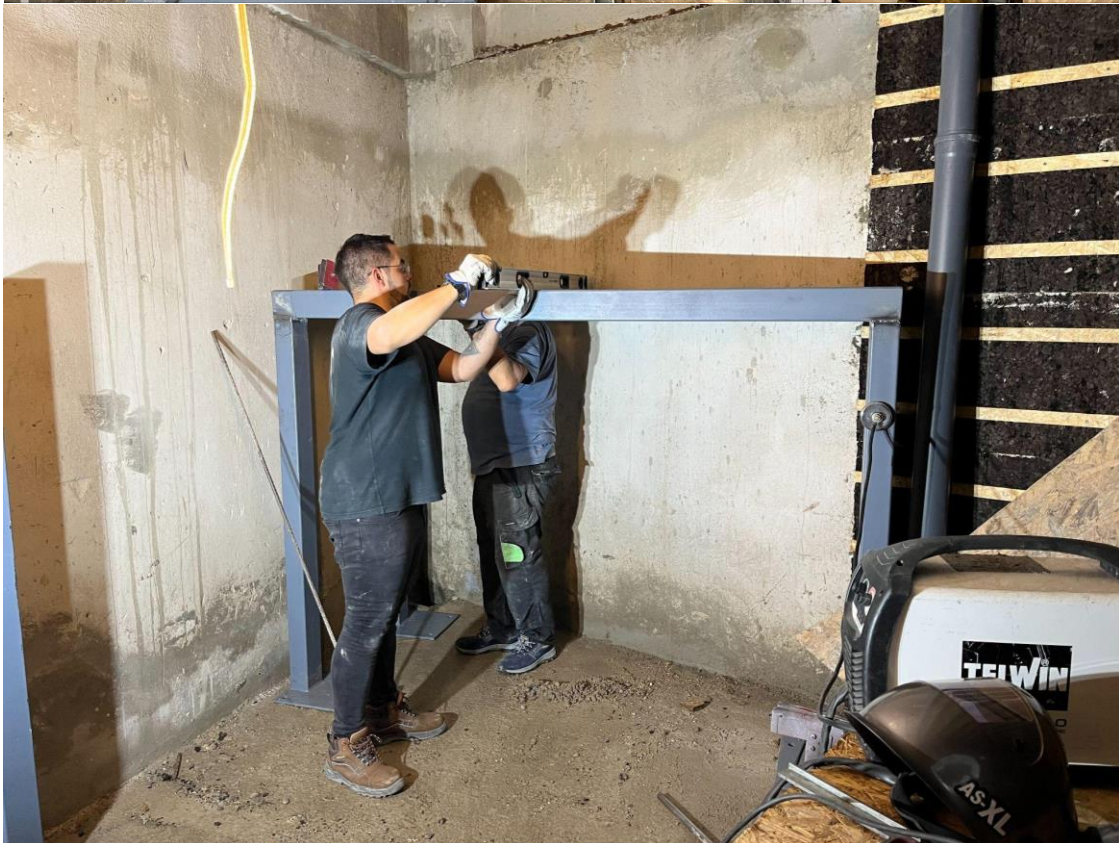
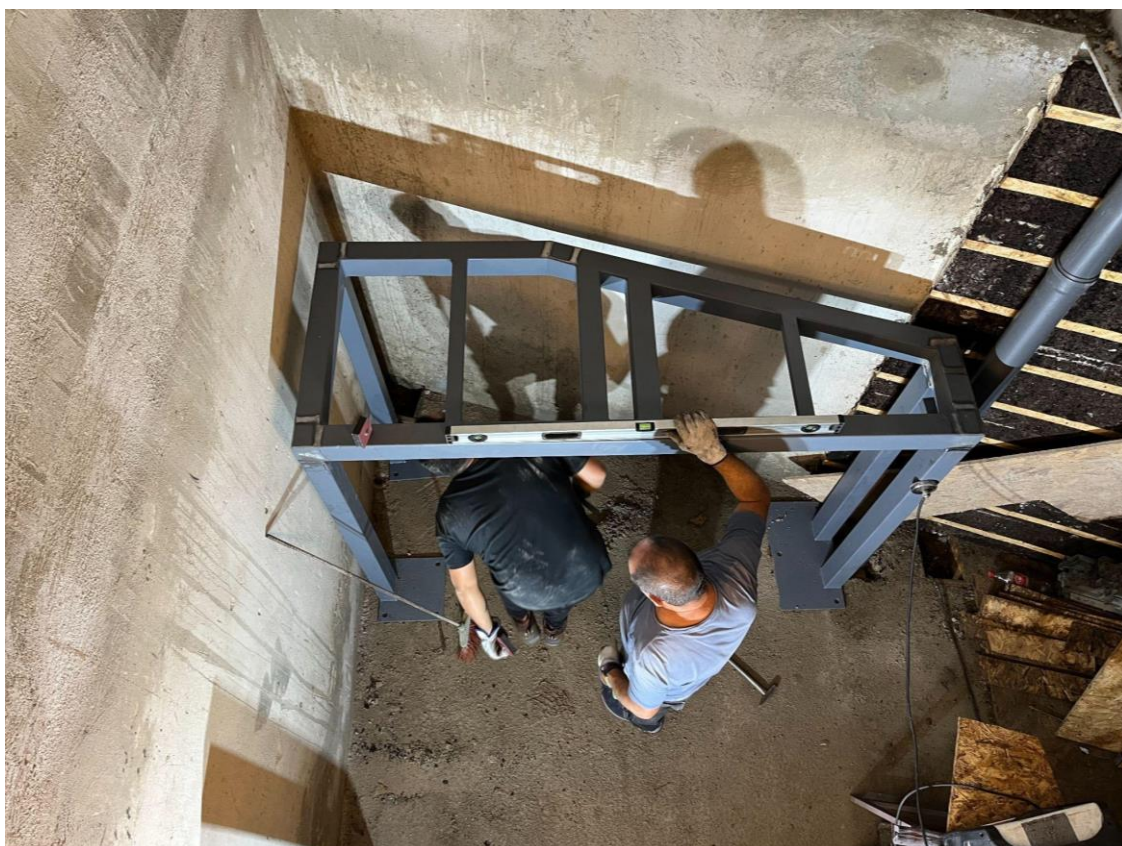
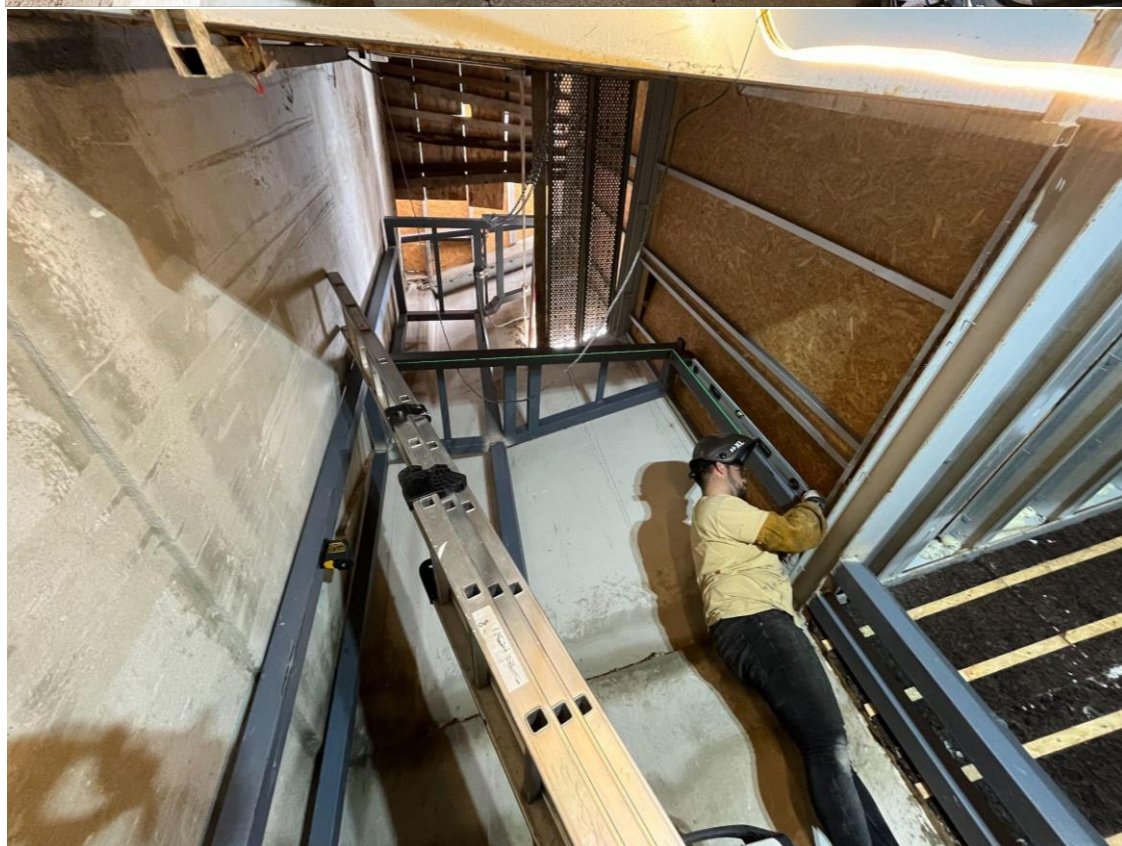
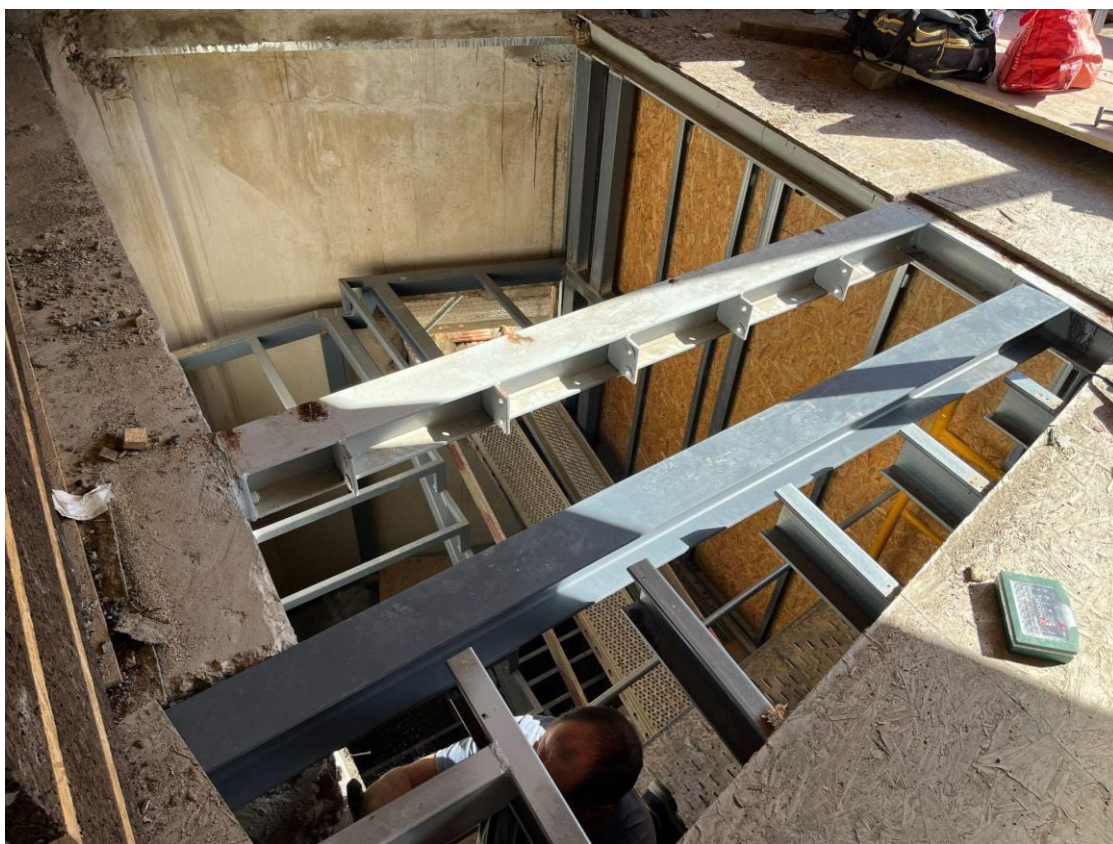
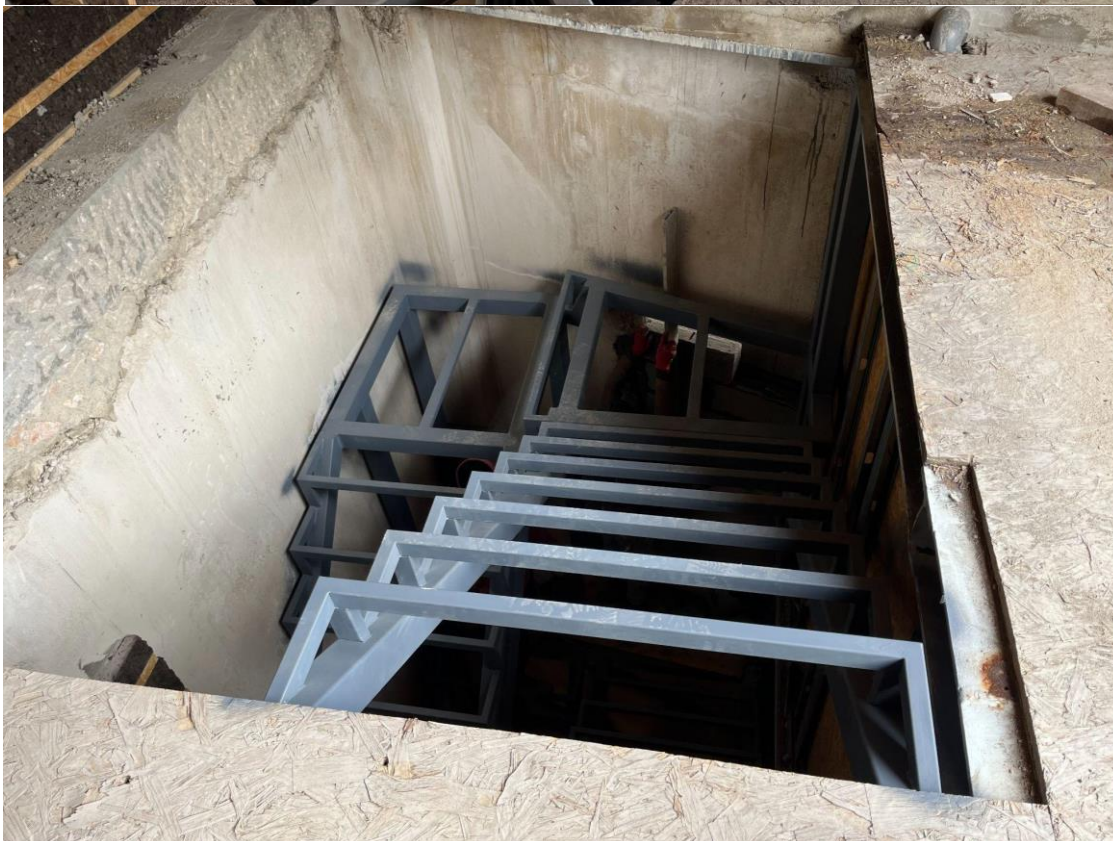
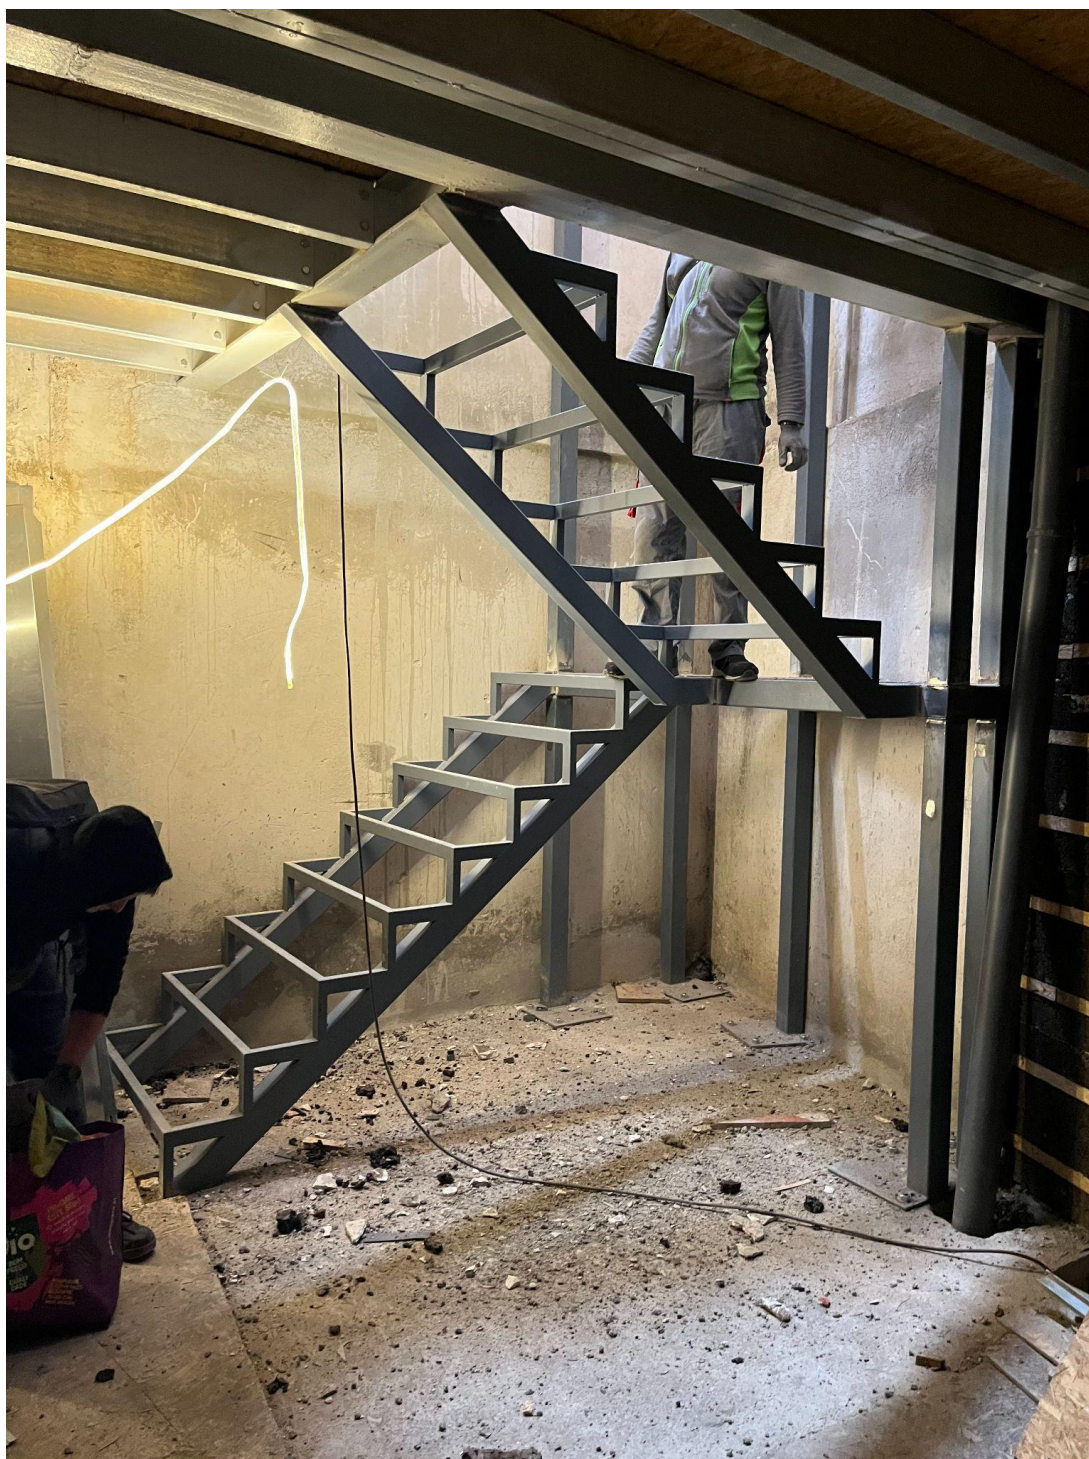
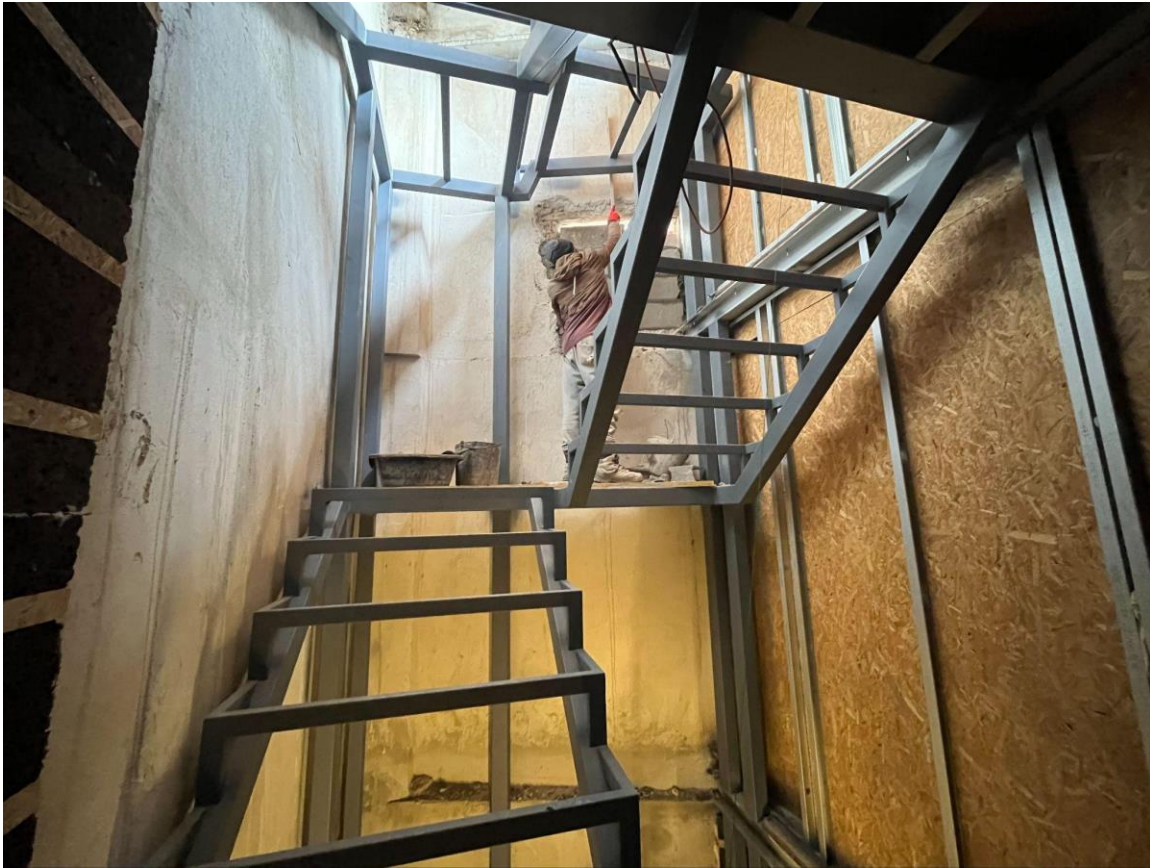
In October, the construction team began the step-by-step assembly of the staircase steel structures for both the main building and the duplex apartments. The process involved an organized approach, beginning with the pre-assembly of individual components to ensure precision and quality. Once the parts were fully prepared, they were systematically installed and securely attached to the building framework. This methodical workflow not only ensured structural integrity but also streamlined the overall assembly process, adhering to the construction efficiency and safety.
