Project: Largo Rodrigues de Freitas no 4 e 5 e Beco da Lage no 4, 1100-455 Lisboa

Report Number: Freiras - 25

Construction Progress Report

Monthly Period Reporting

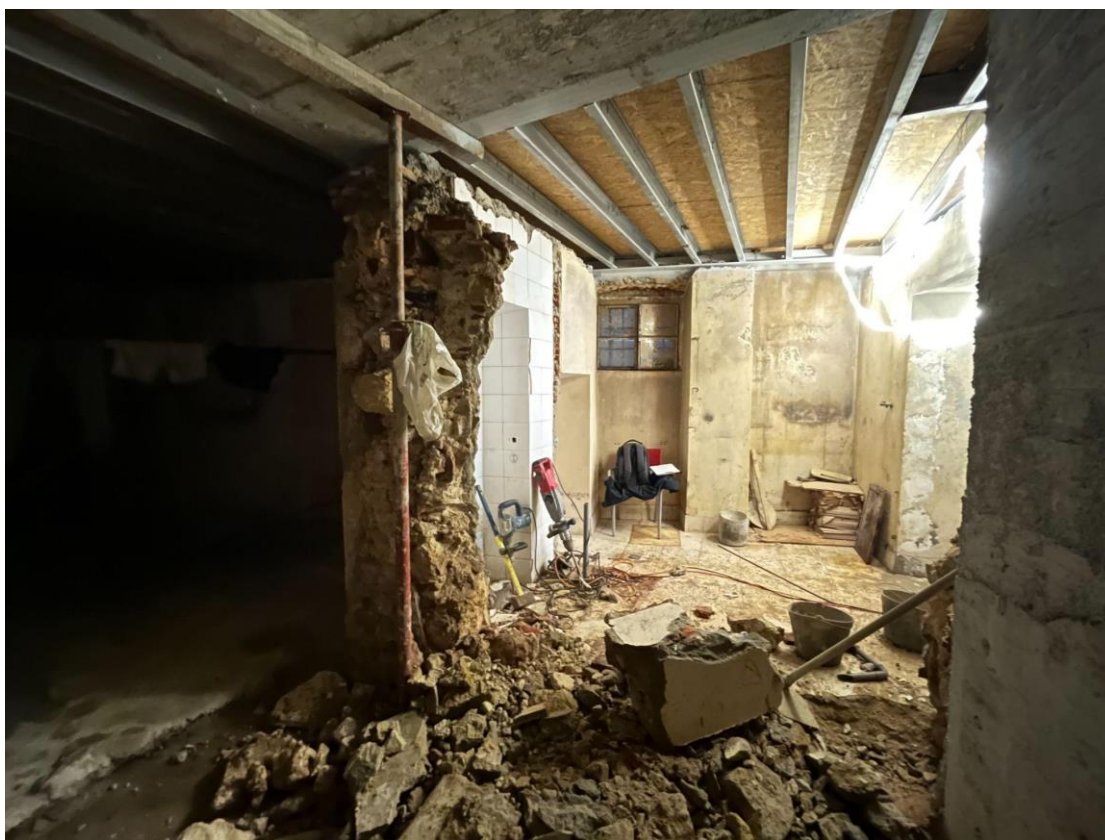
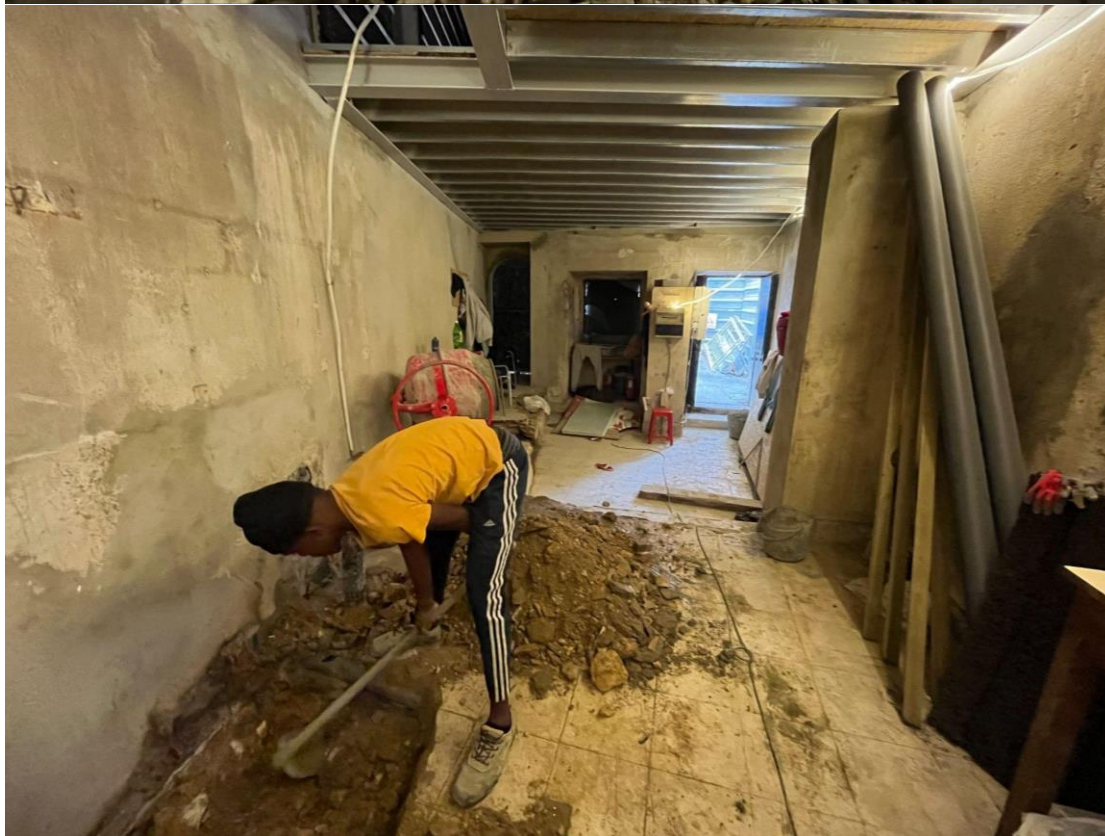
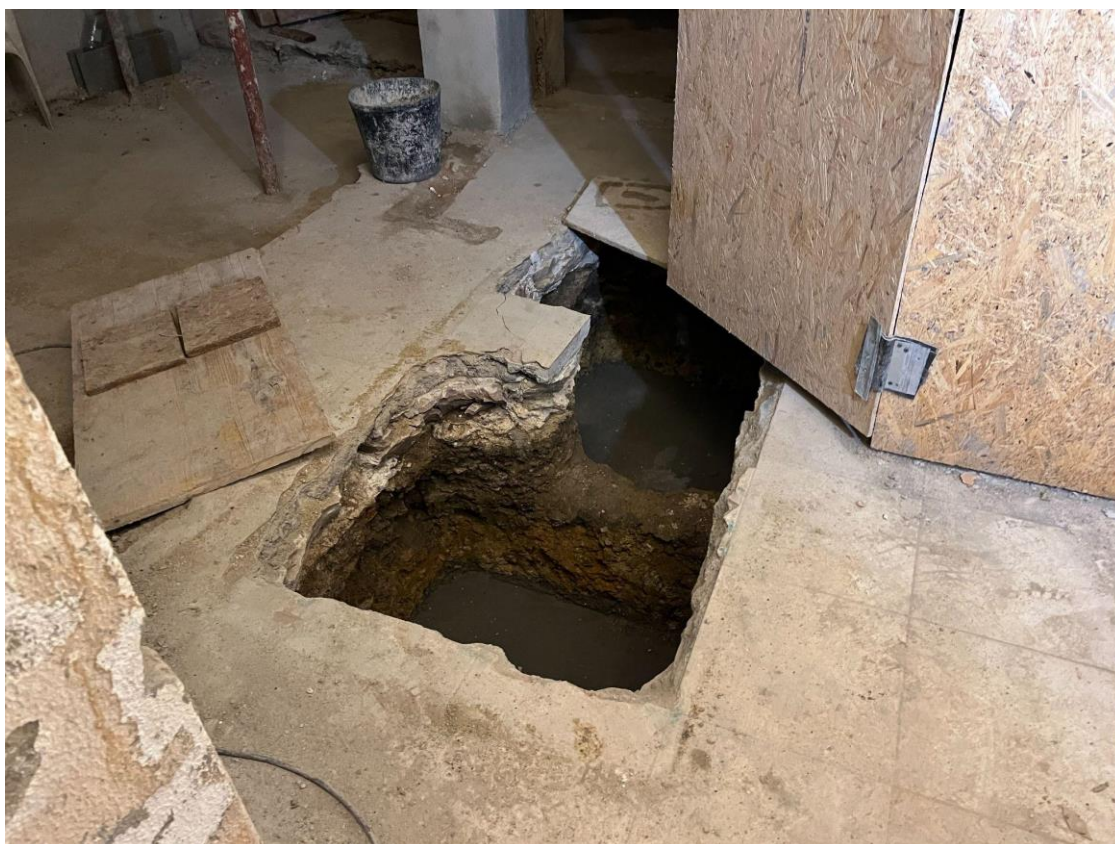
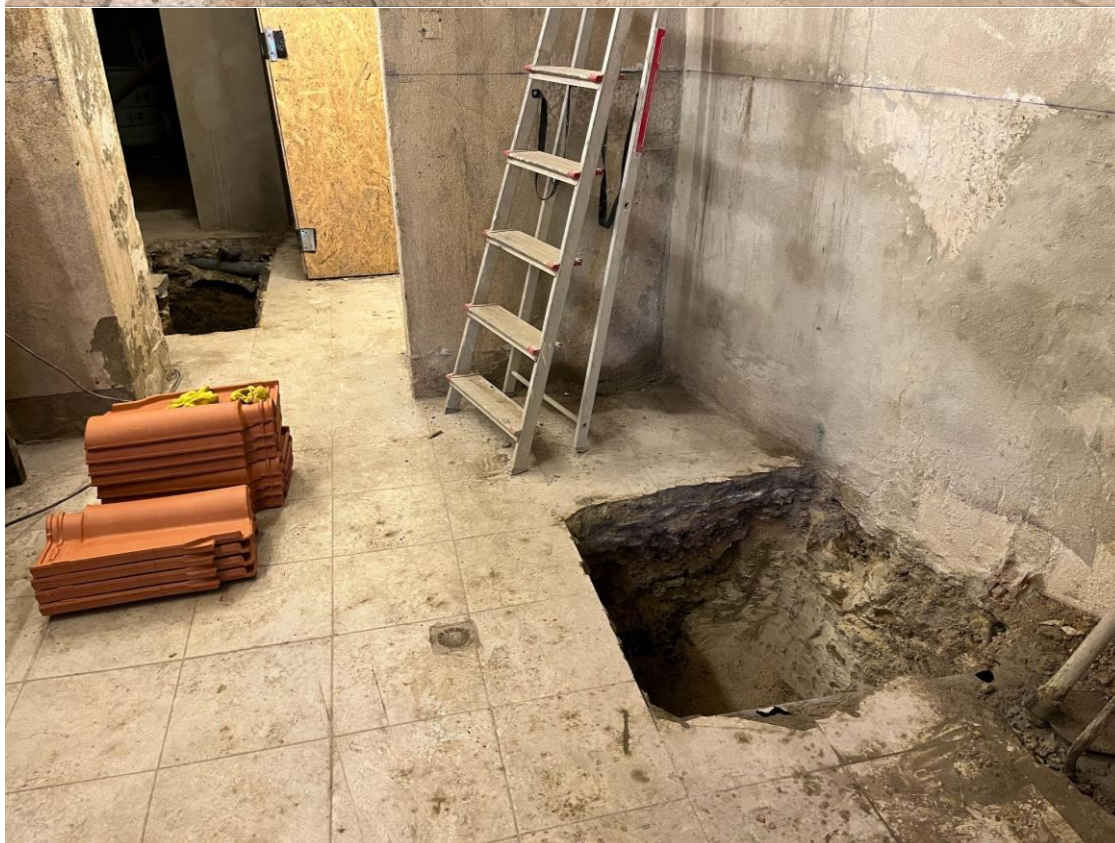
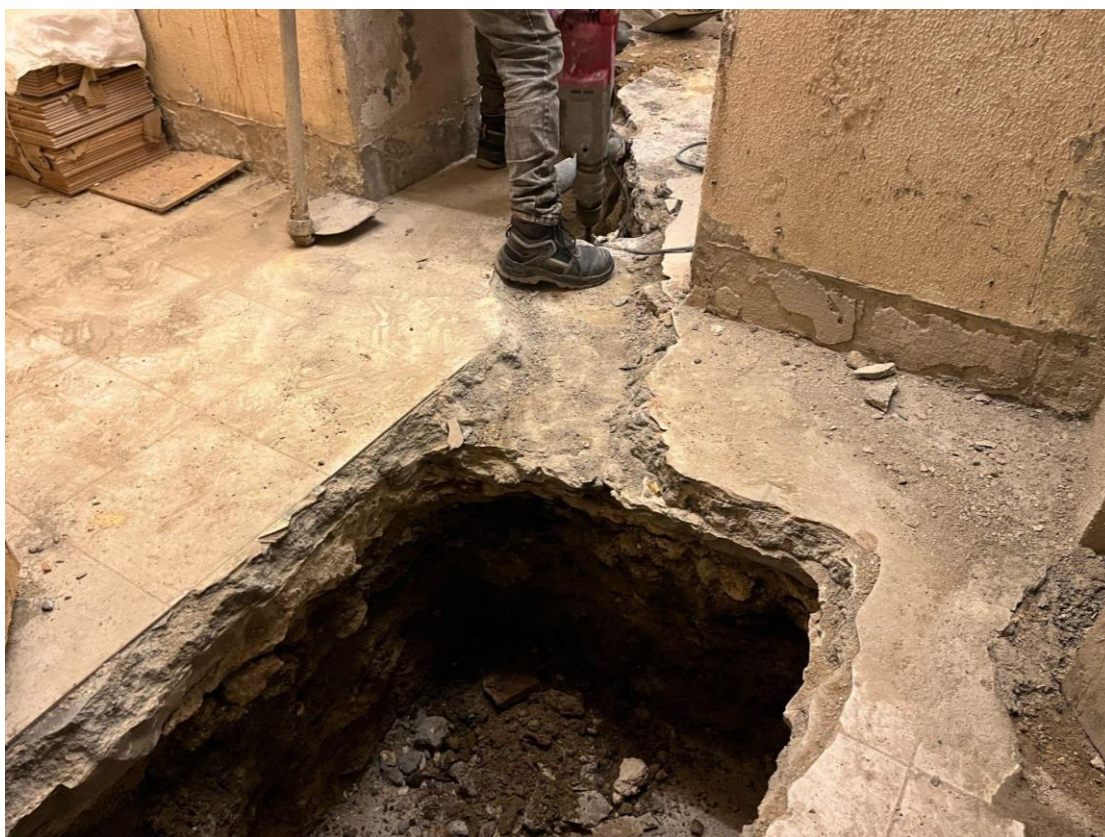
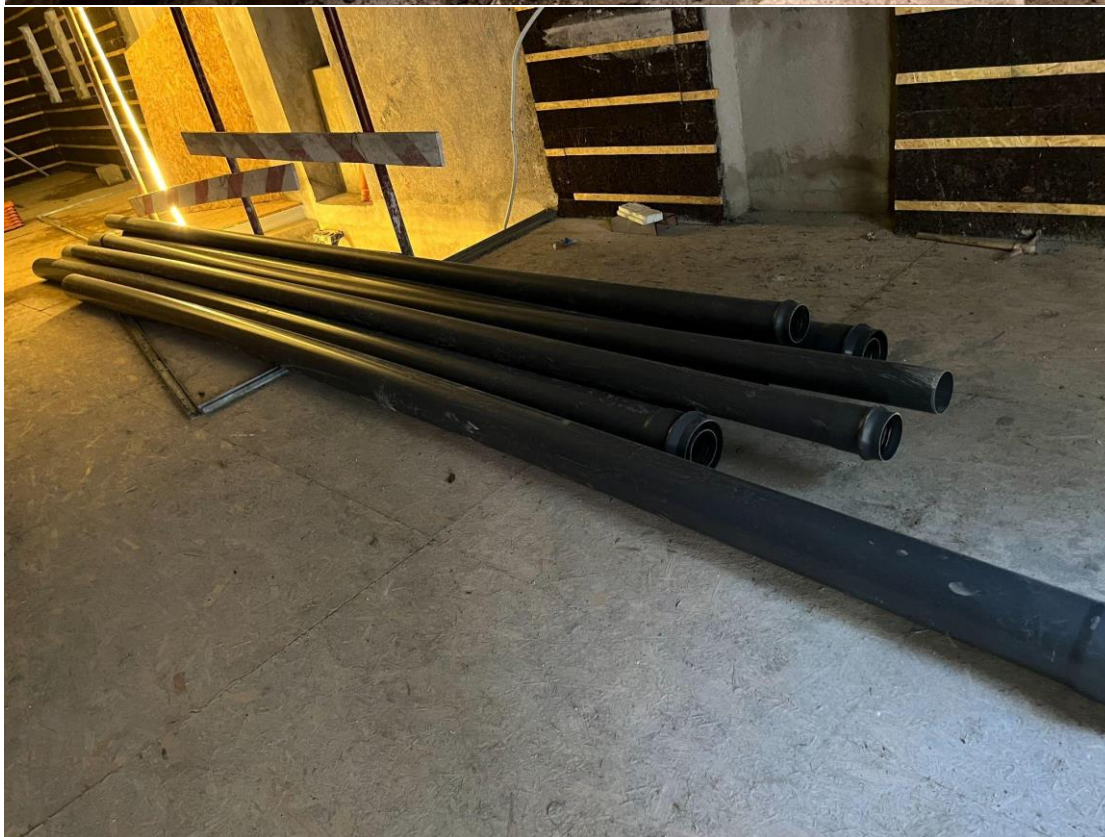
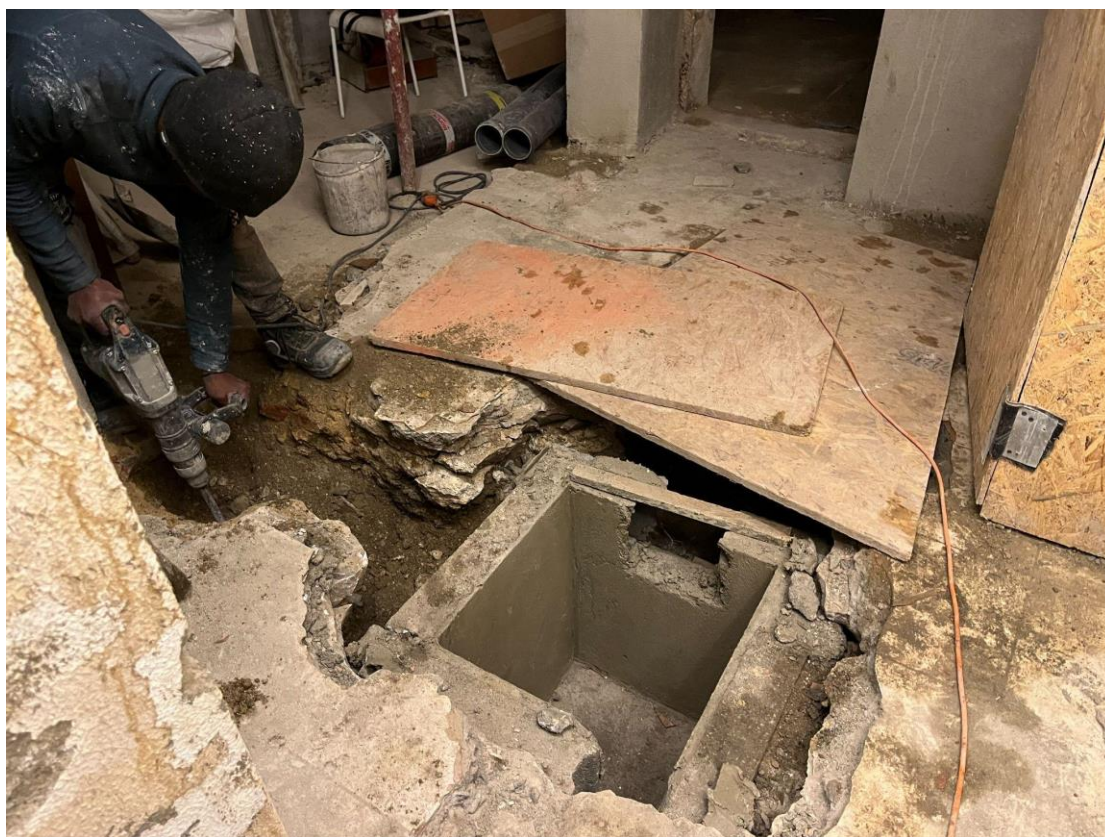
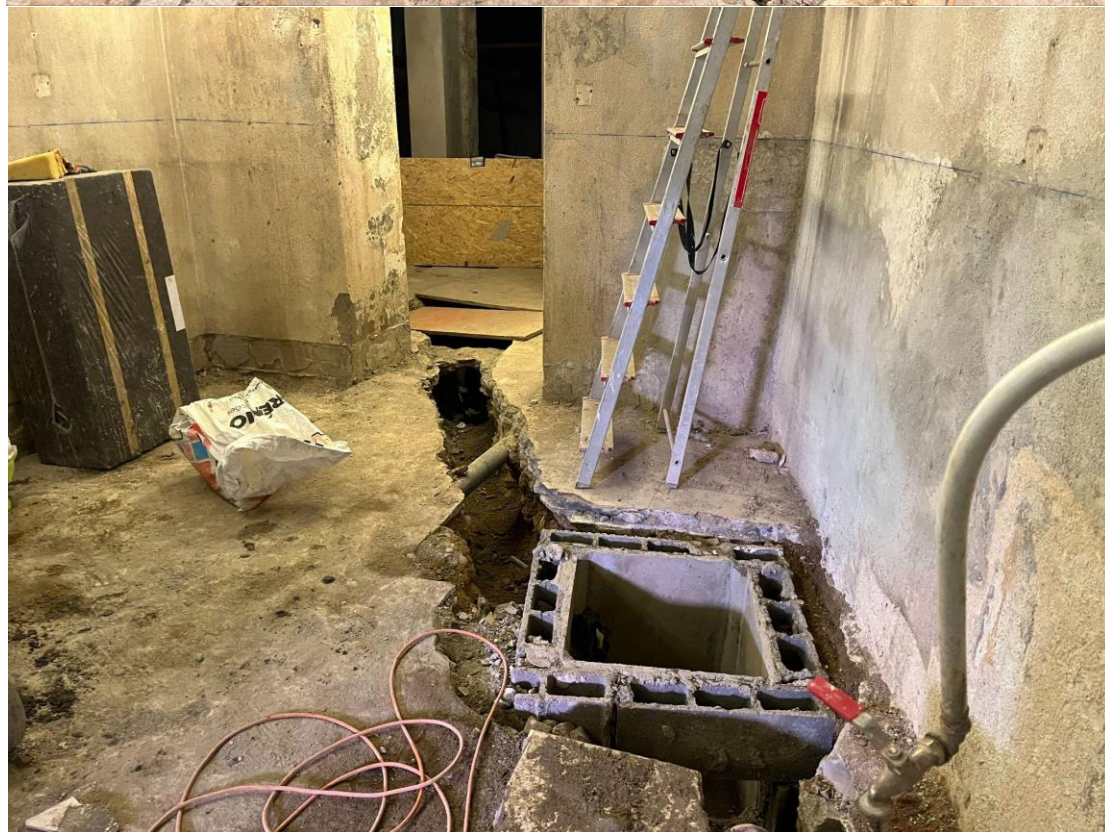
The construction team began work on the sewage network in October while demolishing part of the non-structural ground-floor walls. During this phase, the sewage box of the system was relocated to optimize its position within the overall infrastructure.

In November, the team advanced to the next stage of the process. Builders meticulously formed the sewage box using reinforced concrete, ensuring alignment with design specifications. This stage focused on achieving both structural integrity and compliance with regulatory standards, contributing to a functional sewage network for the building.

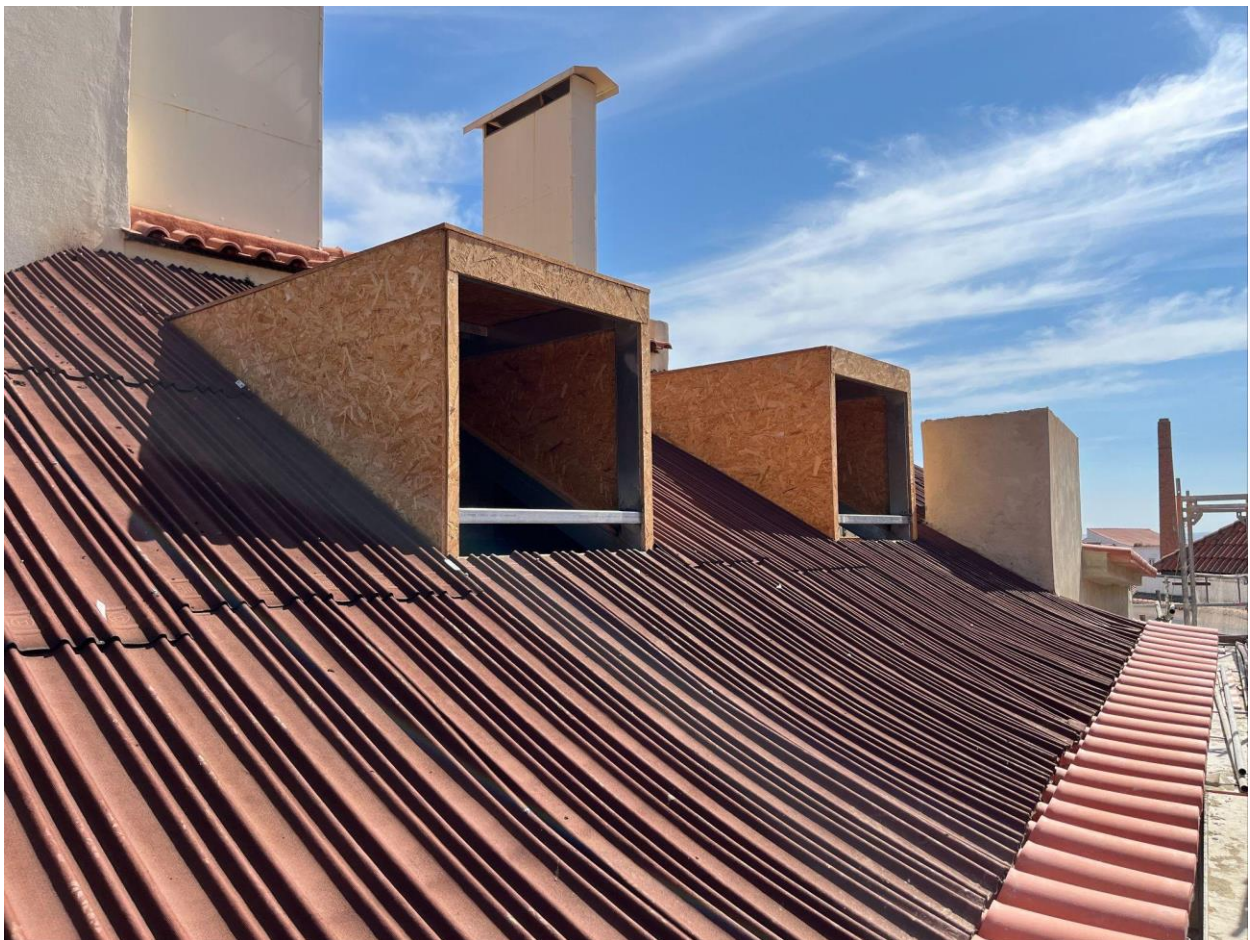
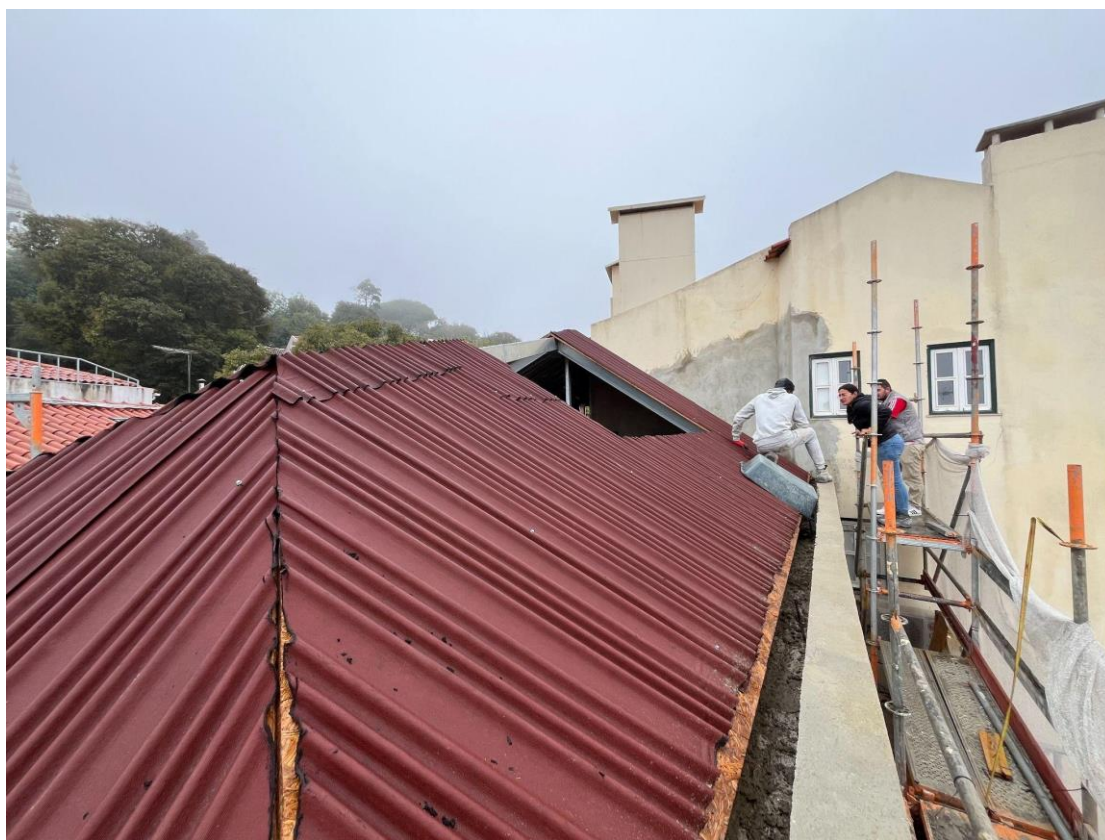
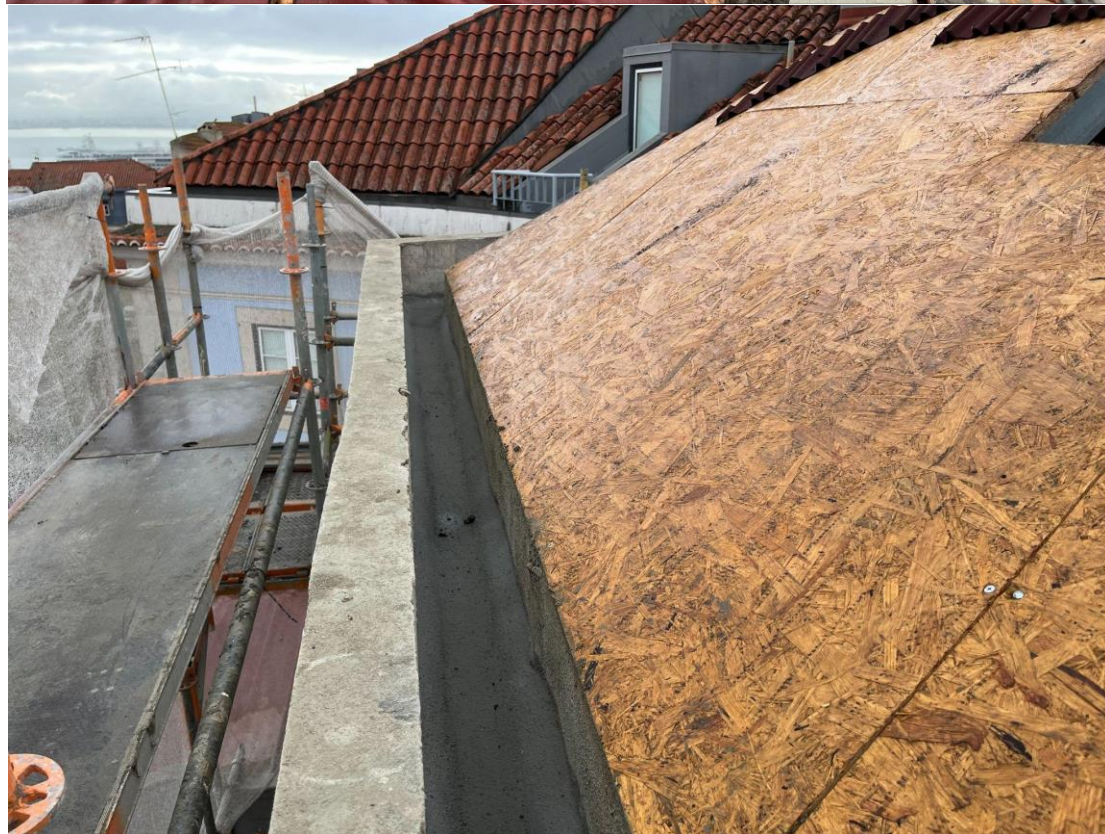
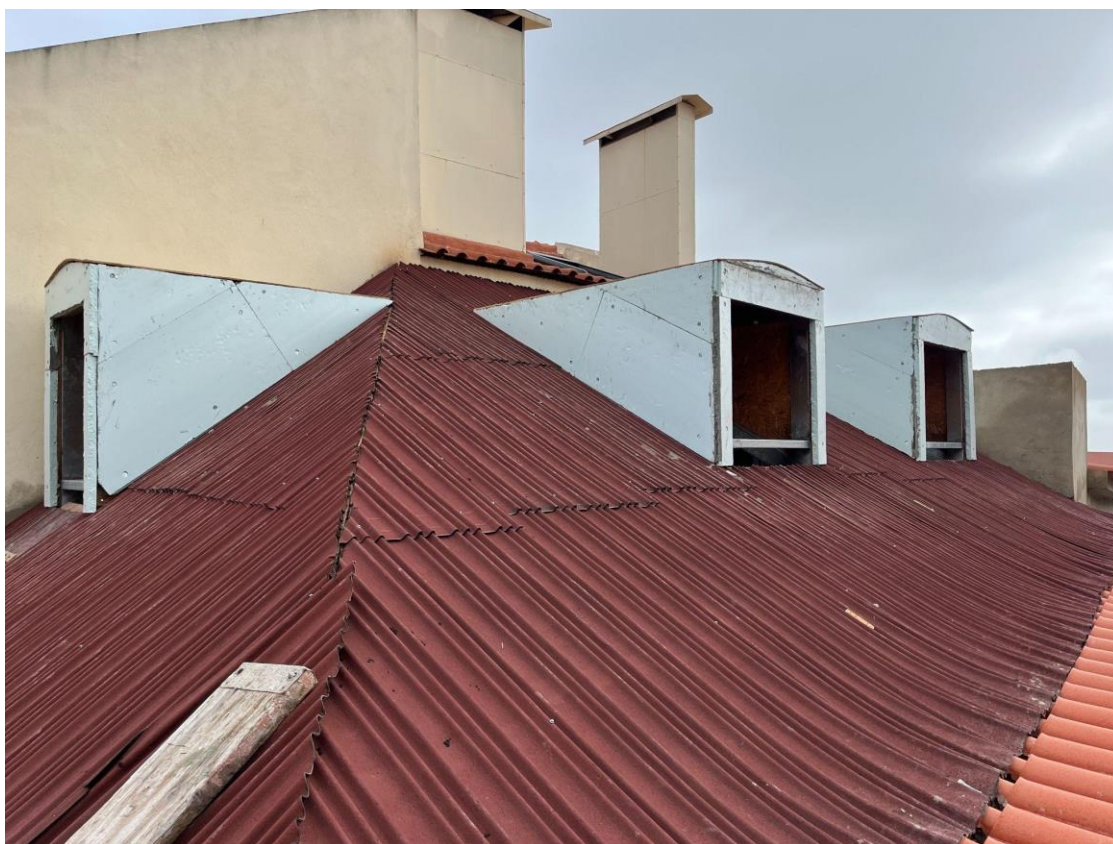
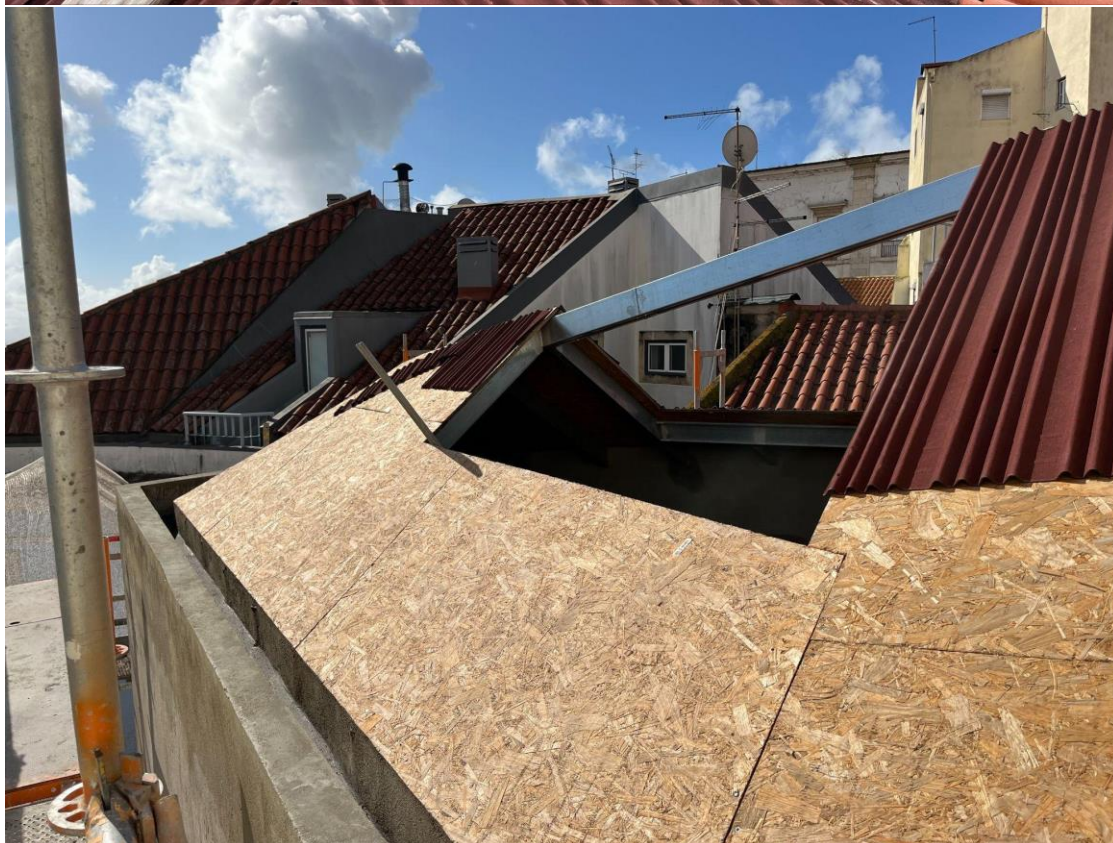
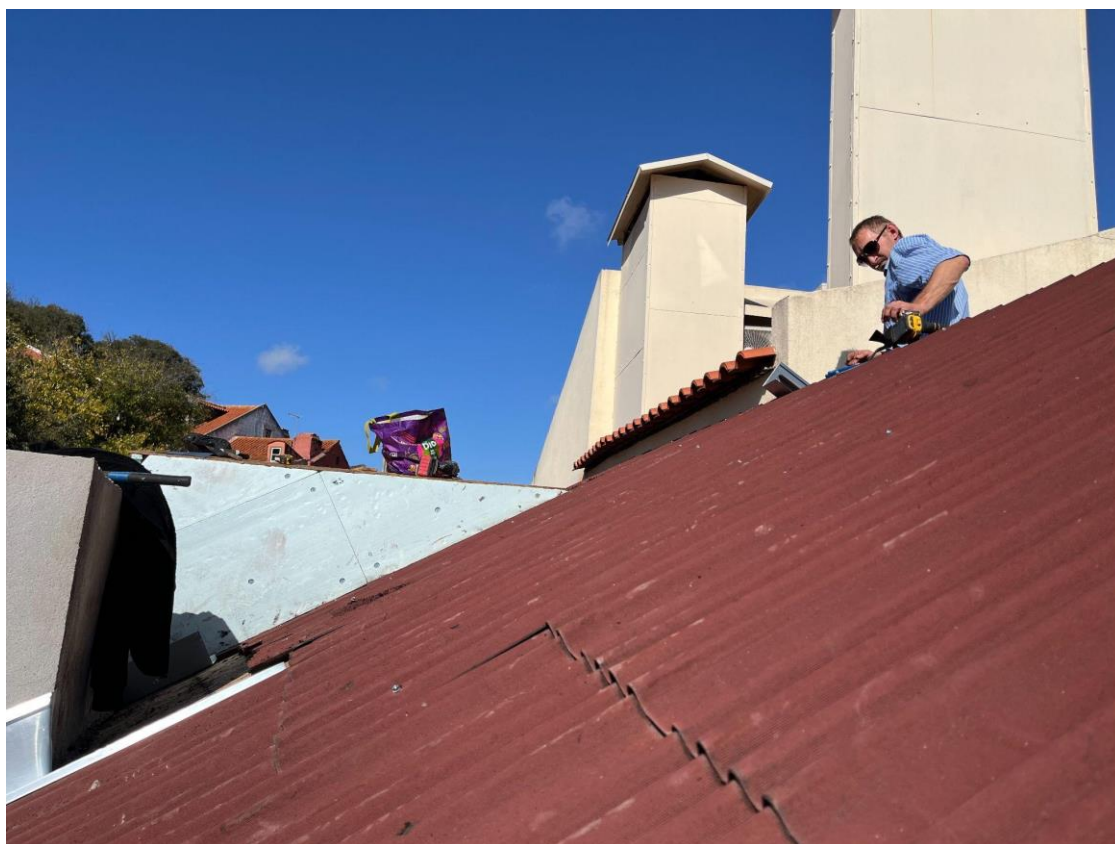
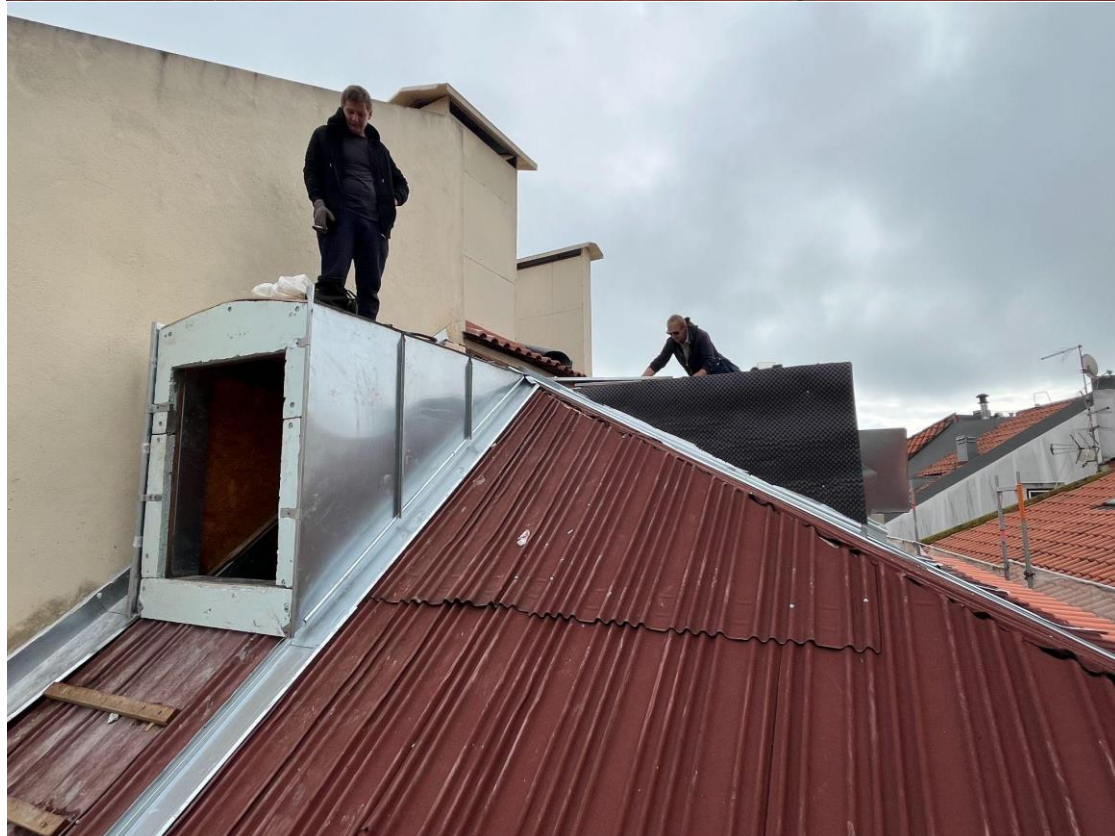
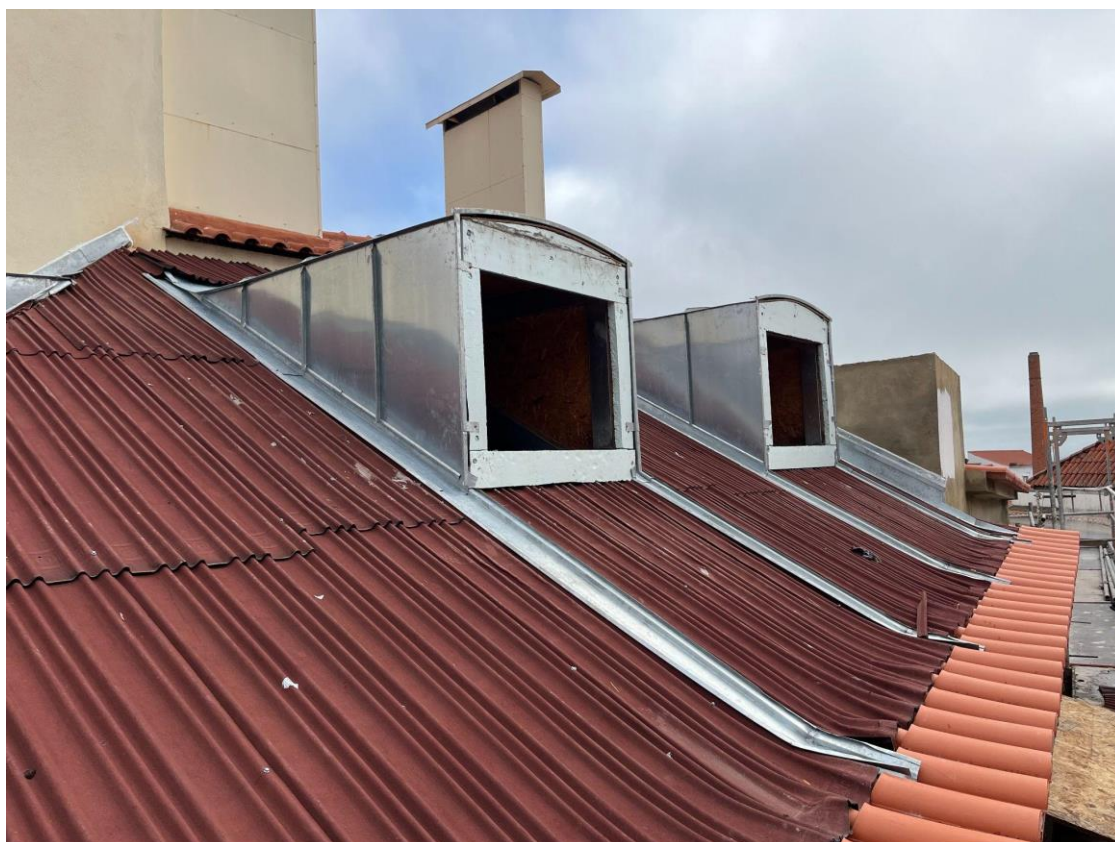
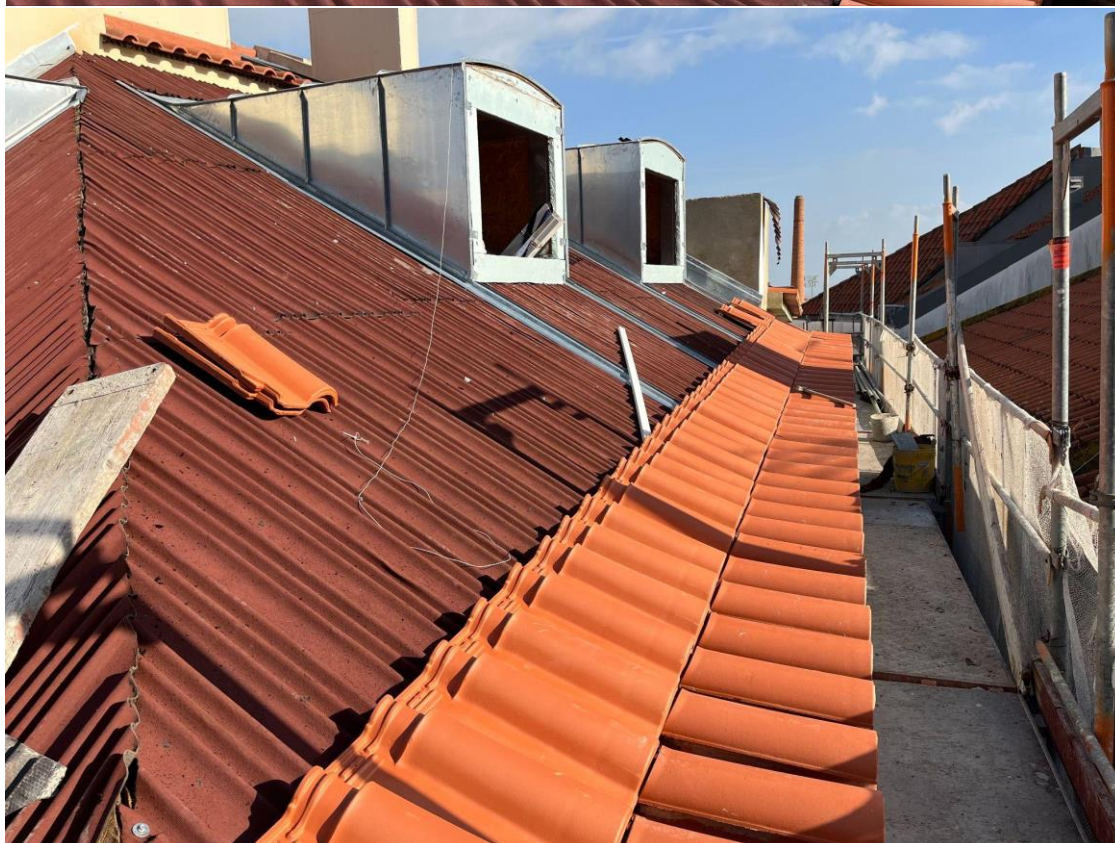
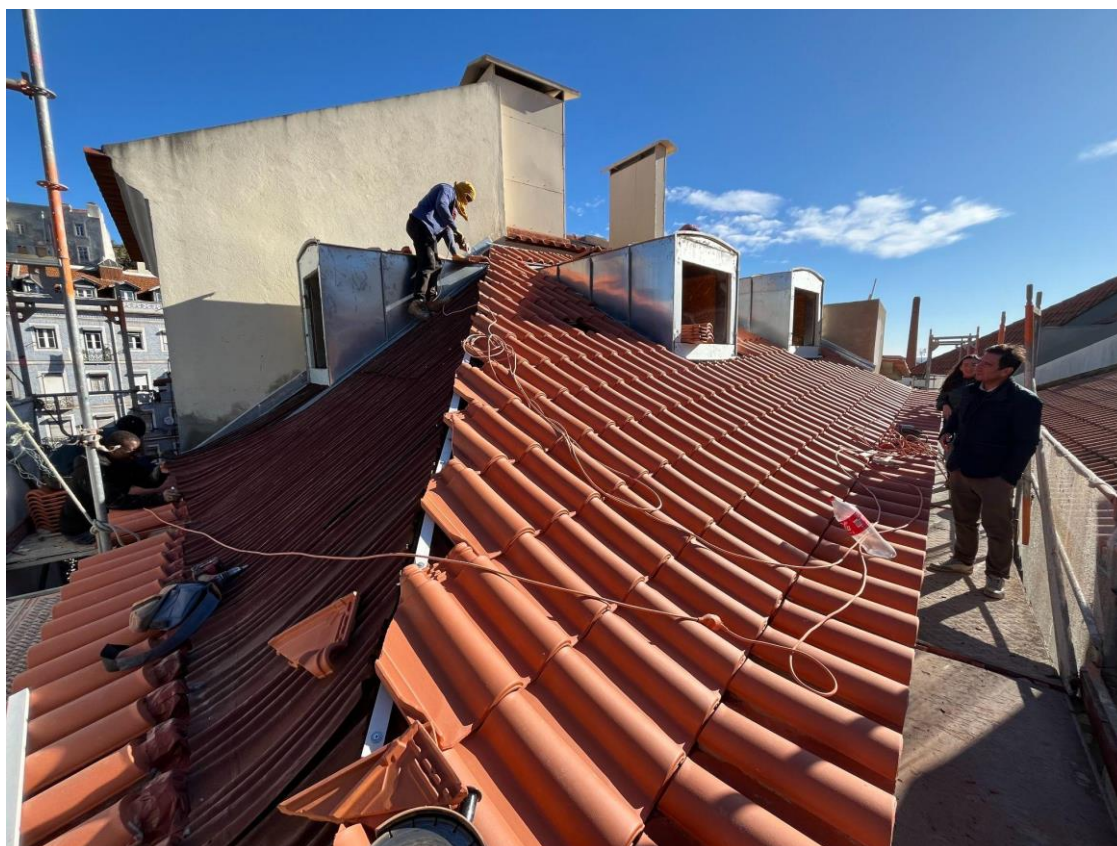
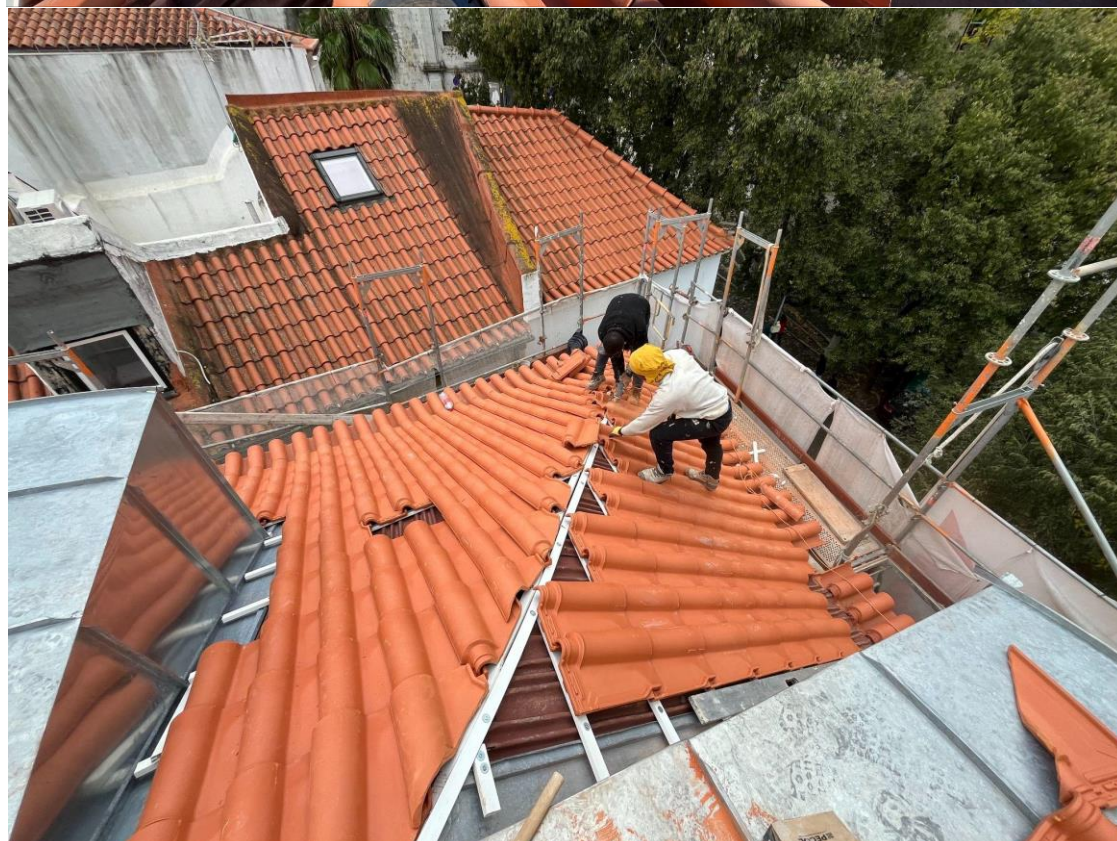
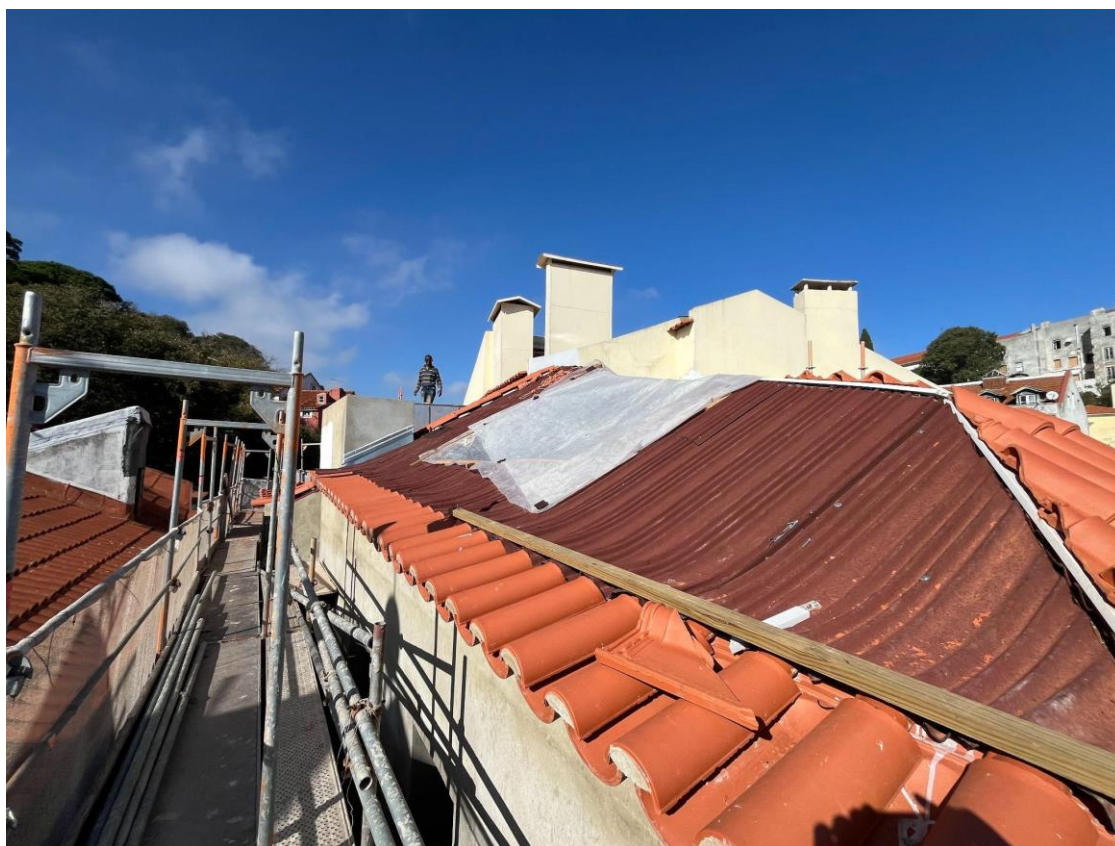
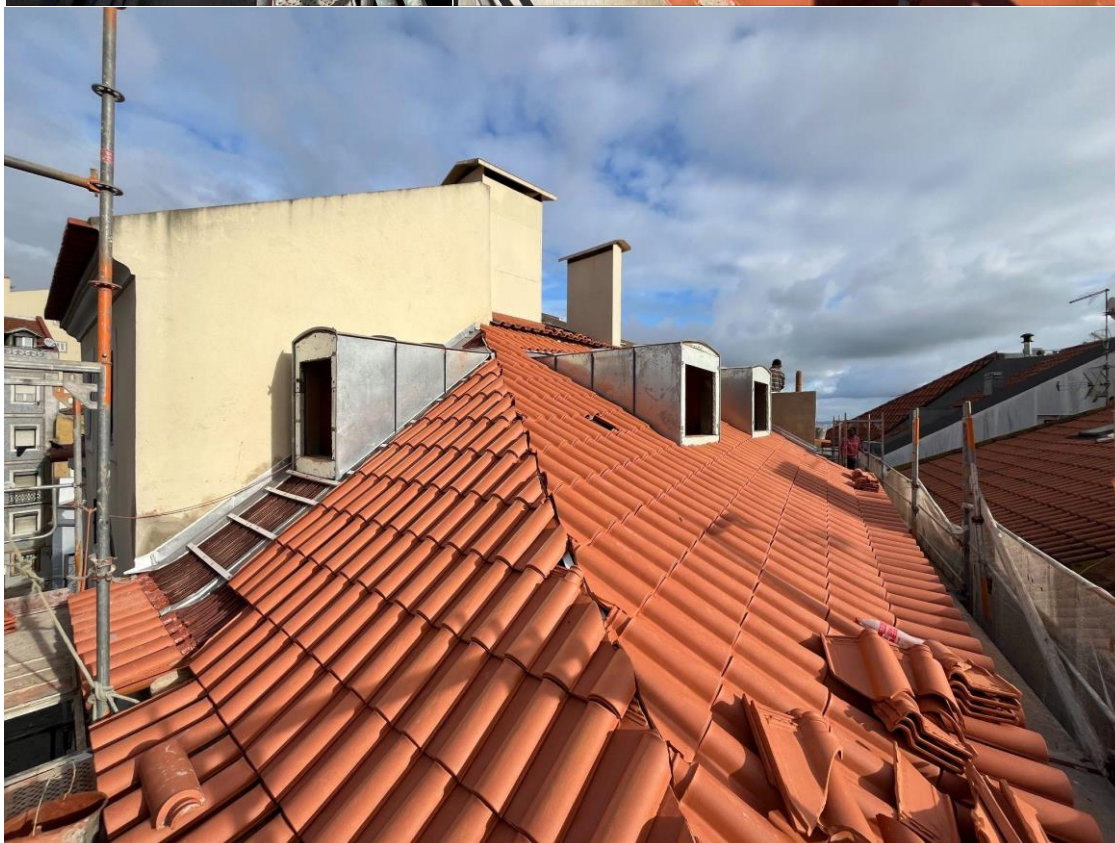
In October and November, the construction team continually maintained a focus on completing the roof. Following the successful installation of sub-tiling materials on the roof panels, they proceeded to install insulation around the dormer windows. Subsequently, zinc cladding was applied to the dormers, adding both durability and aesthetic appeal.

Simultaneously, the team began tiling the roof with traditional red roof tiles carefully, preserving the building's classic architectural character. In addition to these tasks, they constructed a stormwater drainage system along the roof edges, designed to manage rainwater efficiently and prevent water accumulation. This comprehensive approach ensured the roof's functionality, durability, and visual harmony with the building's design.
