Project: Largo Rodrigues de Freitas no 4 e 5 e Beco da Lage no 4, 1100-455 Lisboa

Report Number: Freiras - 25

Construction Progress Report

Monthly Period Reporting

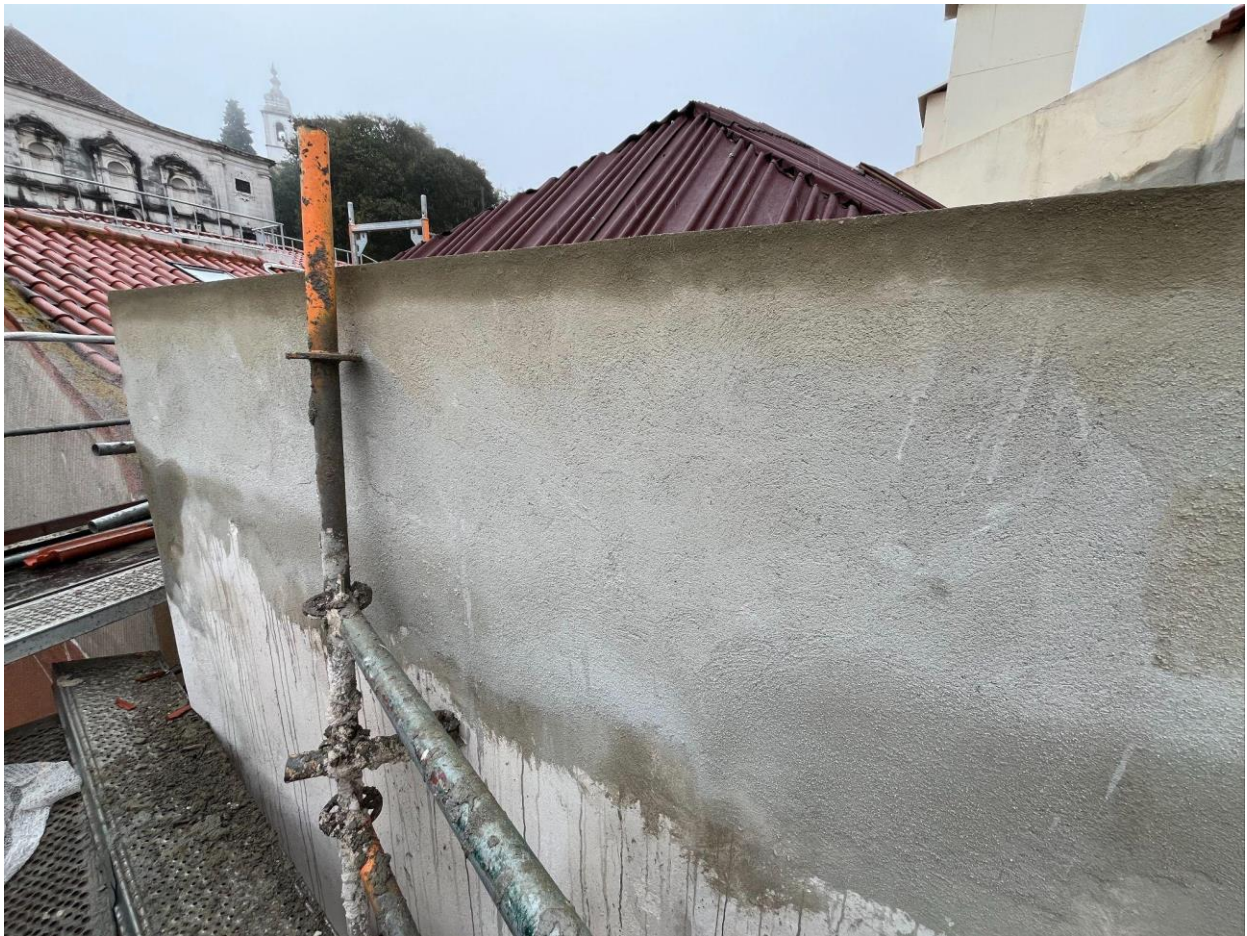
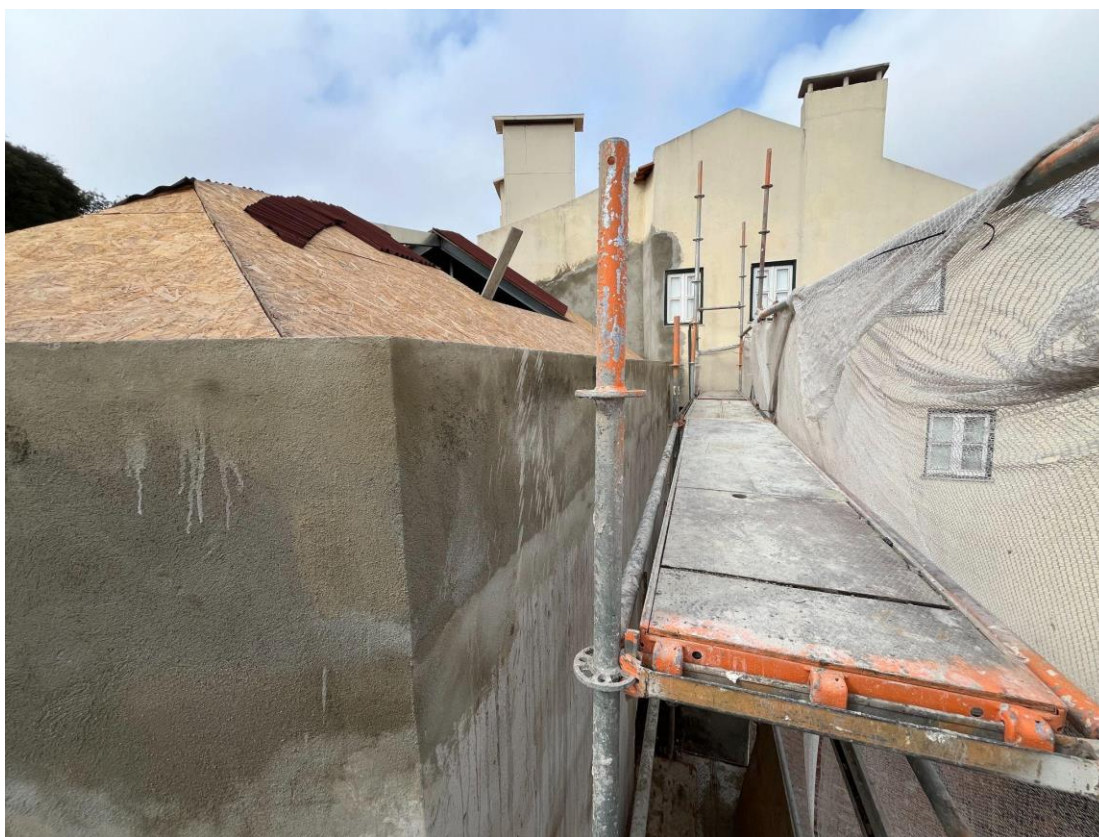
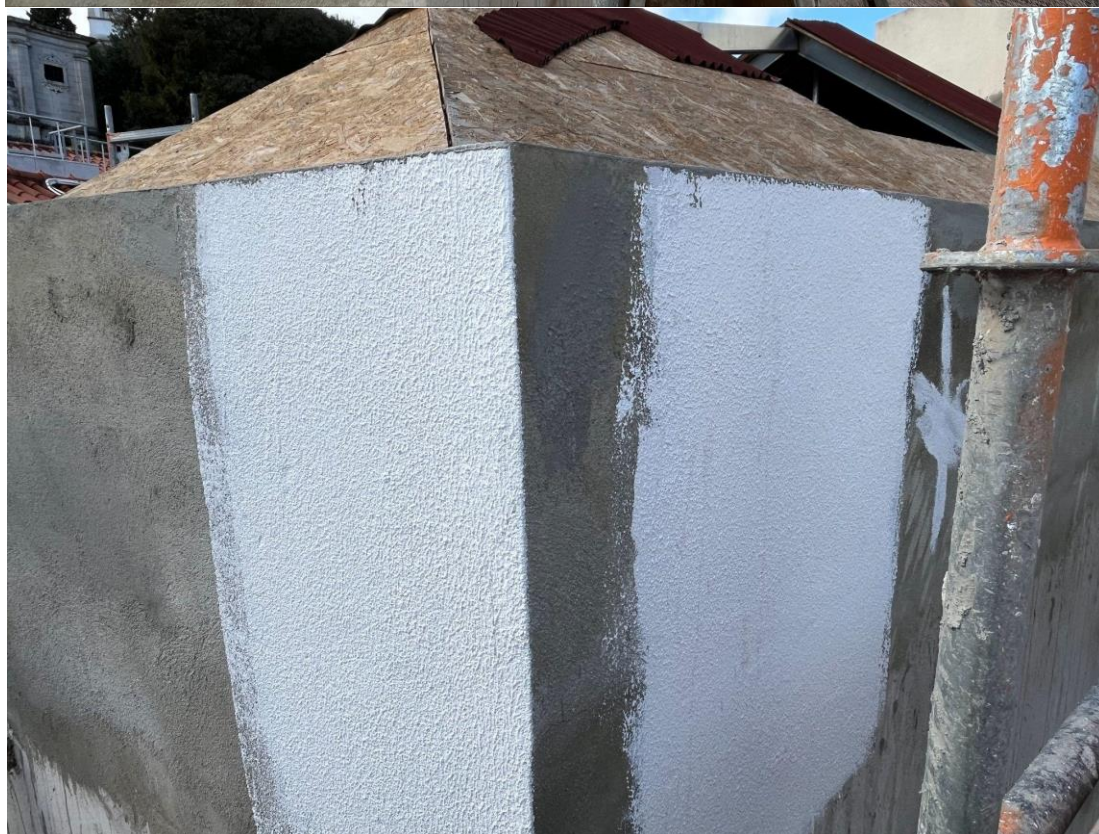
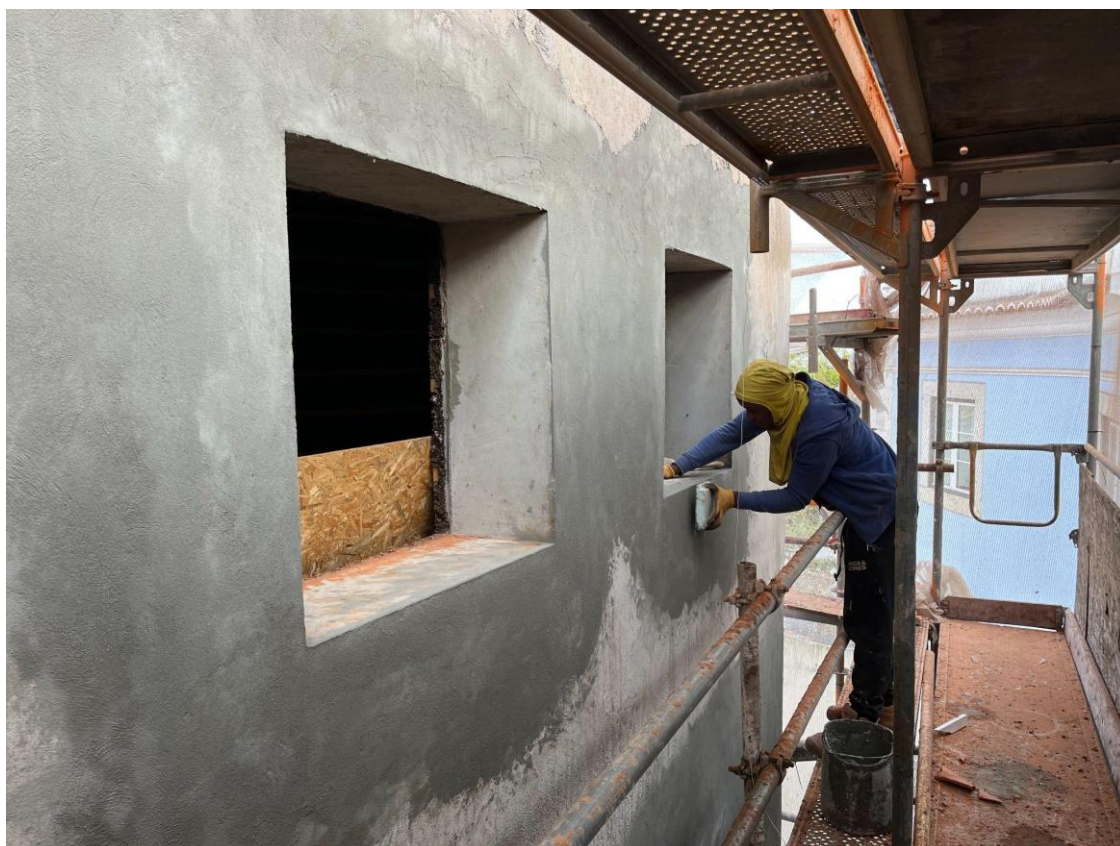
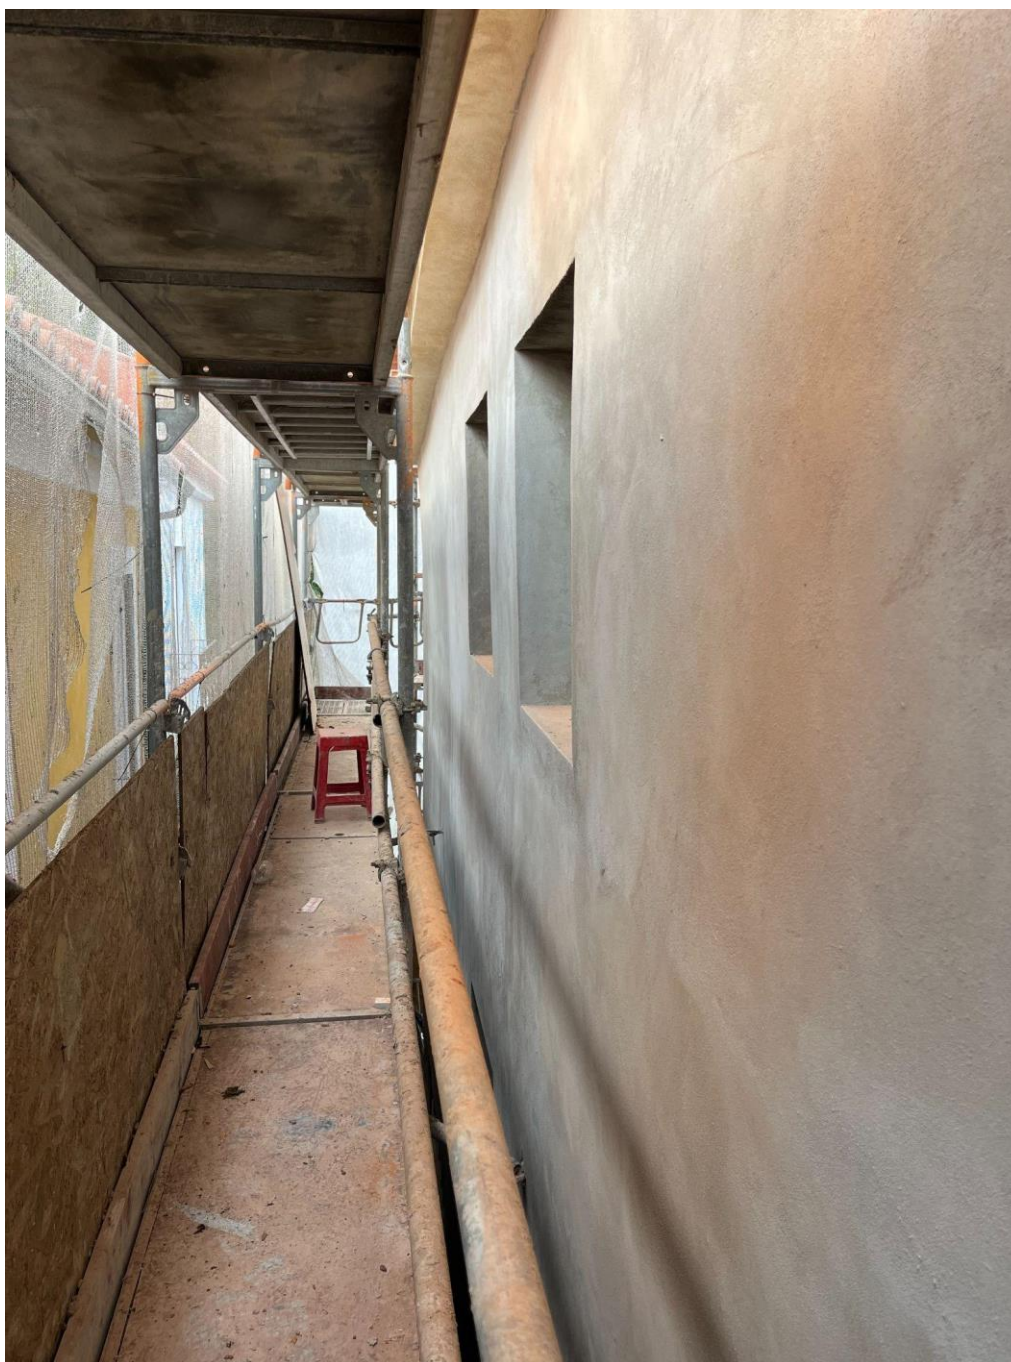
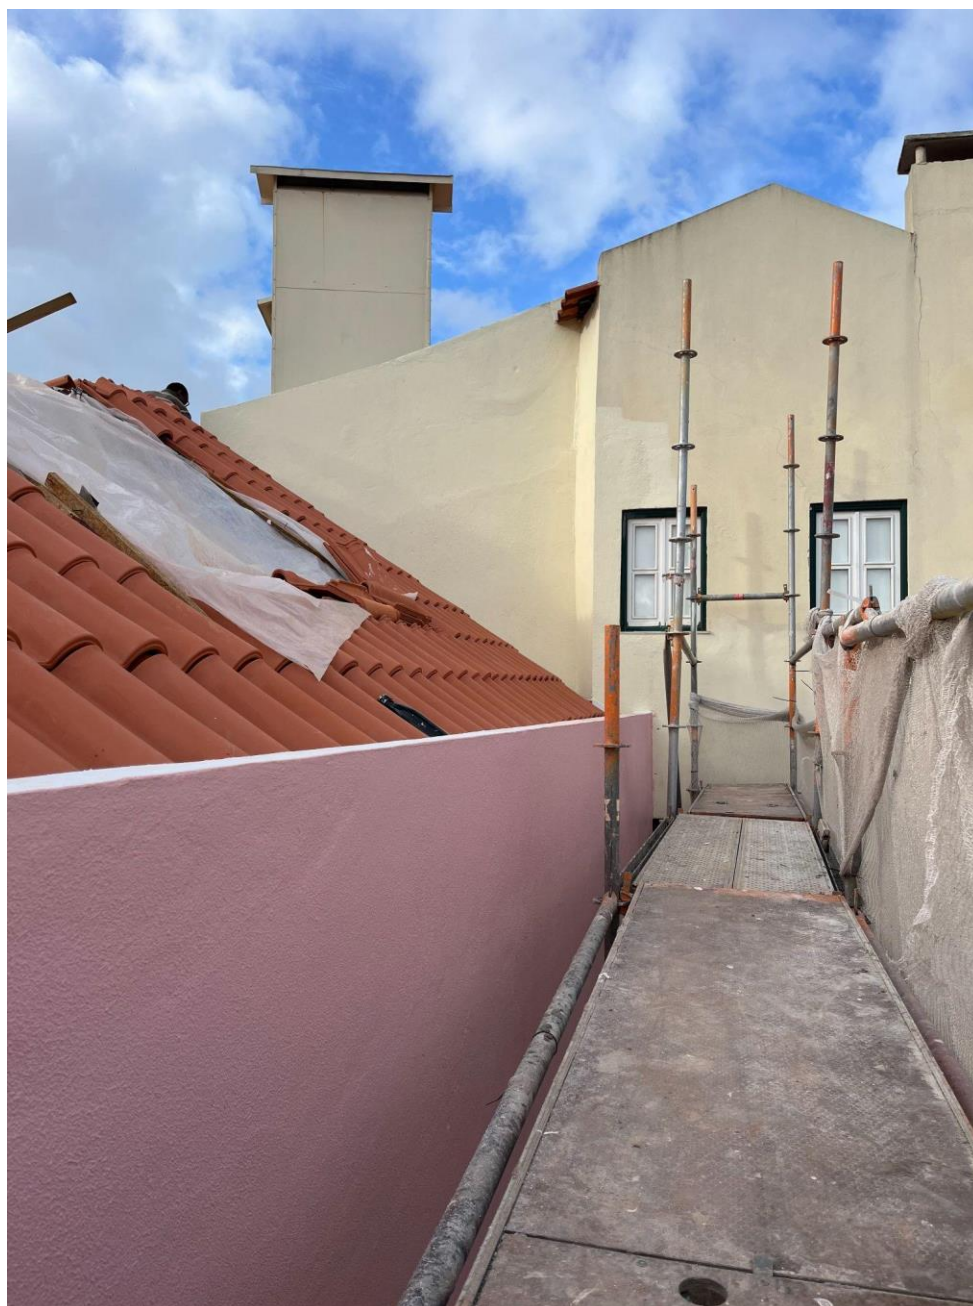
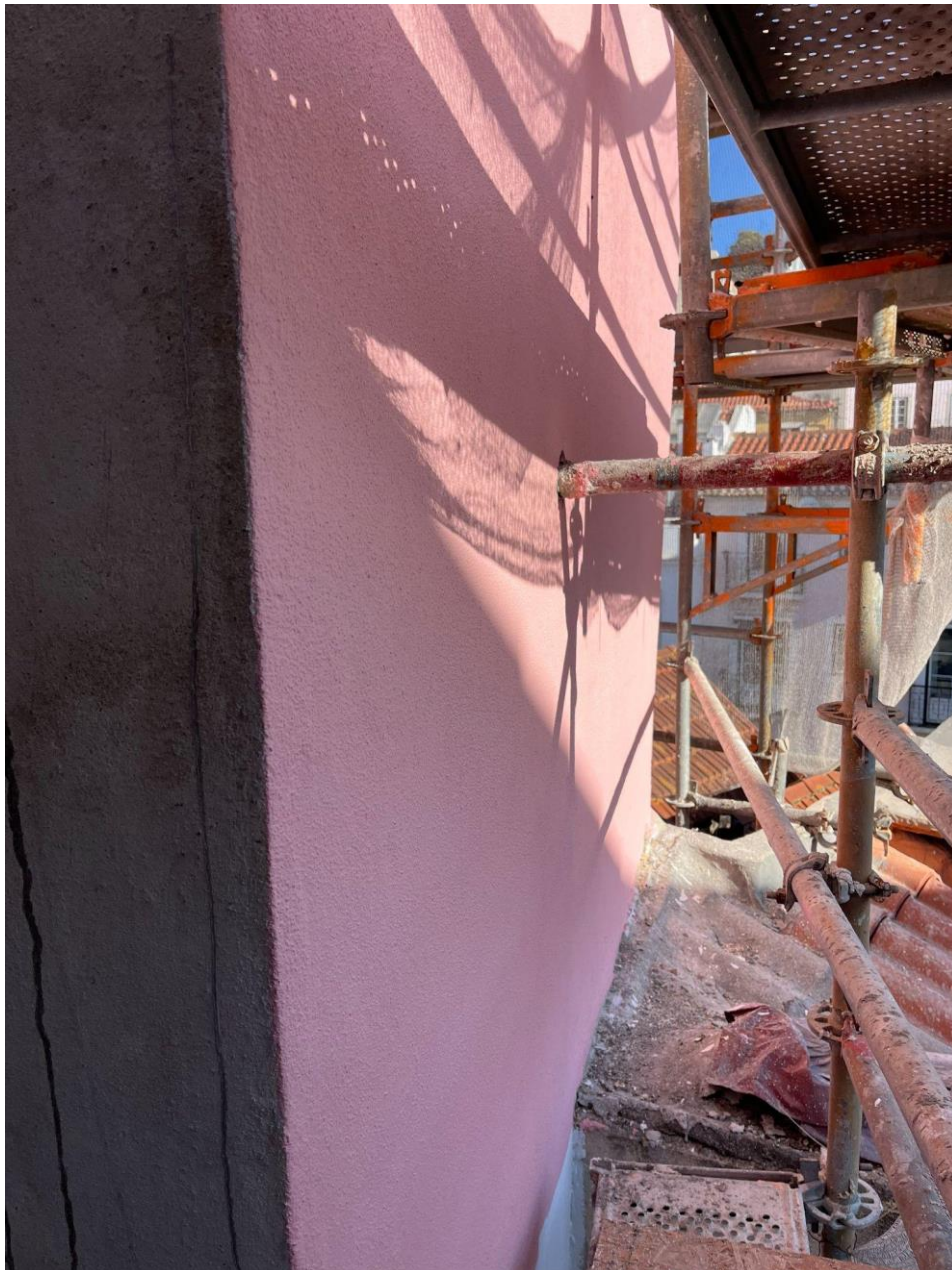
In November, the construction team began work on the façade repairs, focusing on restoring the exterior. They started with the careful removal of the existing plaster, preparing the surface for refurbishment. After completing the removal, they applied new plaster to the surface and filled in any gaps, to create a smooth and even surface. Following that, the team applied the first layer of paint in a white shade, then in pink, preparing the façade for further finishing.
