**Project:** Largo Rodrigues de Freitas no 4 e 5 e Beco da Lage no 4, 1100-455 Lisboa

**Report Number:** Freiras - 20

## Construction Progress Report

Start: Friday, 01 March 2024 End: Sunday, 31 March 2024

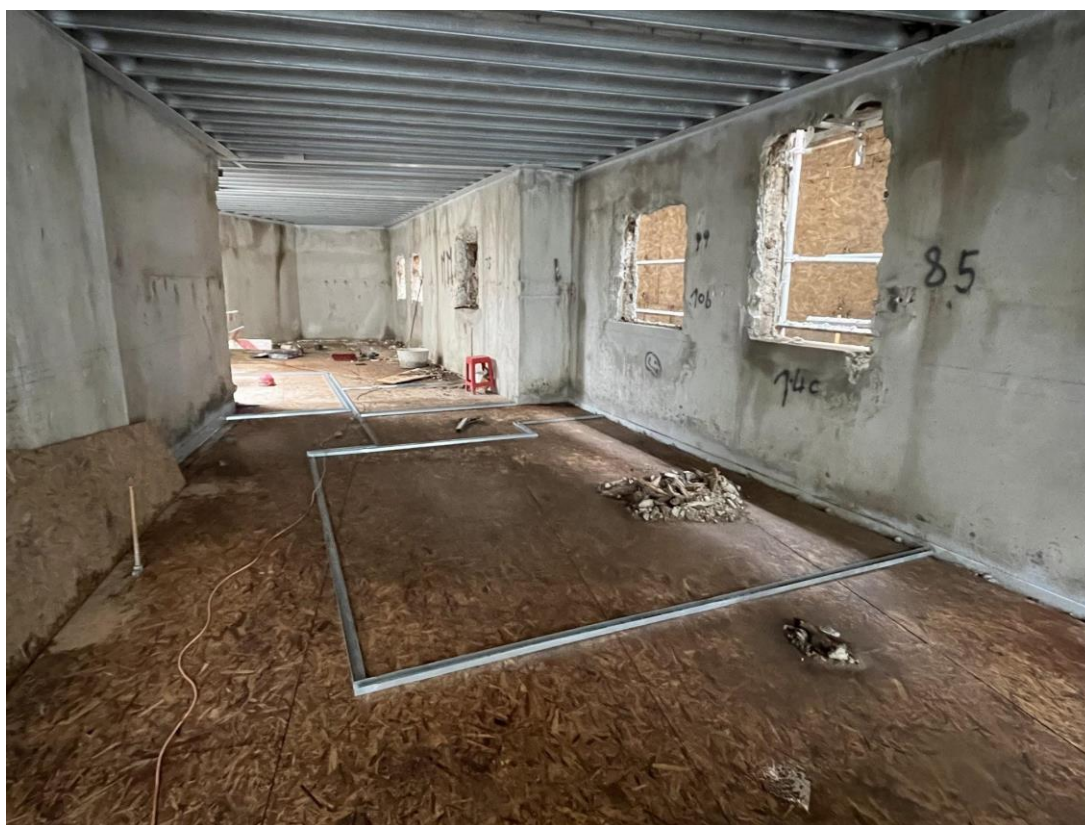
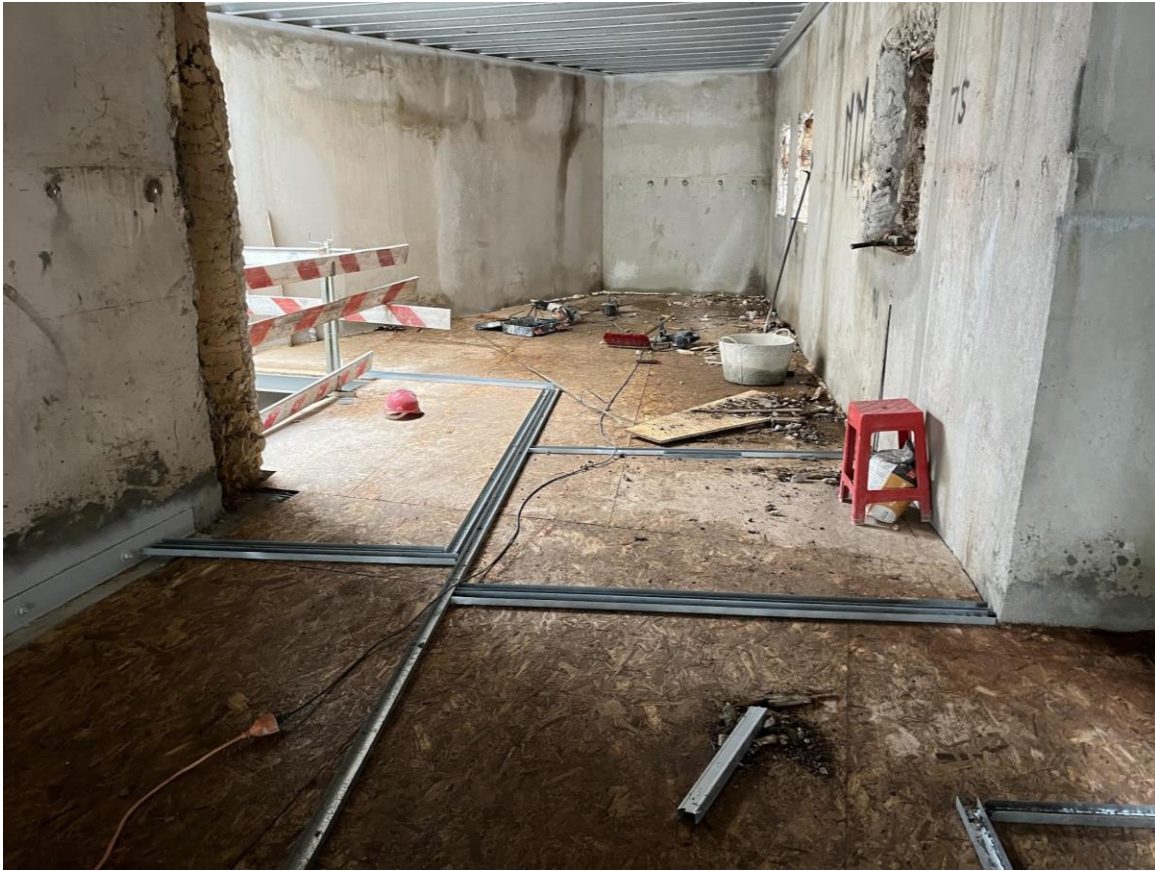
**In March, following the completion of installing the steel structure and placing panels on the 1st and 2nd floors, the construction team commenced the process of removing the provisional steel structure, with the exception of the parts on the main facade, which were retained to continue supporting the facade walls.**

**Subsequently, they initiated the placement of the bottom steels for the interior wall structure as a test of the partition wall layout. This step was taken to ensure compliance with the improved structural plan and design, which were based on real site measurements.**
