## Construction Progress Report

Start: Thursday, 01 September 2022 End: Friday, 30 September 2022

**Project:** Rua Nova do Loureiro 43-45, Lisboa

**Report Number:** Laurel - 07

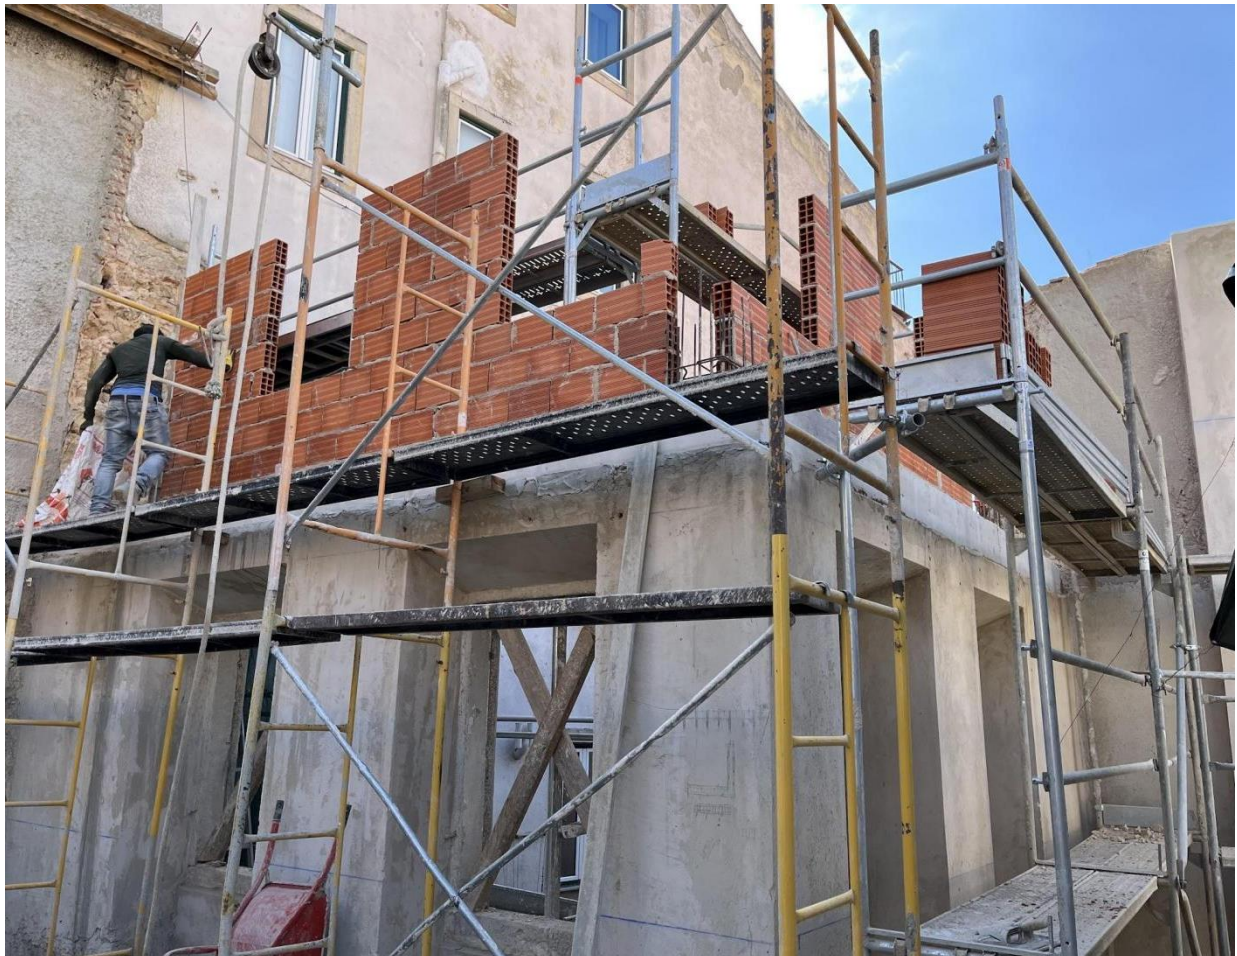
**As mentioned in the last report, the builders demolished the upper walls a bit more to prepare for the capping beam made of steel and concrete, which ties all the piling together to create the foundation for the next step. In September, they continued installing the columns and bricks on the beam to rebuild the external walls of the building facing the garden. Meanwhile, they started to prepare to build capping beams on the front façade walls.**

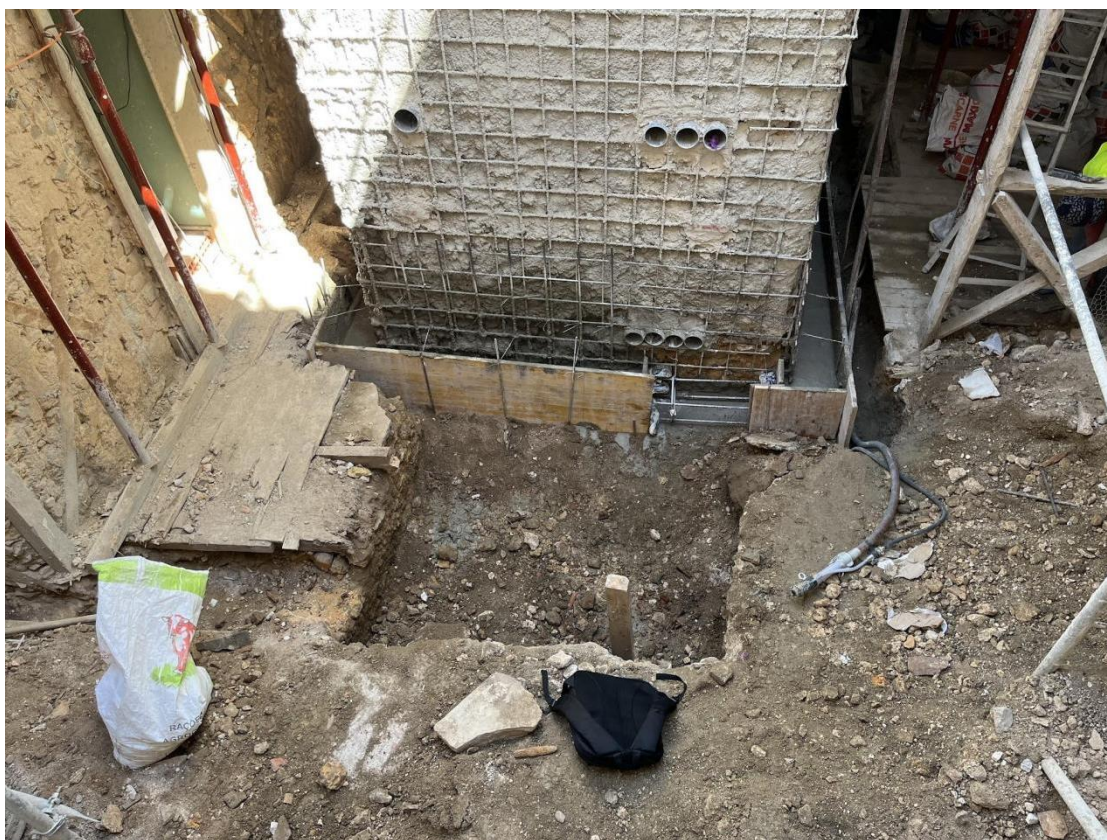
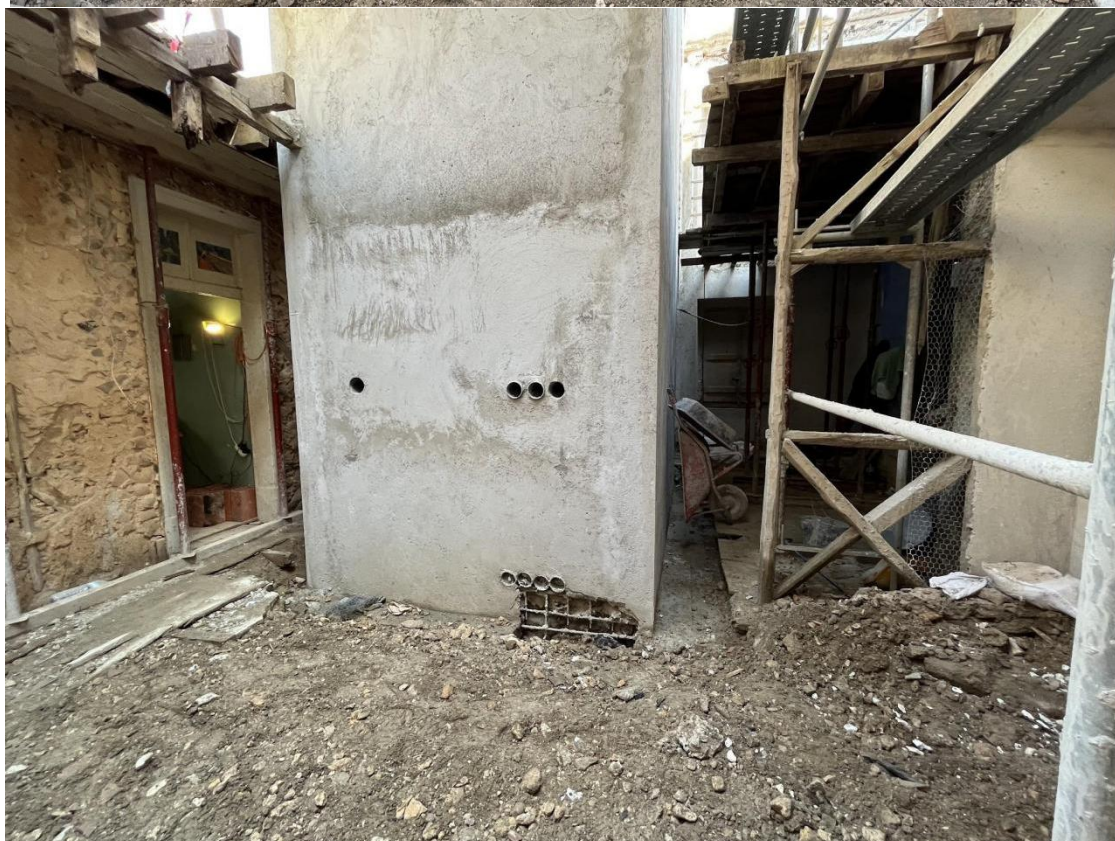
**In September, the builders finished working on applying reinforcement plaster on the staircase walls. and poured concrete as the foundation of the staircase in order to make it stronger.**

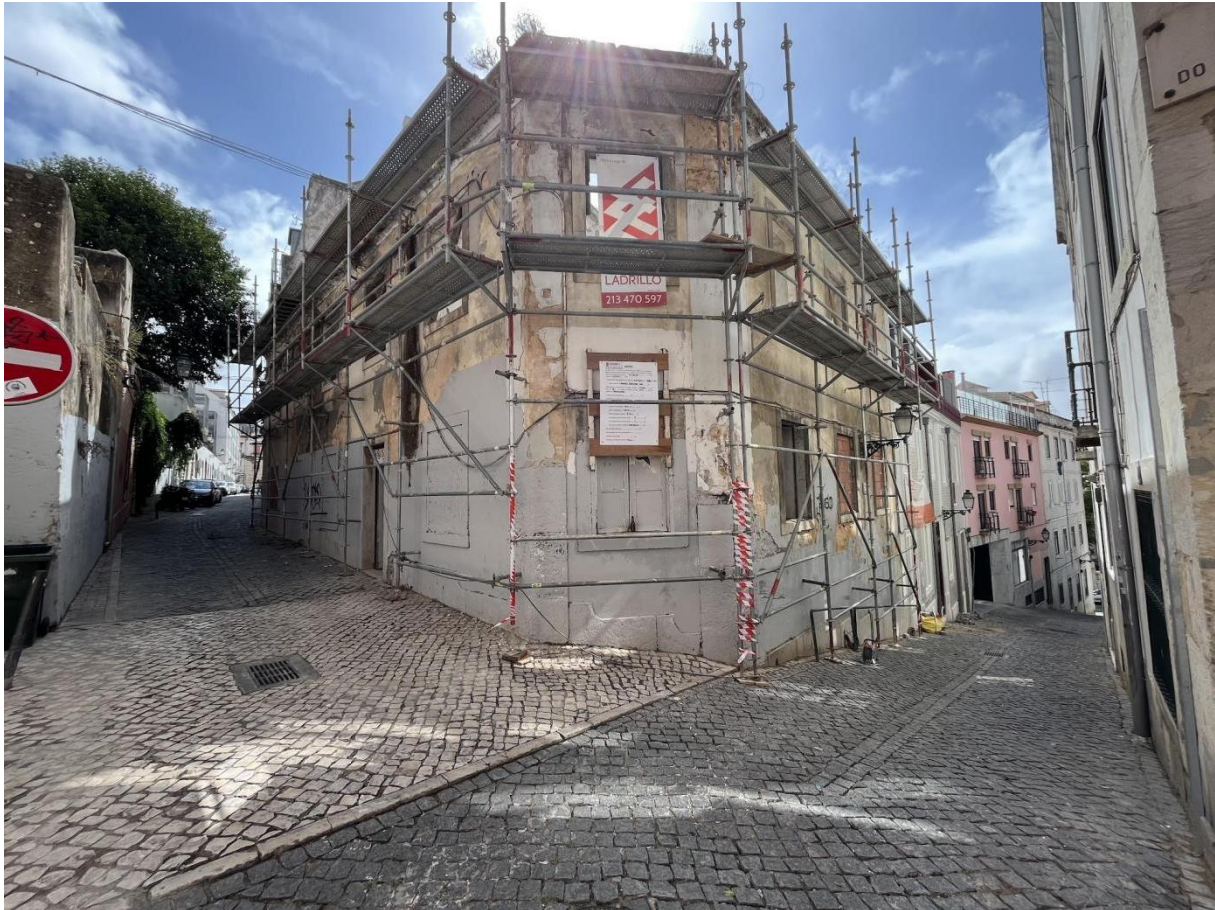
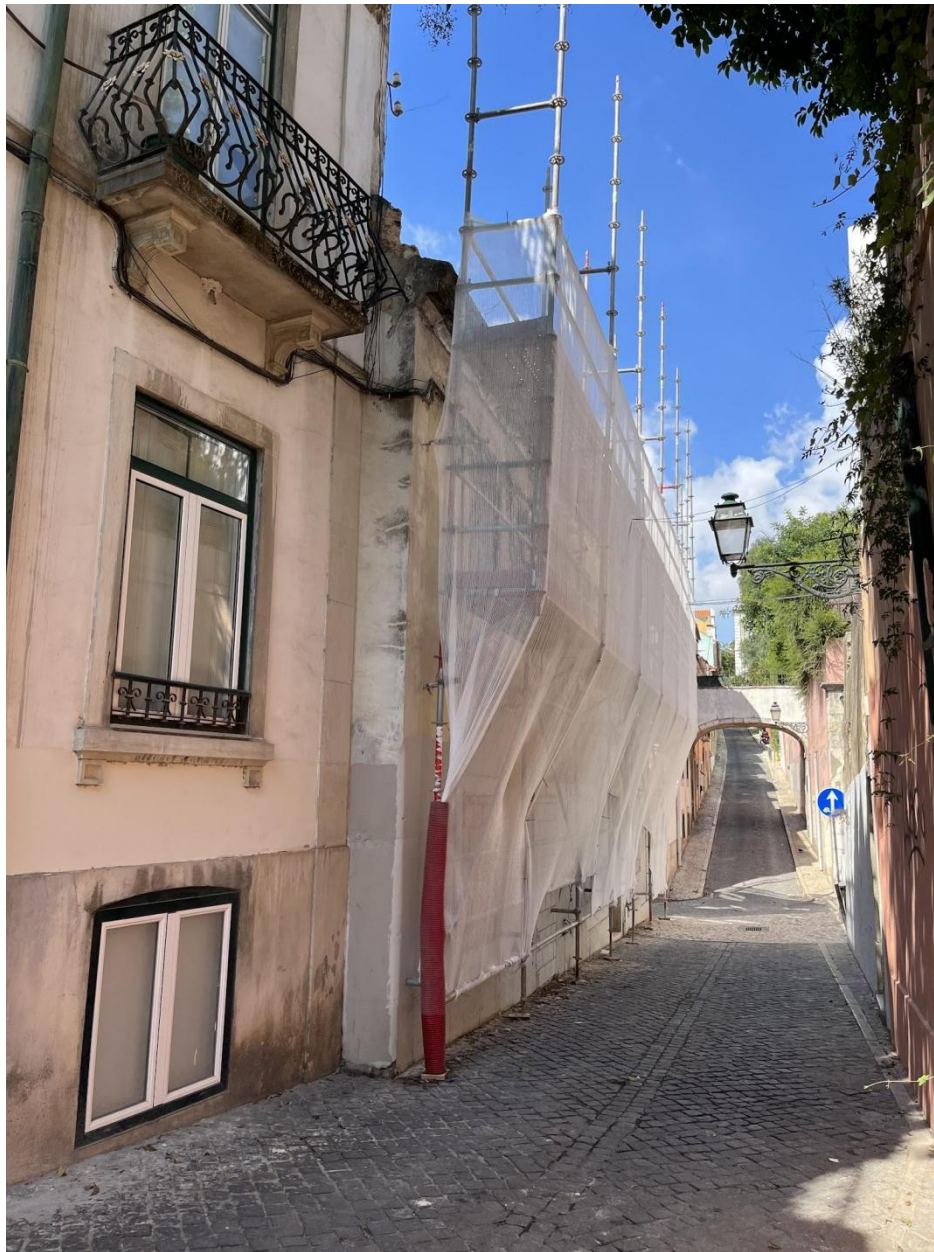
**Following the plan, the builders installed scaffoldings on the front facade to better work on the job site and protect the facade of the building.**
